Regarding: Lead Paint Condition Assessment  
Atkinson Elementary School  
5800 SE Division Street  
Portland, OR 97206  
PBS Project: 6500.721 Phase 0006

### Assessment of Paint/Varnish in Deteriorated (Poor) Condition

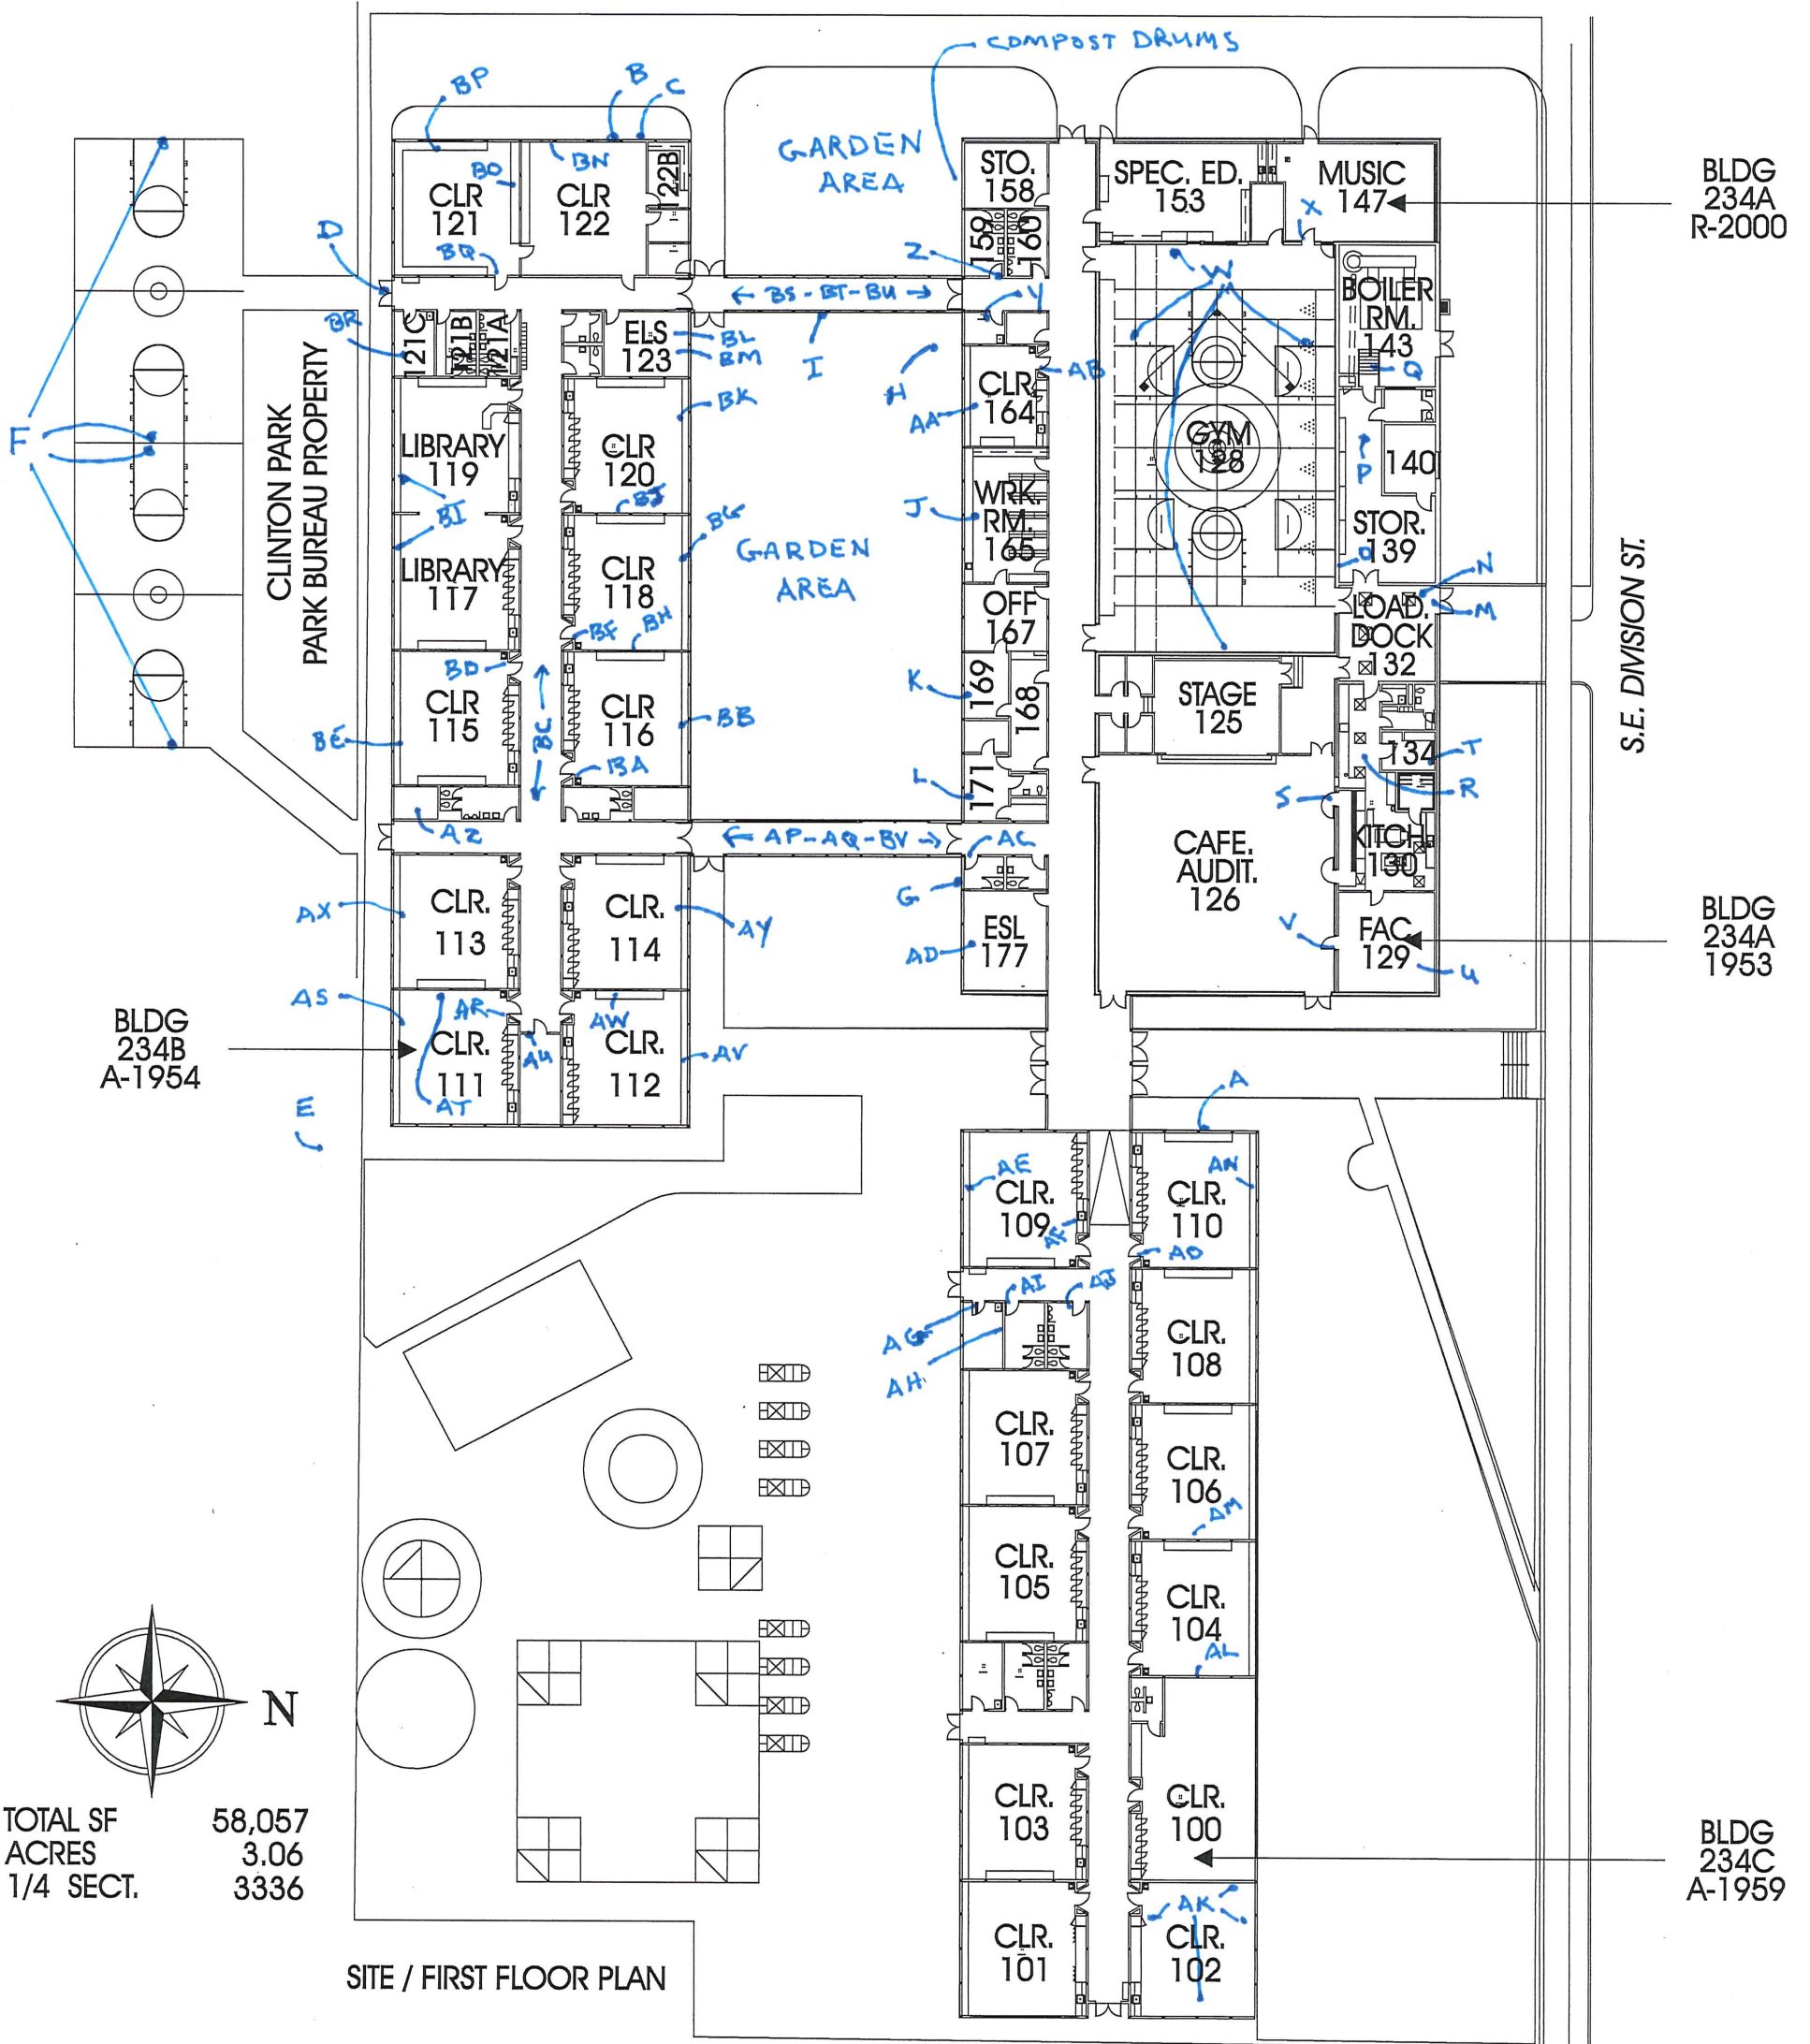
SITE / FIRST FLOOR PLAN

Paint stabilization at the school had not occurred prior to PBS' site visit. The building's painted and varnished surfaces were found to be in fair to good (intact) condition with areas of deteriorated conditions. A table showing the location and quantity of surfaces in deteriorated condition is attached to this report.

Paint chips were not noted on concrete, but were noted in soil on the west exterior side of classroom 122.

PBS recommends that all painted or varnished surfaces in poor condition be stabilized. Paint chips on the soil on the west exterior side of classroom 122 should be removed.
