October 21, 2016

Regarding: Lead Paint Condition Assessment
Markham Elementary School
10531 SW Capitol Highway
Portland, Oregon, 97219
PBS Project: 6500.721 Phase 0035

Assessment of Paint/Varnish in Deteriorated (Poor) Condition

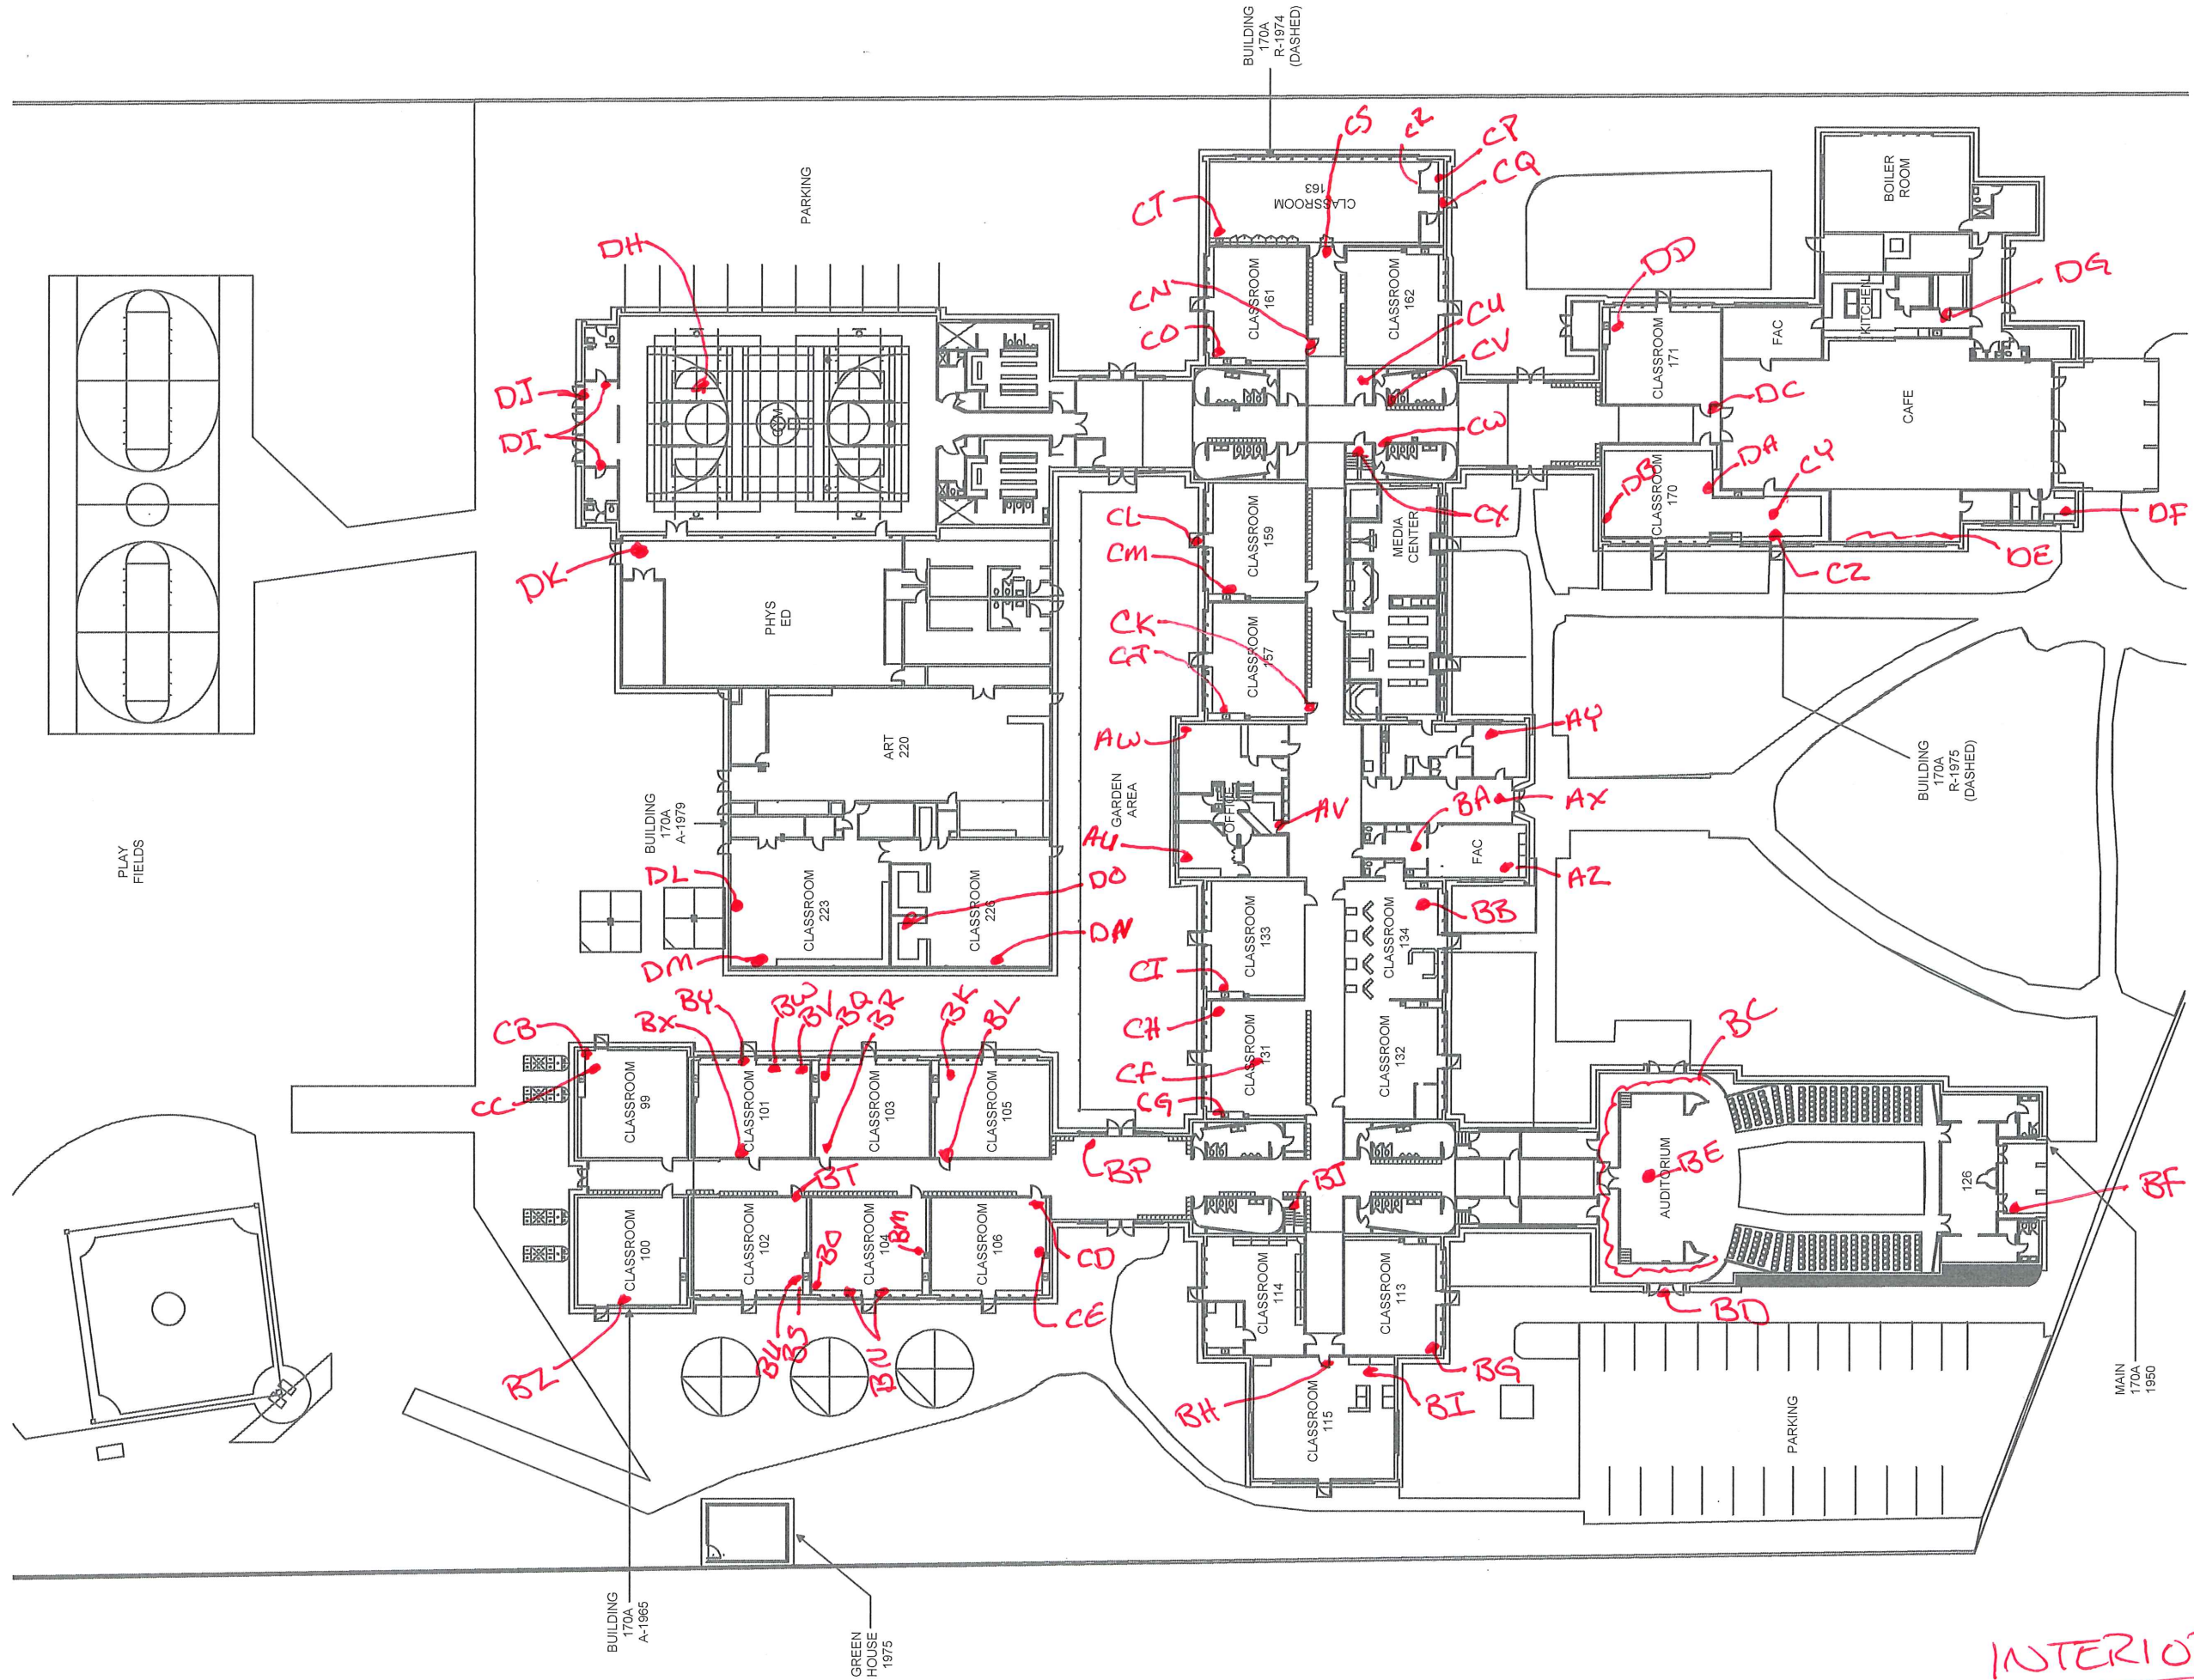
INTERIOR

Overall, the building's painted and varnished surfaces were found to be in de-minimis (fair) condition; however, multiple areas of deteriorated (poor) condition were observed. A table showing the locations and quantity of surfaces in deteriorated condition, and a field drawing matching the locations, is attached to this report.

PBS recommends that all painted or varnished surfaces in poor condition be stabilized. Paint chip debris around the perimeter of the building should be cleaned up, or a fence should be placed around these areas to avoid contact by children playing, as an interim control.

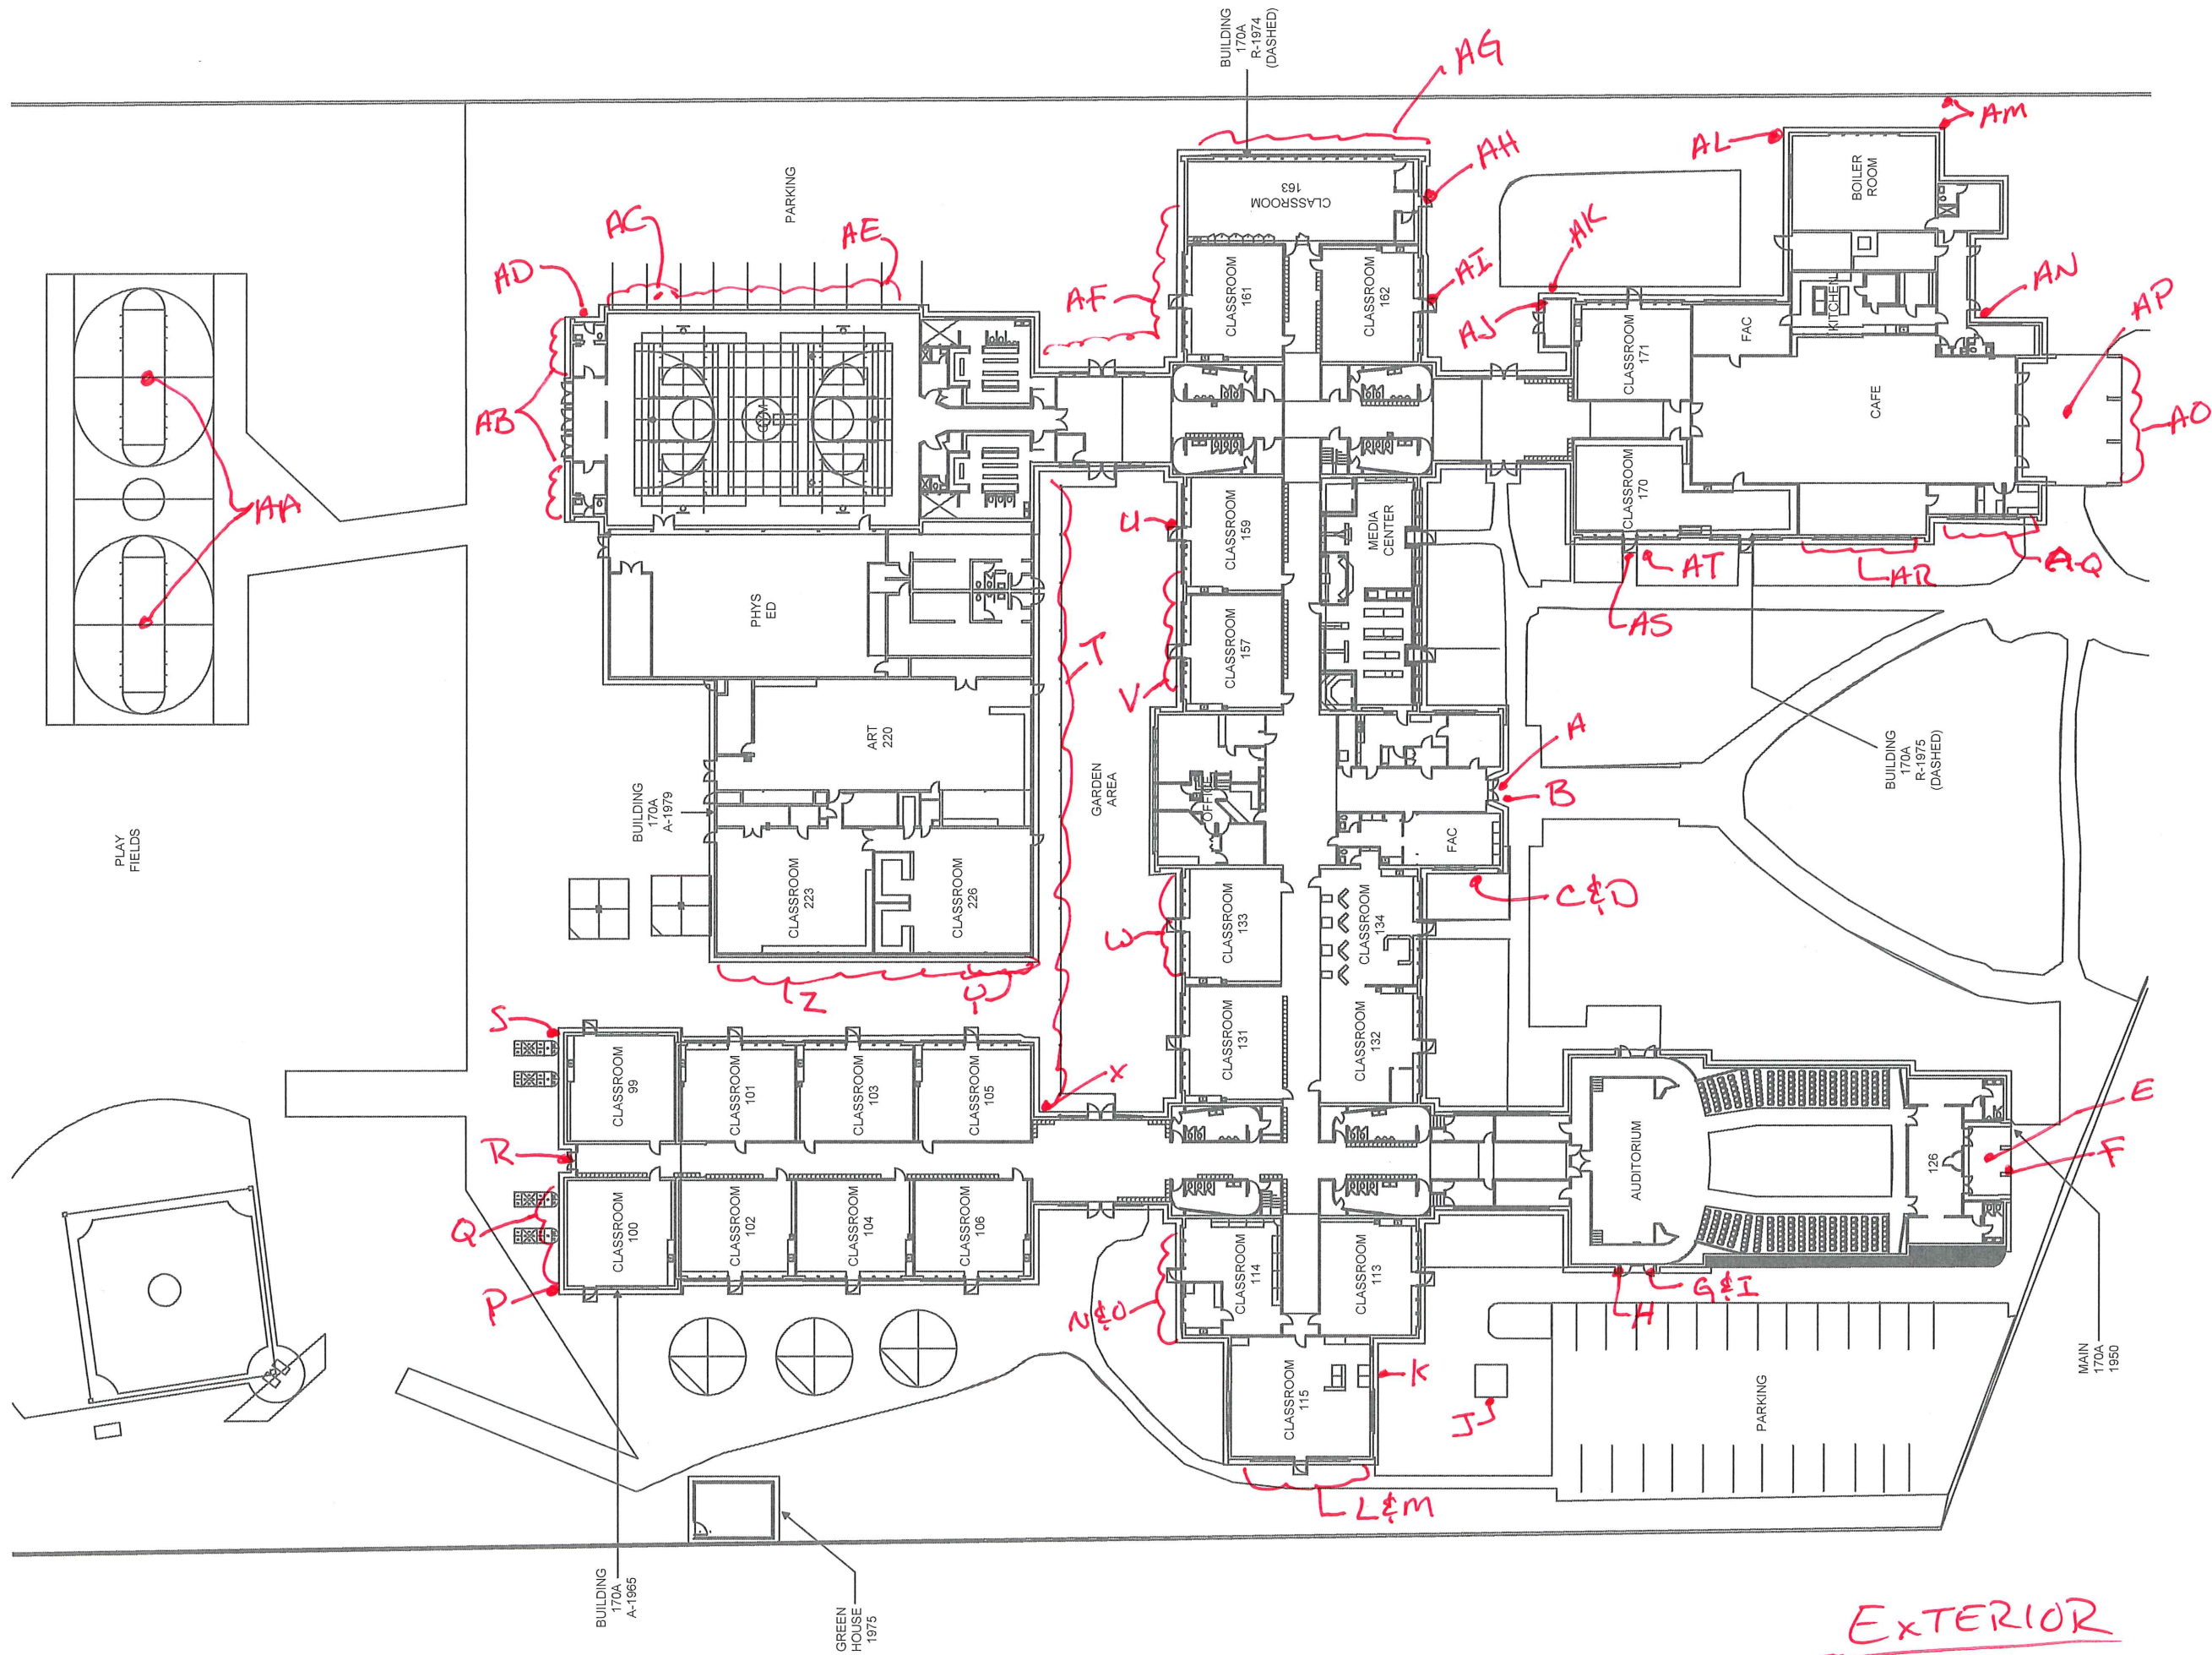
EXTERIOR

Small amounts of paint chip debris were observed around the perimeter of the building, within the flowerbeds, and on asphalt and concrete. Paint chips in the flowerbeds near the garden area are at a distance that would not cause an immediate concern, but they should be removed.
