Regarding: Lead Paint Condition Assessment
Beach Elementary School
1710 N Humboldt Street
Portland, OR 97217
PBS Project: 6500.721 Phase 0007

Beach Elementary School
Assessment of Paint/Varnish in Deteriorated (Poor) Condition

Beach Elementary School 1710 N Humboldt Street 97217 Facility Plan

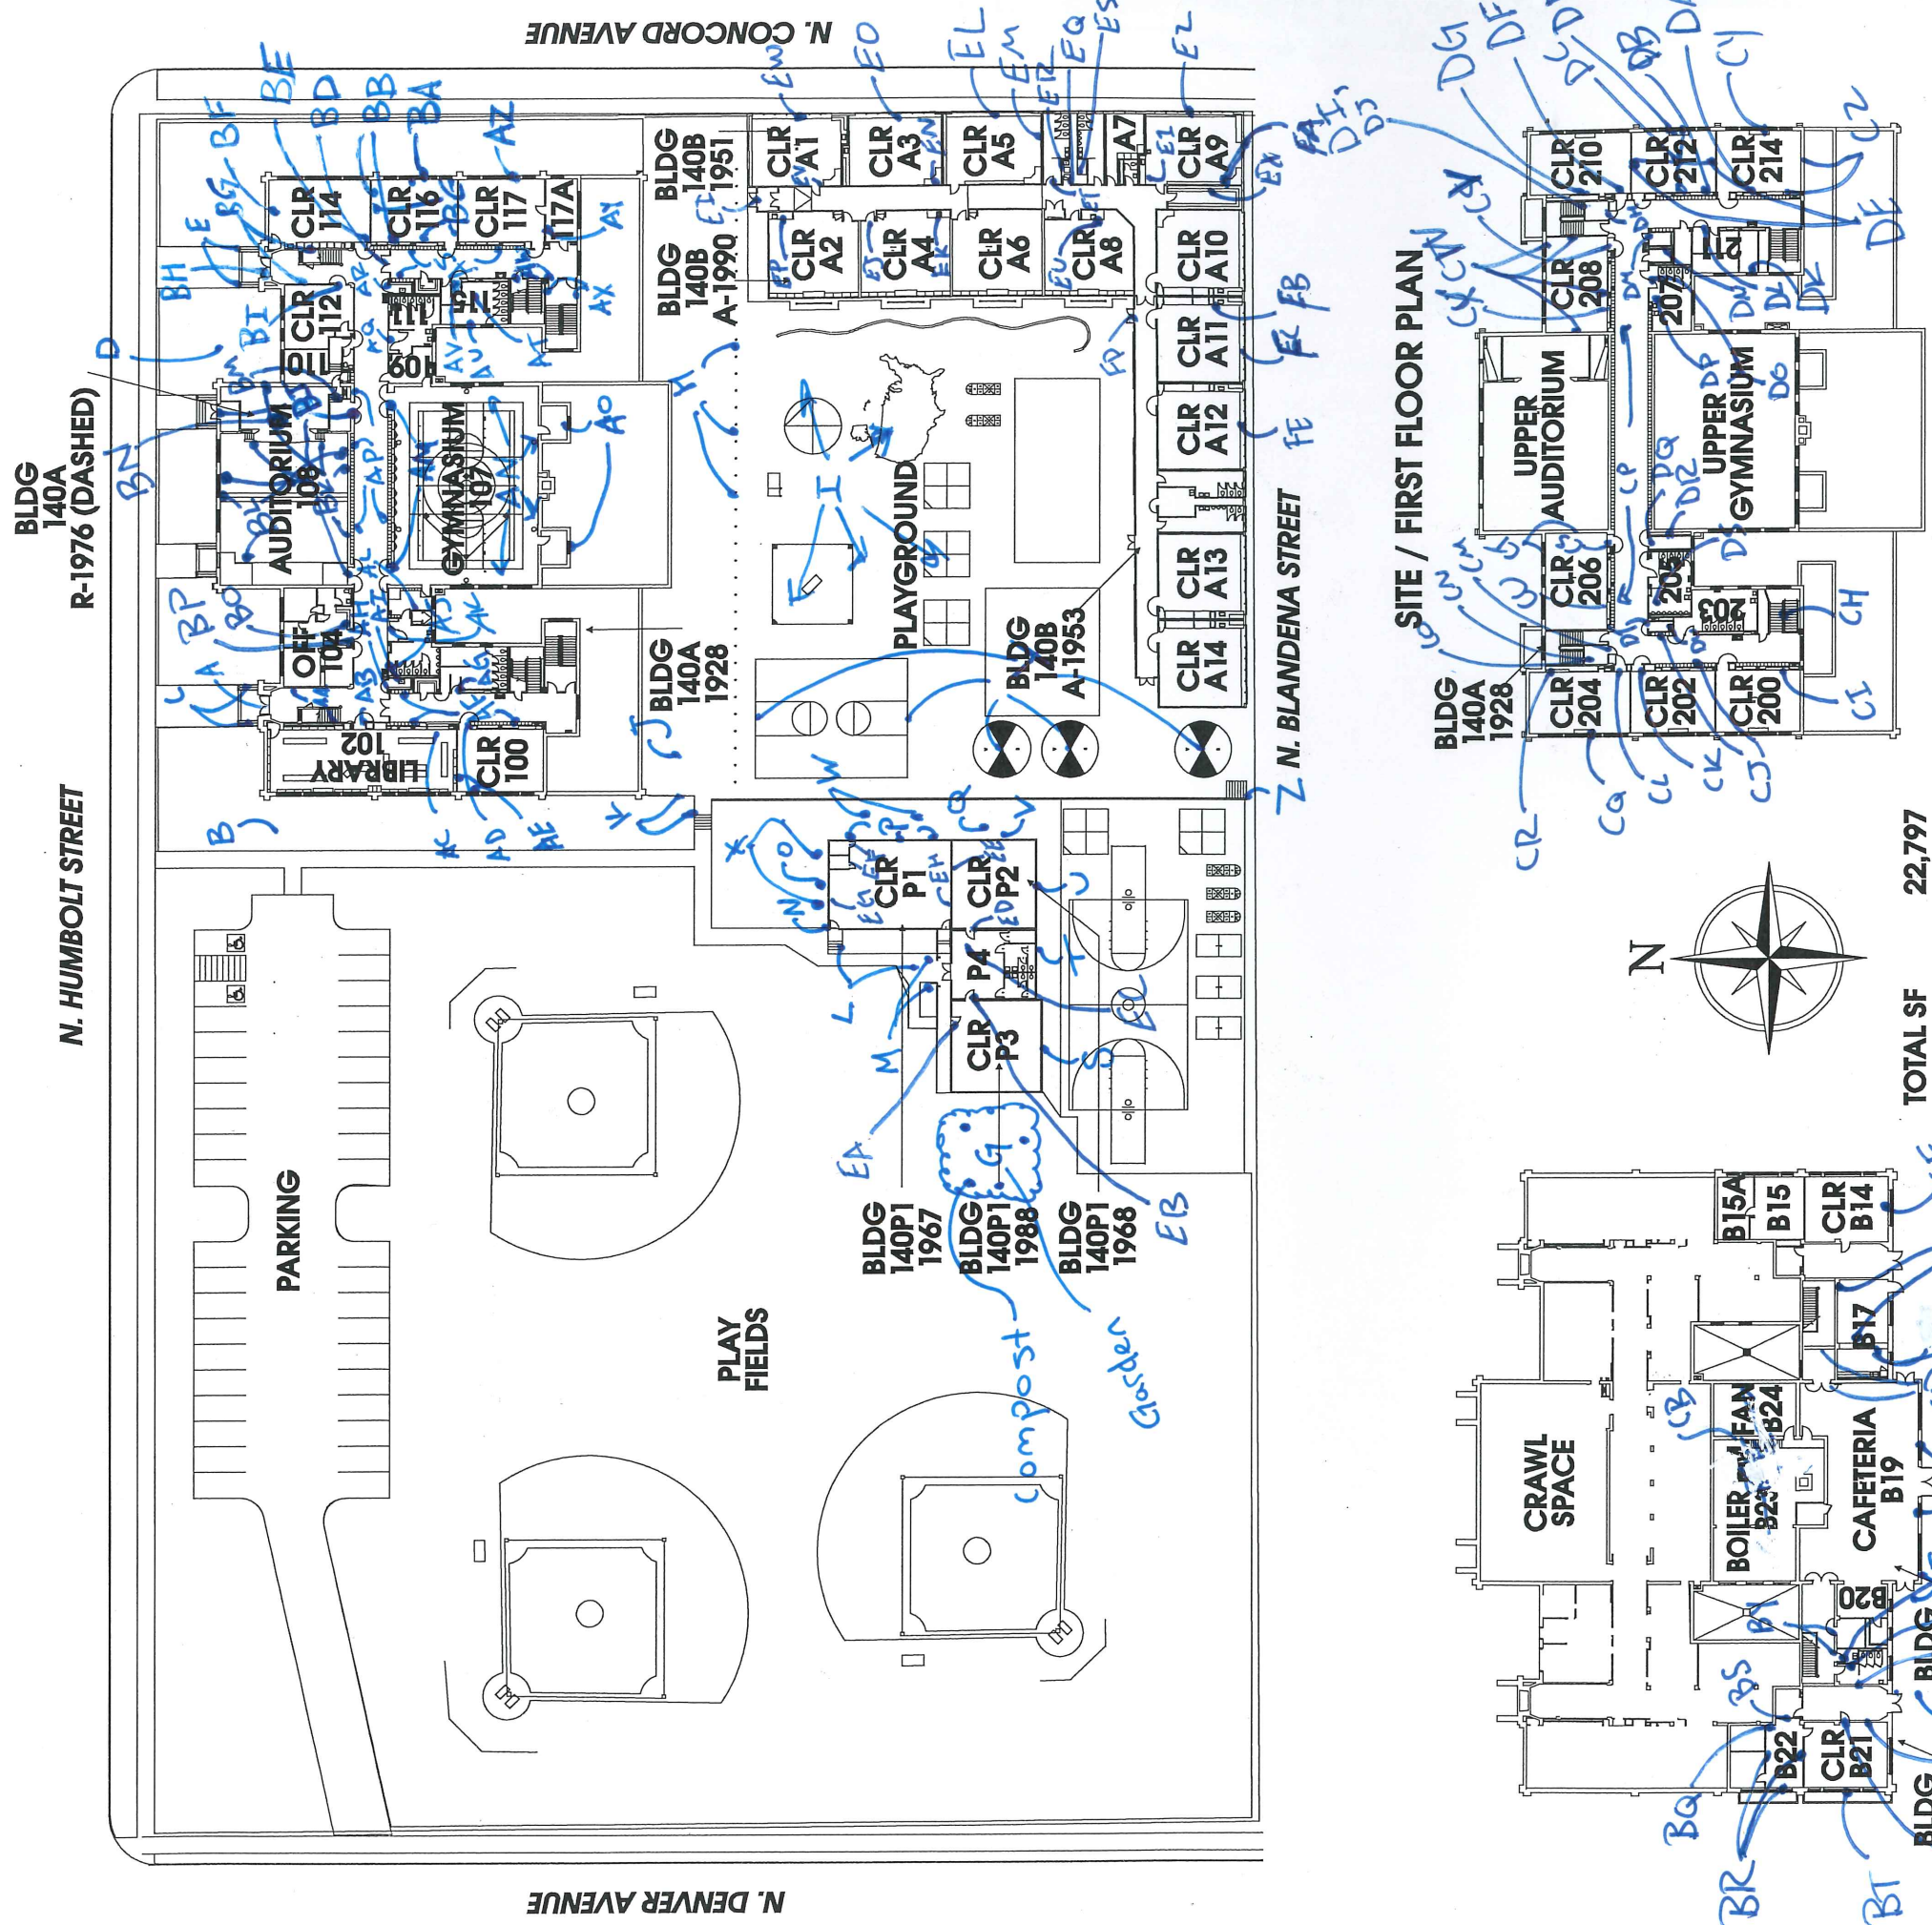
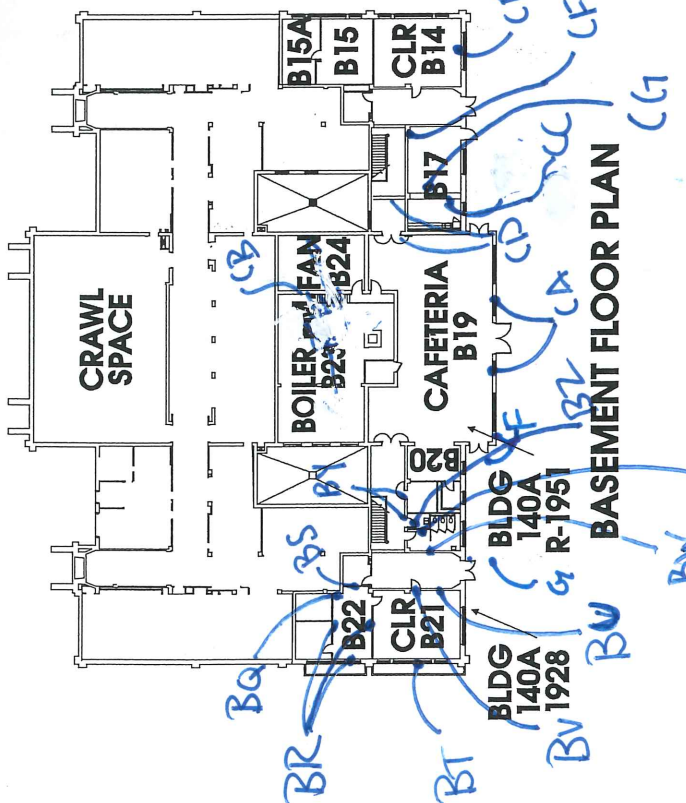
SITE / FIRST FLOOR PLAN

Overall, the building's painted and varnished surfaces were found to be in fair to intact condition with areas of deteriorated conditions. A table showing the location and quantity of surfaces in deteriorated condition is attached to this report.

Paint chips were observed on concrete and soil on the east and north sides of the "P" portable.

PBS recommends that all painted or varnished surfaces in deteriorated condition be stabilized. Paint chips on concrete and soil on the east and north sides of the "P" portable should be removed.
