Regarding: Lead Paint Condition Assessment
Duniway Elementary School
7700 SE Reed College Place
Portland, Oregon 97202
PBS Project: 6500.721 Phase 0019

Duniway Elementary School
Assessment of Paint/Varnish in Deteriorated (Poor) Condition

Dunaway Elementary School 7700 SE Red College Place Facility Plan

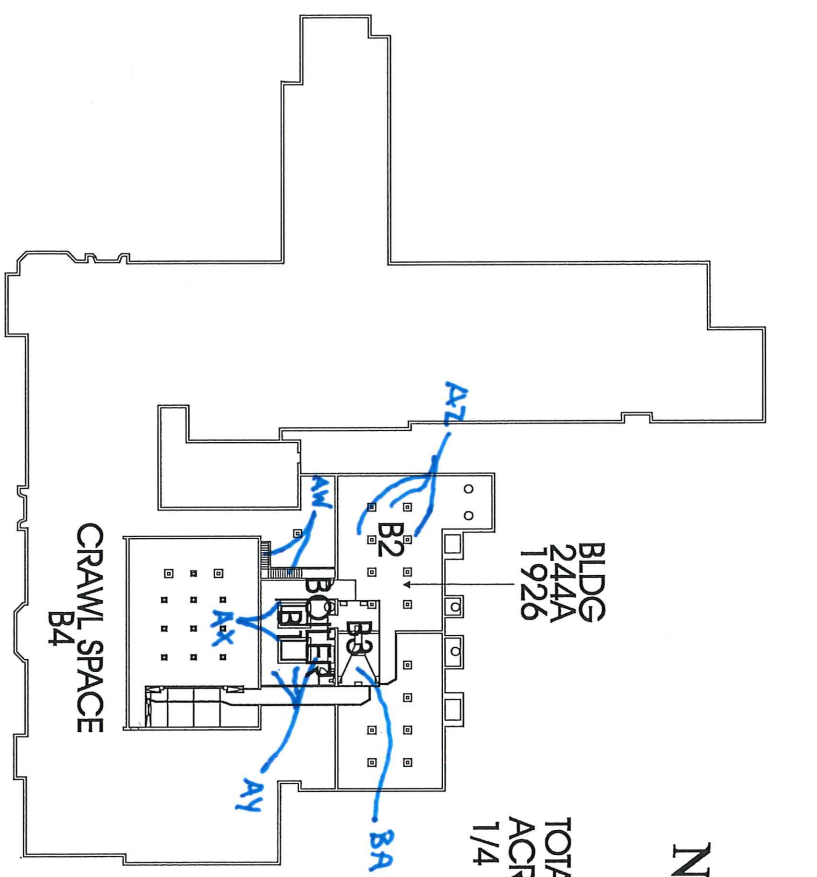
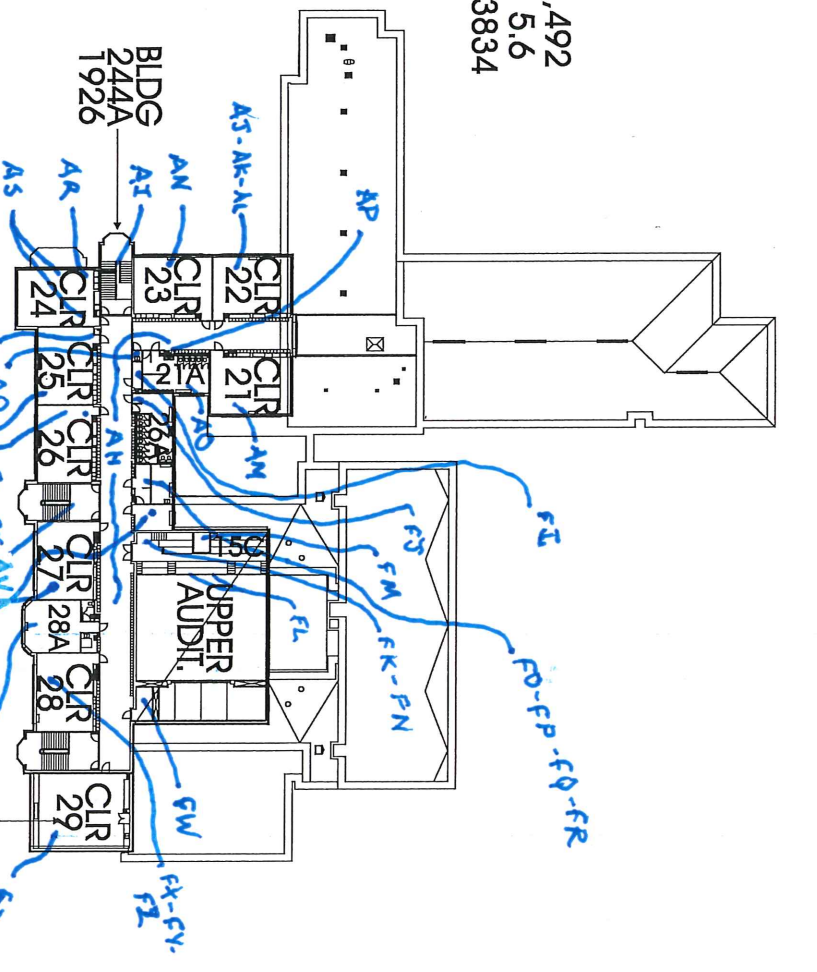
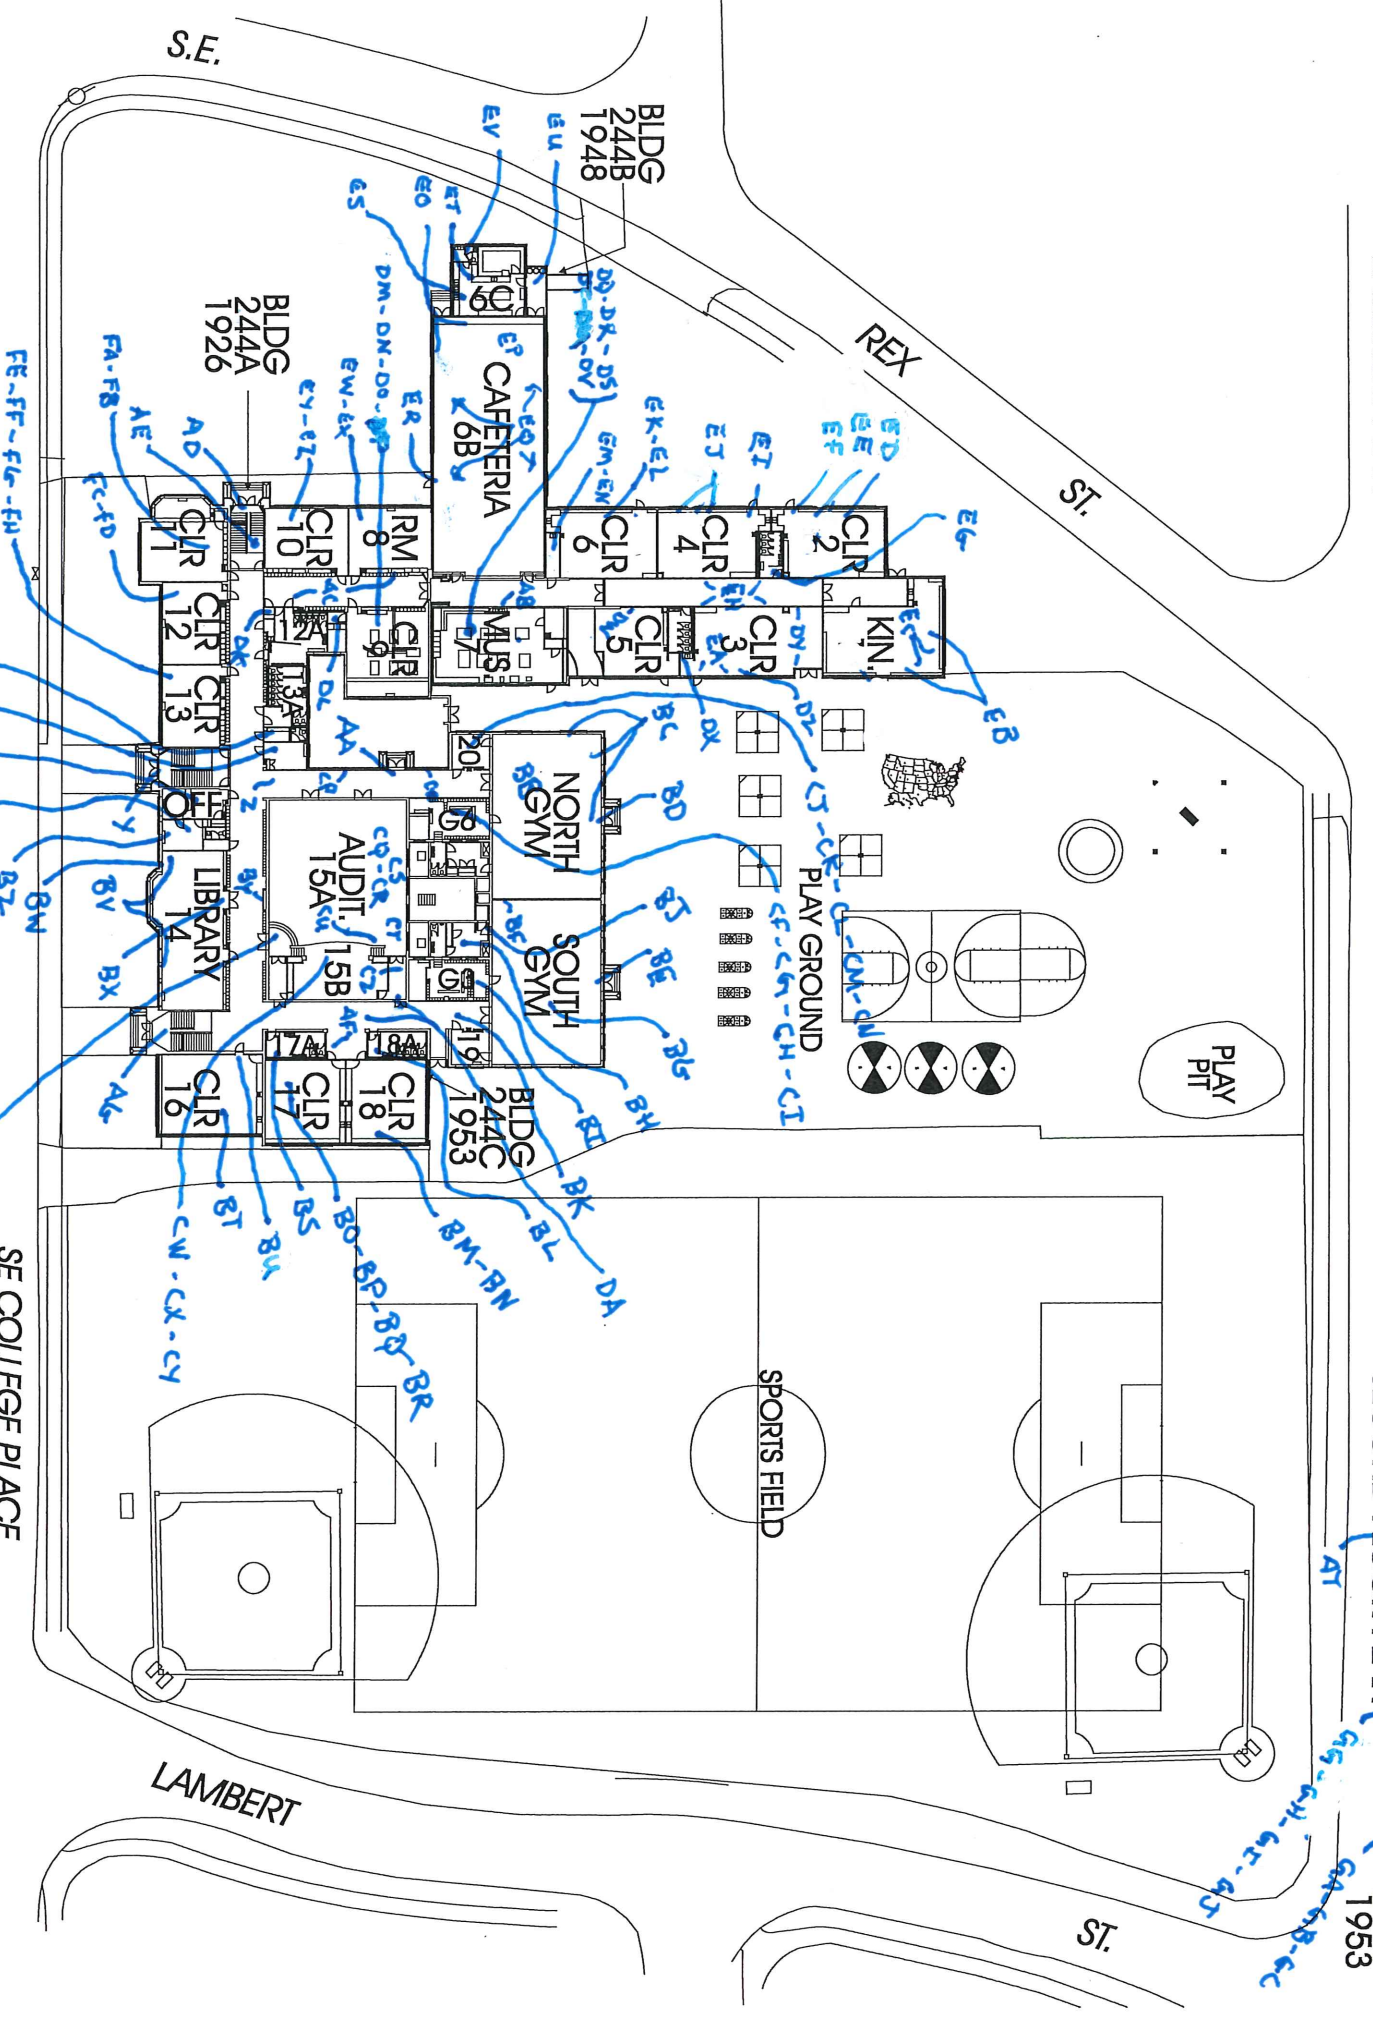
INTERIOR

Overall, the building's painted and varnished surfaces were found to be in fair to intact condition with areas of deteriorated conditions. A table showing the location and quantity of surfaces in poor condition is attached to this report.

Areas of high concern noted during PBS' visit were the cafeteria serving line, classroom 28 windowsills, and the auditorium balcony projection room. These areas were subsequently addressed by stabilizing the paint on the serving-line wall and HEPA vacuuming varnish and paint chips on the windowsills and in the projection room. This work was completed by a remediation contractor on November 16, 2016.

PBS recommends that all painted or varnished surfaces in deteriorated condition be stabilized. Paint chips in the courtyard, around the primary wing and in the west side bushes should be removed. The compost pile should be relocated to an area away from painted surfaces. Gardens should either be relocated away from painted surfaces or not used for growing vegetables.

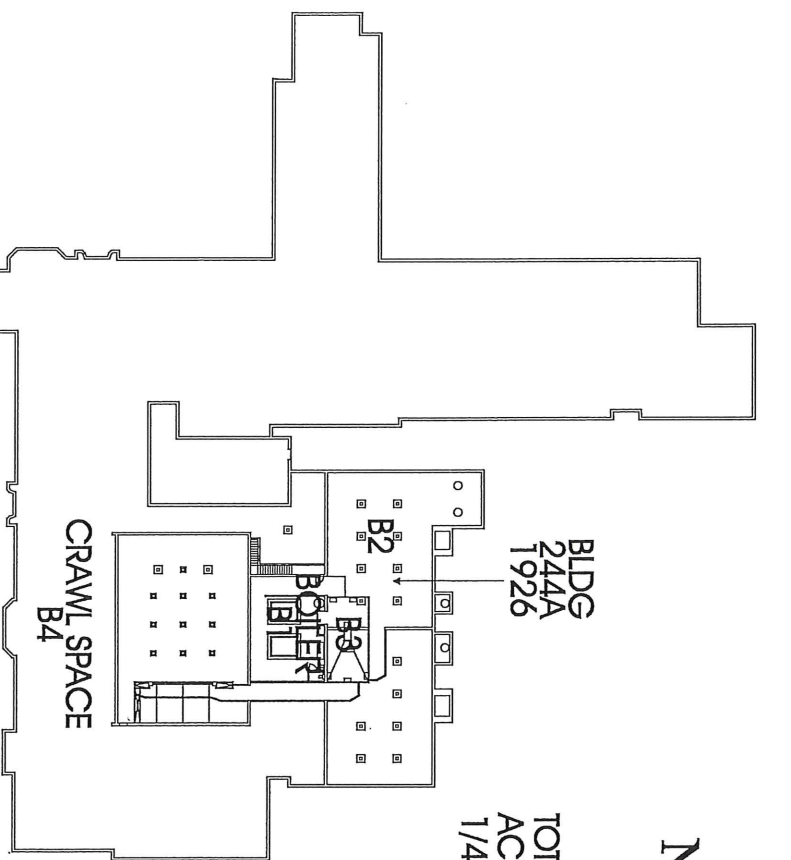
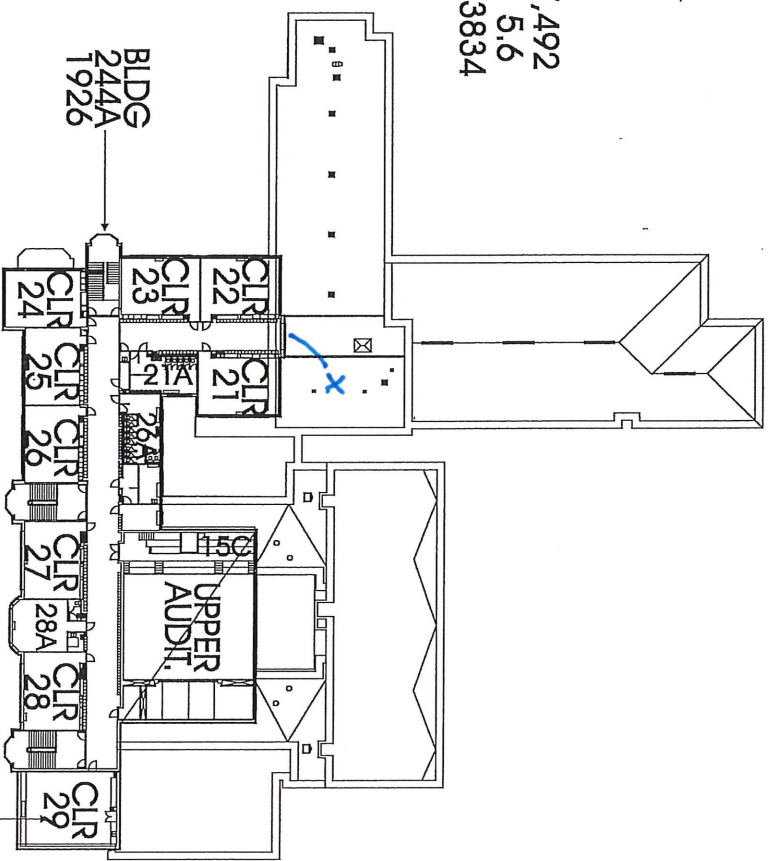
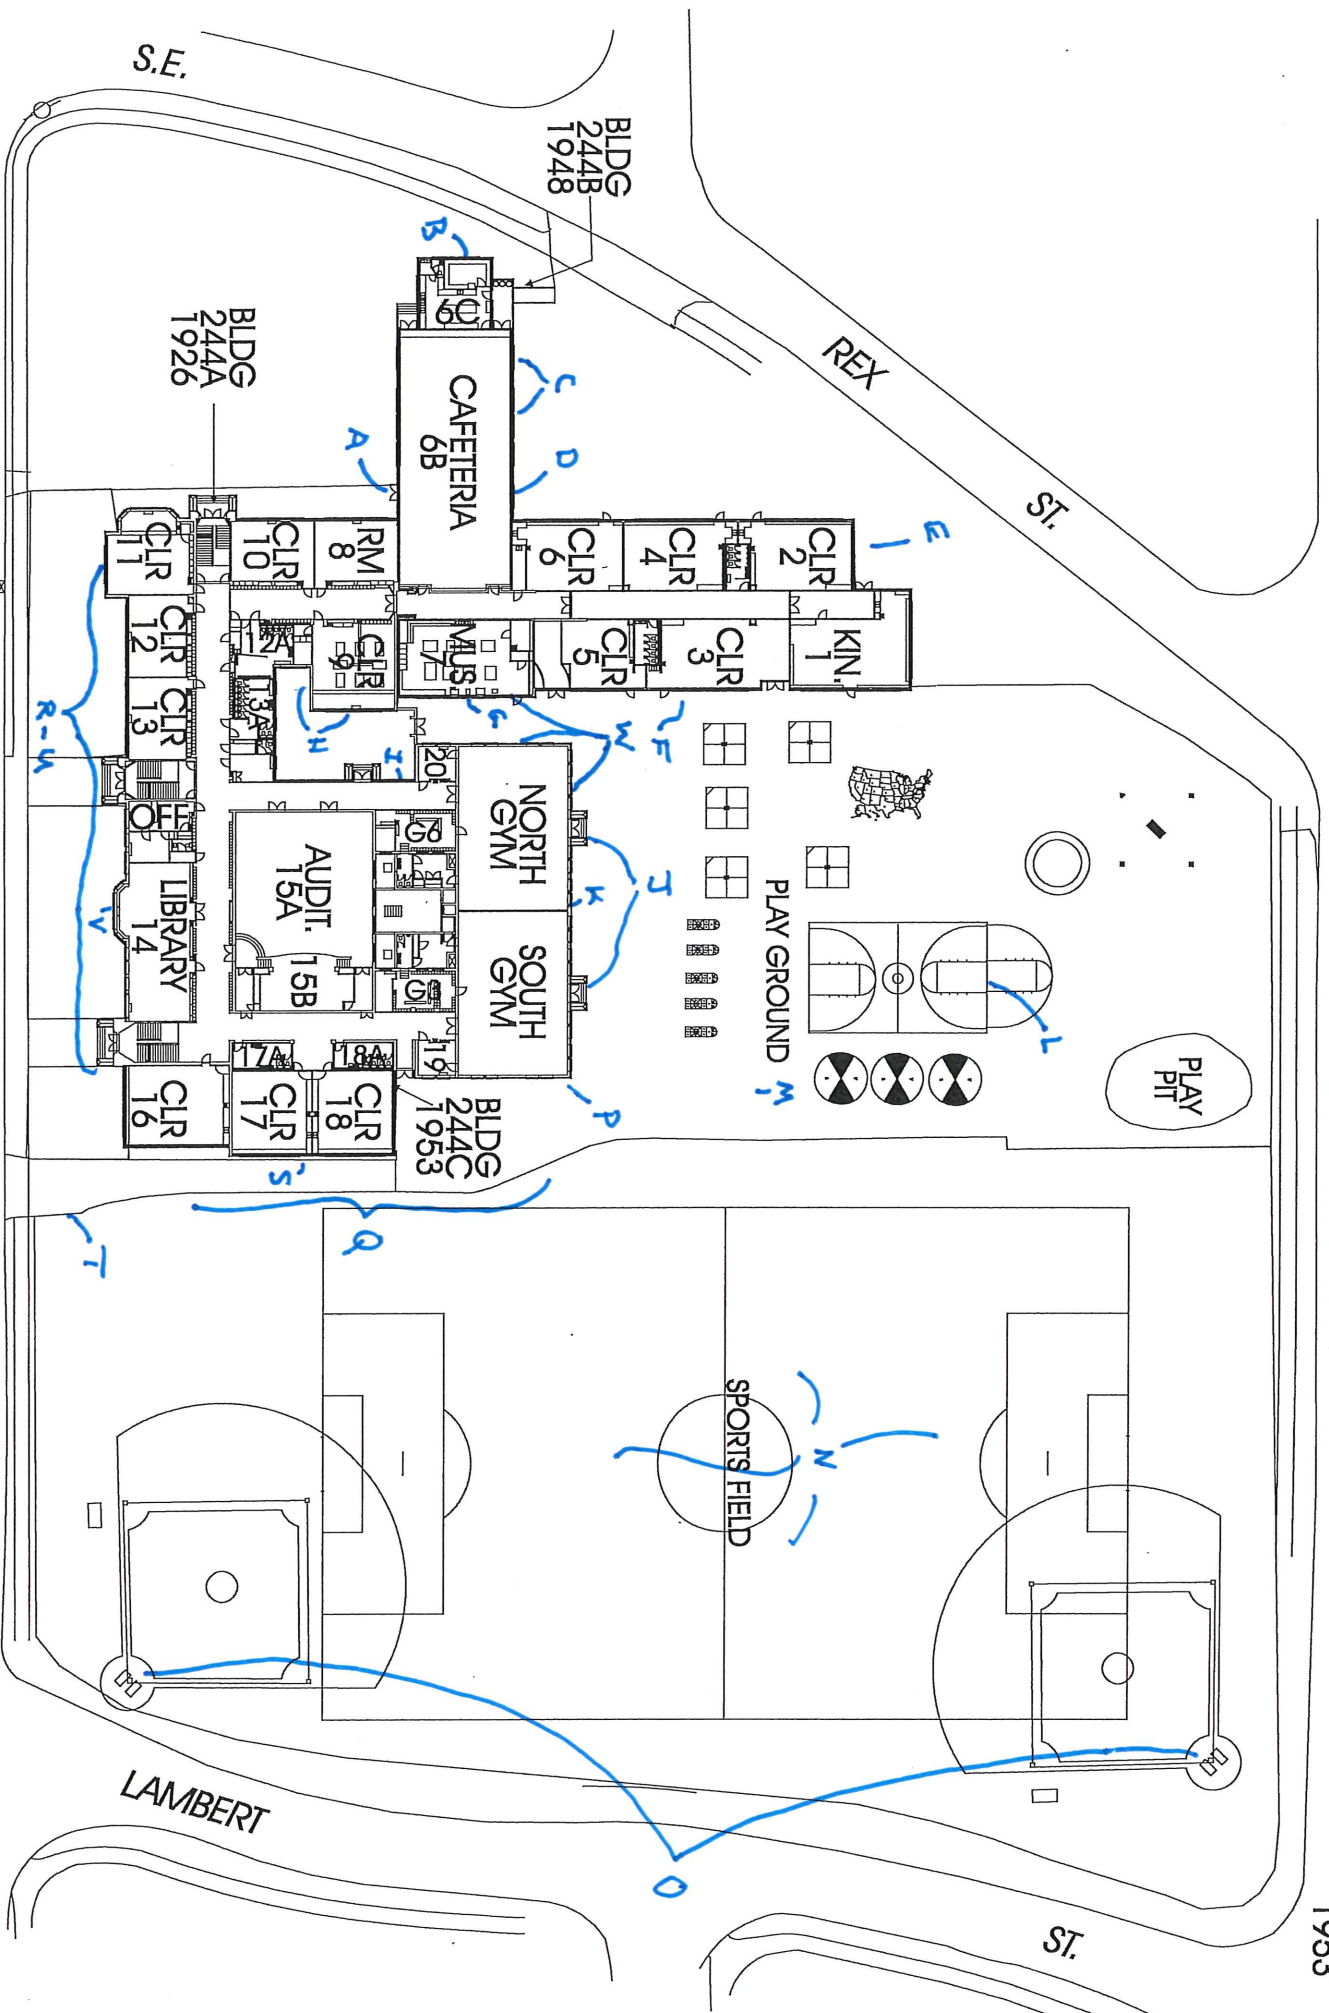
EXTERIOR

A small amount of paint chip debris was observed in the dirt under and around bushes on the west side of the building, in the courtyard around, but not in, the gardens, on asphalt outside the cafeteria, and on asphalt outside the primary wing.

A compost pile exists on the south side of the building near an exterior wall. Gardens that appeared to be used primarily for ornamental plants were located along the south side of the elementary wing and in the courtyard. Paint on soffits, cornices, windows, and downspouts in these areas were in poor condition.

Wood window assemblies are in deteriorated condition in numerous locations throughout the building. Dirt, dust, and paint chips were observed in representative window troughs inspected.
