Regarding: Lead Paint Condition Assessment
Alameda Elementary School
2732 NE Fremont Street
Portland, OR 97212
PBS Project: 6500.721 Phase 0003

Assessment of Paint/Varnish in Deteriorated (Poor) Condition

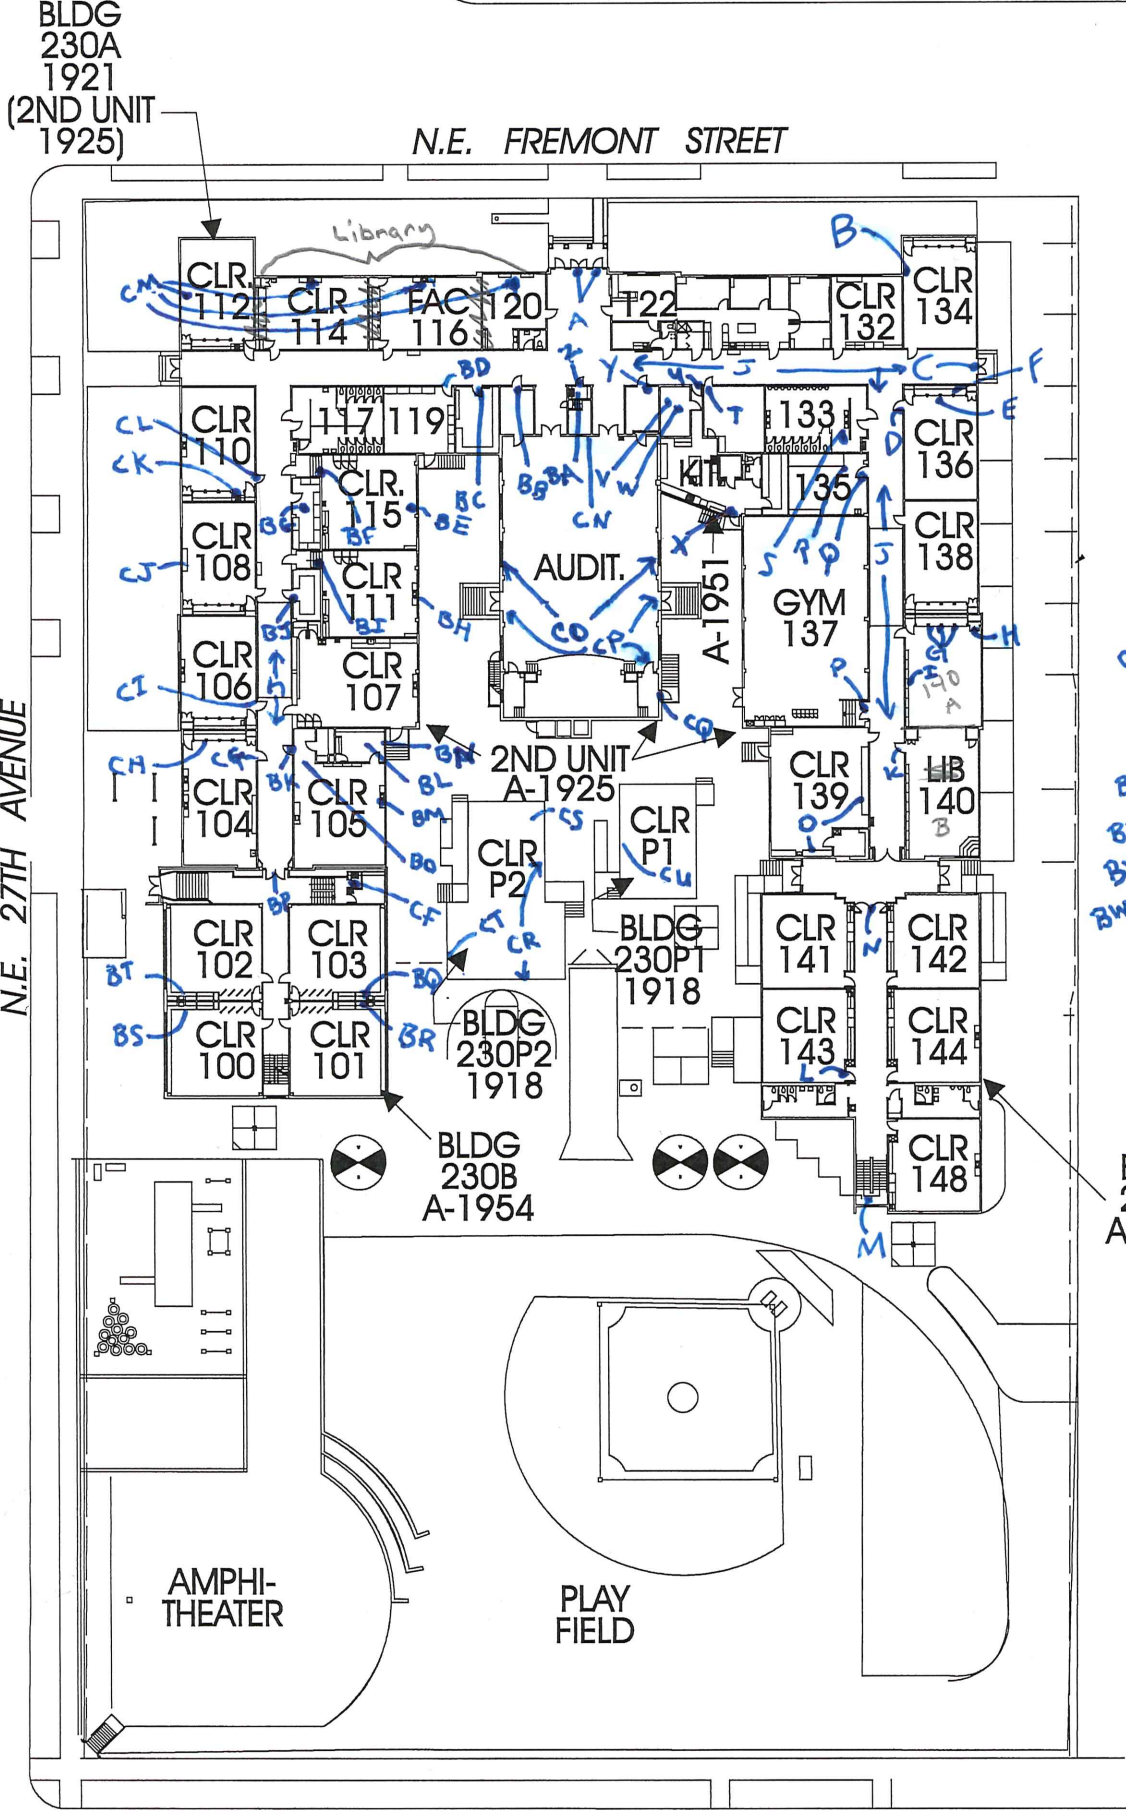
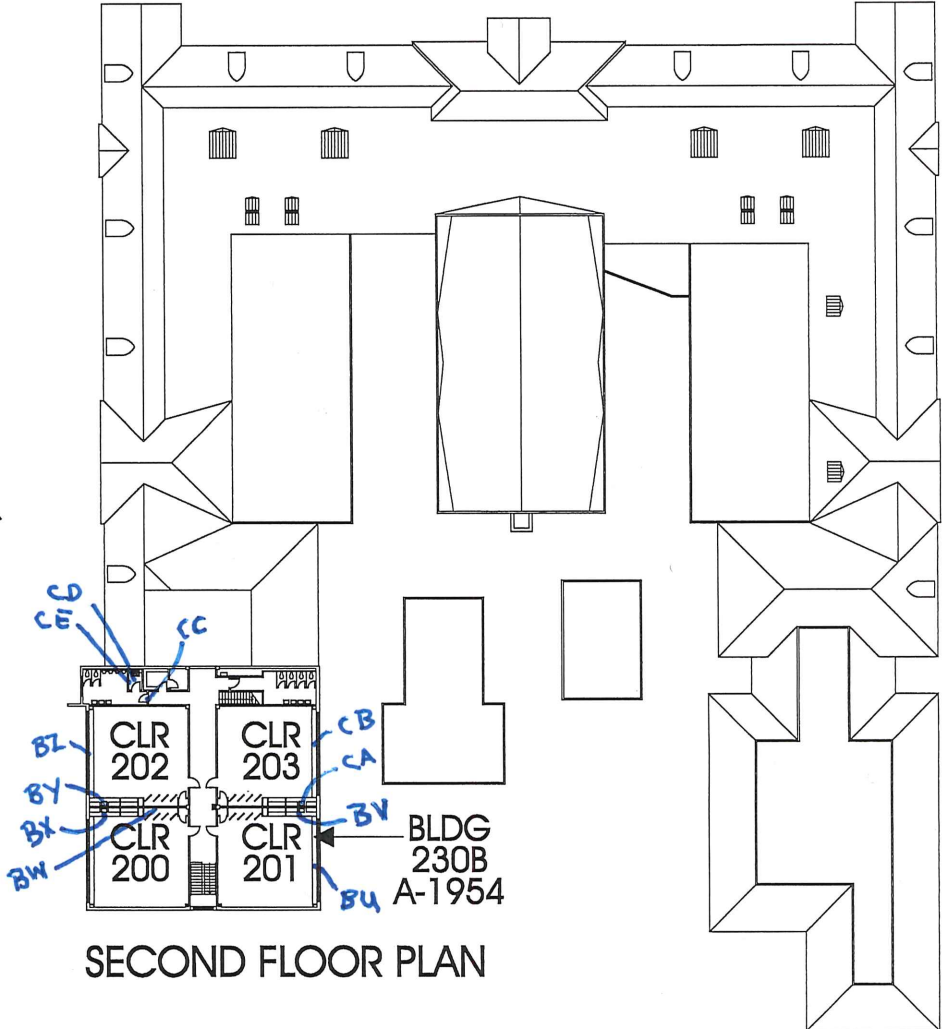
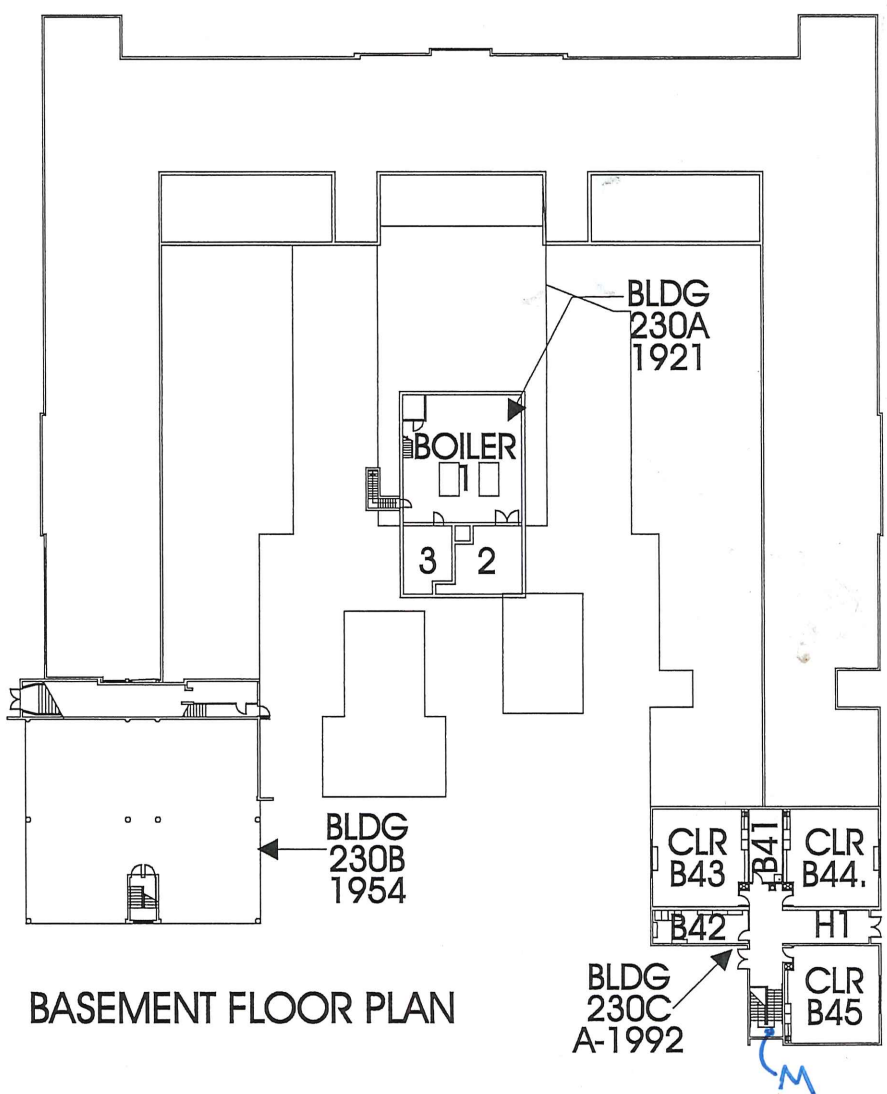
INTERIOR

ID	Interior / Exterior	Location	Room Name / #	Structure	Above / Below five feet	K-2nd Grade	Substrate	Quantity
A	Interior	main entry	Foyer	varnish door	below	yes	wood	2 doors
B	Interior	walls	134	baseboard	below	yes	wood	30 SF
C	Interior	east entry	N/A	varnish door	below	yes	wood	2 doors
D	Interior	entry doors	136	door casing	below	yes	wood	15 SF
E	Interior	north wall	136	upper wall trim	above	yes	wood	10 SF
F	Interior	closet	136	columns inside closet	above/below	yes	wood	15 SF
G	Interior	closet	140A	columns on closet	below	no	wood	15 SF
H	Interior	sink area	140A	cabinet door face	below	no	wood	12 SF
I	Interior	west wall	140A	baseboard	below	no	wood	10 SF
J	Interior	main building corridors	140A	varnish baseboard	below	yes	wood	500 SF
K	Interior	entry doors	140B	door and door frame	below	yes	wood	1 door and 15 SF
L	Interior	entry doors	143	varnish, door and door frame	below	no	wood/metal	1 door and 15 SF

M	Interior	southeast stairwell to basement	N/A	handrail	below	yes	metal	20 SF
N	Interior	entry door into southeast addition	N/A	center post	below	yes	metal	10 SF
O	Interior	cabinets, east and south walls	139	cabinets	below	no	wood	10 SF
P	Interior	gym entry doors	N/A	doors	below	yes	wood	2 each
Q	Interior	custodial office door	135	door and door frame	below	no	wood	1 door and 15 SF
R	Interior	custodial office rafters	135	rafters	below	no	wood	30 SF
S	Interior	northeast boy's bathroom	133	sprinkler pipe	above	yes	rubber	15 SF
T	Interior	speech room, entry doors	131	varnish door and door frame	below	no	wood	1 door and 15 SF
U	Interior	entry door frame, kitchen	N/A	door frame	below	no	wood	15 SF
V	Interior	kitchen fan room, ceiling	N/A	ceiling	above	no	plaster	100 SF

ID	Interior / Exterior	Location	Room Name / #	Structure	Above / Below five feet	K-2nd Grade	Substrate	Quantity
W	Interior	kitchen fan room	N/A	duct work	above/below	no	metal	50 SF
X	Interior	kitchen, screen door to courtyard	N/A	screen door and frame	below	no	wood	1 door and 15 SF
Y	Interior	store room door	127	varnish door and door frame	below	no	wood	1 door and 15 SF
Z	Interior	custodial closet 125B	125B	wood door frame	below	no	wood	15 SF
BA	Interior	main foyer, custodial closet	125B	plaster walls	below	no	plaster	100 SF
BB	Interior	community school, program room	123	wood door frame	below	no	wood	15 SF
BC	Interior	storeroom, doorframe	121	wood door frame	below	no	wood	15 SF
BD	Interior	work room, entry doorframe	119	wood door frame	below	no	wood	15 SF
BE	Interior	classroom, east wall	115	radiator cover	below	yes	metal	30 SF
BF	Interior	classroom, stairs	115	stair skirt	below	yes	wood	5 SF
BG	Interior	book room	113	rain drain pipe	above/below	no	metal	10 SF

BH	Interior	classroom; east wall	111	radiator cover	below	yes	metal	30 SF
BI	Interior	classroom, stairs	111	stair skirt	below	yes	wood	5 SF
BJ	Interior	storeroom, door and frame	109	varnish door and door frame	below	no	wood	1 door and 15 SF
BK	Interior	classroom, hallway door	105	door frame	below	no	wood	15 SF
BL	Interior	classroom, storage	105B	walls	above/below	no	plaster	375 SF
BM	Interior	classroom, east wall	105	radiator cover	below	no	metal	30 SF
BN	Interior	classroom, storage	105B	radiator	below	no	metal	20 SF
BO	Interior	classroom, walls	105	plaster walls	above/below	no	plaster	300 SF
BP	Interior	entry door into southwest addition	N/A	center post	below	yes	metal	10 SF
BQ	Interior	classroom, sink area	103	cabinet door faces	below	yes	wood	15 SF
BR	Interior	classroom, sink area	101	cabinet door faces	below	yes	wood	15 SF
BS	Interior	classroom, sink area	100	cabinet door faces	below	yes	wood	15 SF

ID	Interior / Exterior	Location	Room Name / #	Structure	Above / Below five feet	K-2nd Grade	Substrate	Quantity
BT	Interior	classroom, sink area	102	cabinet door faces	below	no	wood	15 SF
BU	Interior	classroom, east wall	201	window sill	below	no	plaster	30 SF
BV	Interior	classroom, sink area	201	cabinet door faces	below	no	wood	15 SF
BW	Interior	classroom, north wall	200	plaster walls	below	no	plaster	150 SF
BX	Interior	classroom, sink area	200	cabinet door faces	below	no	wood	15 SF
BY	Interior	classroom, sink area	202	cabinet door faces	below	no	wood	15 SF
BZ	Interior	classroom, west wall	202	window sill	below	no	plaster	30 SF
CA	Interior	classroom, sink area	203	cabinet door faces	below	no	wood	15 SF
CB	Interior	classroom, east wall	203	window sill	below	no	plaster	30 SF
CC	Interior	second floor, boy's restroom	N/A	varnish door	below	yes	wood	1 door
CD	Interior	second floor, boy's restroom, closet	204	ladder	below	yes	metal	15 SF

CE	Interior	second floor, boy's restroom, closet	204	walls	below	yes	plaster	105 SF
CF	Interior	custodial closet	209	walls and ceiling	above/below	no	plaster	175 SF
CG	Interior	classroom, east wall	104	door frame	below	yes	wood	155 SF
CH	Interior	classroom, north wall	104	closet columns	below	yes	wood	50 SF
CI	Interior	classroom, east wall	106	door frame	below	no	wood	15 SF
CJ	Interior	classroom, west wall	108	radiator cover	below	yes	metal	30 SF
CK	Interior	classroom, south wall	110	cabinet door faces	below	yes	wood	10 SF
CL	Interior	classroom, east wall	110	wood door jam	below	yes	wood	15 SF
CM	Interior	library	N/A	radiator covers	below	yes	metal	4 each, 30 SF each
CN	Interior	auditorium, north wall	N/A	furtex 12"X12" tiles	above/below	yes	ceiling tile, furtex	100 SF
CO	Interior	auditorium	N/A	lower east and west walls	below	yes	plaster	450 SF
CP	Interior	auditorium doors	N/A	varnished wood doors	below	yes	wood	6 doors

ID	Interior / Exterior	Location	RoomName / #	Structure	Above / Below five feet	K-2nd Grade	Substrate	Quantity
CQ	Interior	backstage, east side	N/A	varnished wood panic door	below	yes	wood	1 door
CR	Interior	portable, #2	N/A	window frams, sills and sashes	above/below	yes	wood	13 assemblies
CS	Interior	portable, #2	N/A	northeast storage room walls	above/below	no	plaster	200 SF
CT	Interior	portable, #2	N/A	southwest storage room walls	below	no	plaster	150 SF
CU	Interior	portable, #1	N/A	west wall windows, frames and sashes	above/below	no	wood	7 assemblies
CV	Exterior	portable, east entry	P2	stairs and porch landing	below	no	wood	100 SF
CW	Exterior	courtyard, west wing	107/111	foundation	below	yes	concrete	20 SF
CX	Exterior	portable, west entry	P1	ramp and porch	below	no	wood	100 SF
CY	Exterior	east addition, courtyard	141	ada ramp and foundation	below	no	concrete	100 SF
CZ	Exterior	east addition, east side	B44	handrail	below	no	metal	20 SF

PBS recommends that all painted or varnished surfaces in poor condition be stabilized.

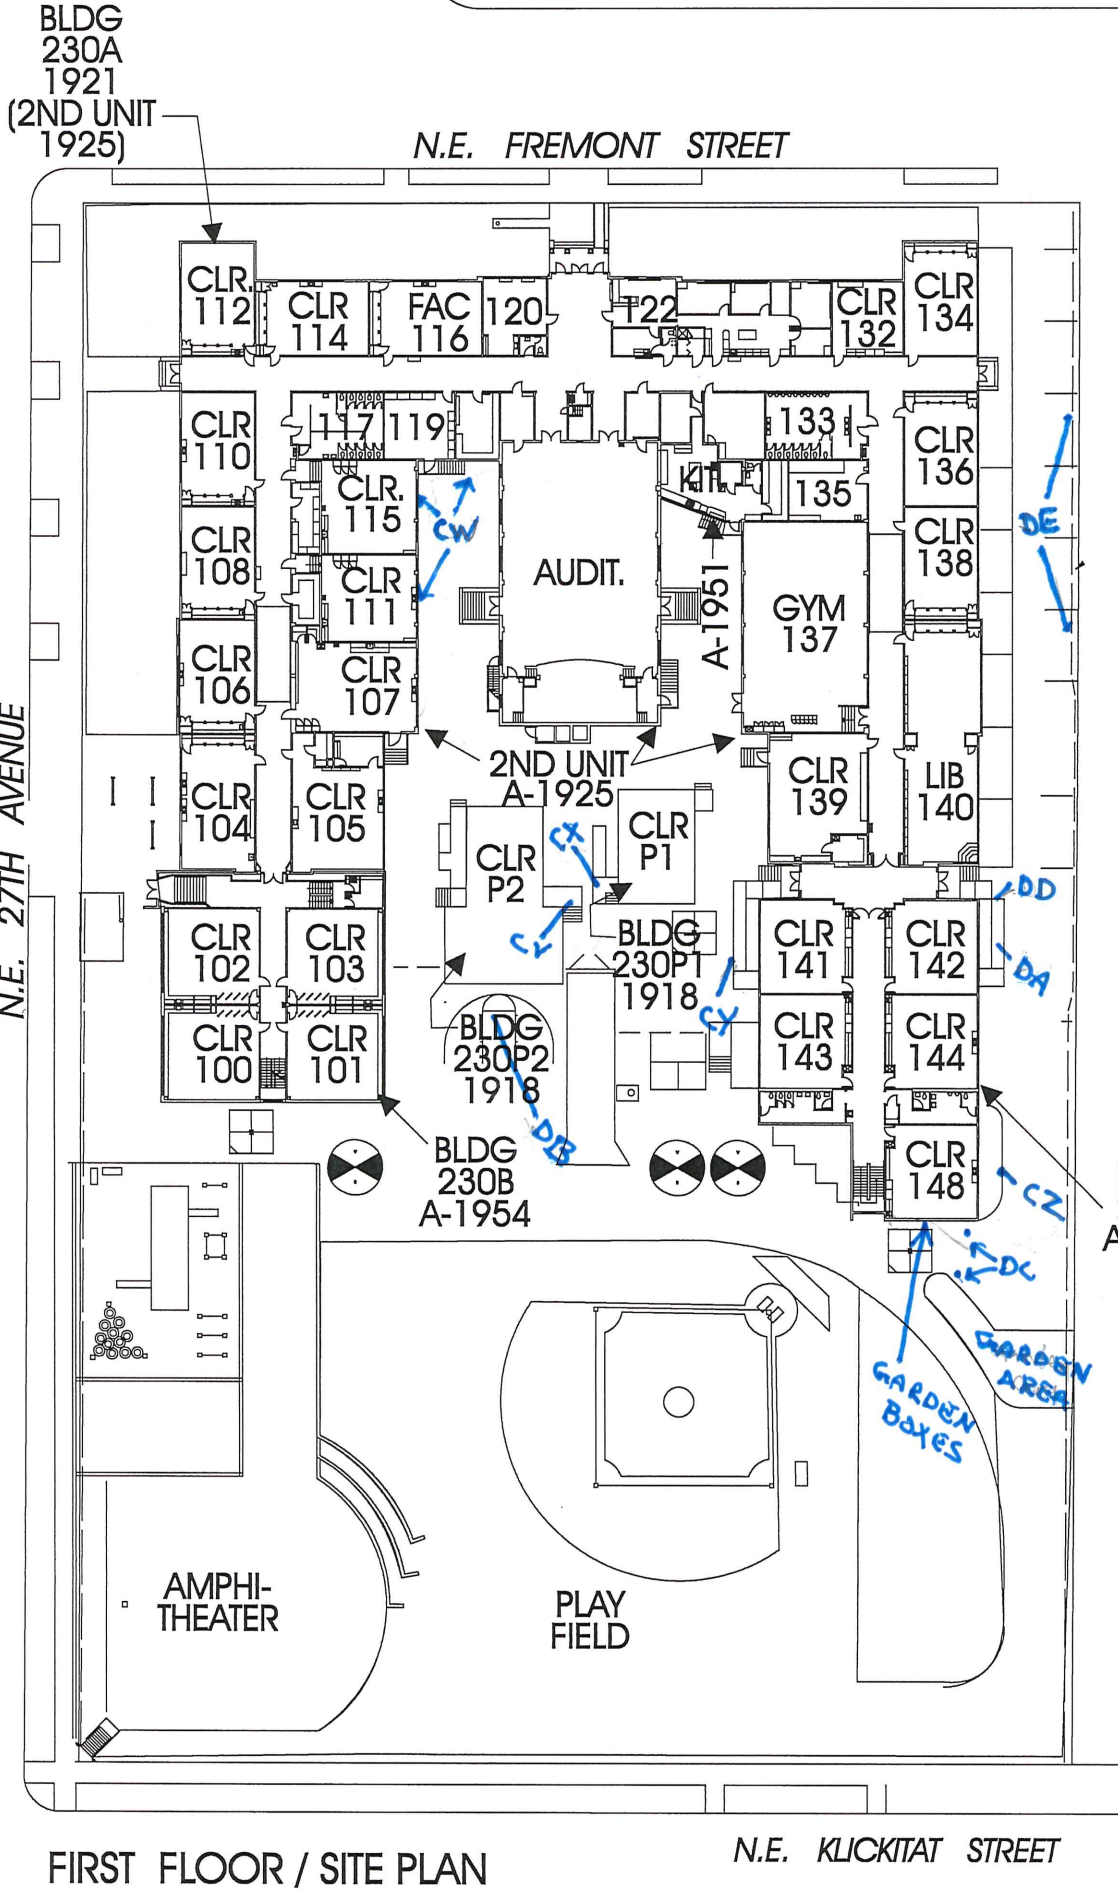
EXTERIOR

DA	Exterior	east addition, east side	142	ADA ramp and foundation	below	no	concrete	150 SF
DB	Exterior	east addition, south side	N/A	basketball pole	below	no	metal	5 SF
DC	Exterior	east addition, south side	148	2 chain posts	below	no	metal	15 SF
DD	Exterior	east addition, east side	142	2 ballard posts to ADA ramp	below	no	metal	15 SF
DE	Exterior	east driveway	N/A	no parking curb	below	no	concrete	225 SF
