Regarding: Lead Paint Condition Assessment
Jefferson High School
5210 N Kerby Avenue
Portland, Oregon 97217
PBS Project: 6500.721 Phase 0076

**Jefferson High School
Assessment of Paint/Varnish in Deteriorated Condition**

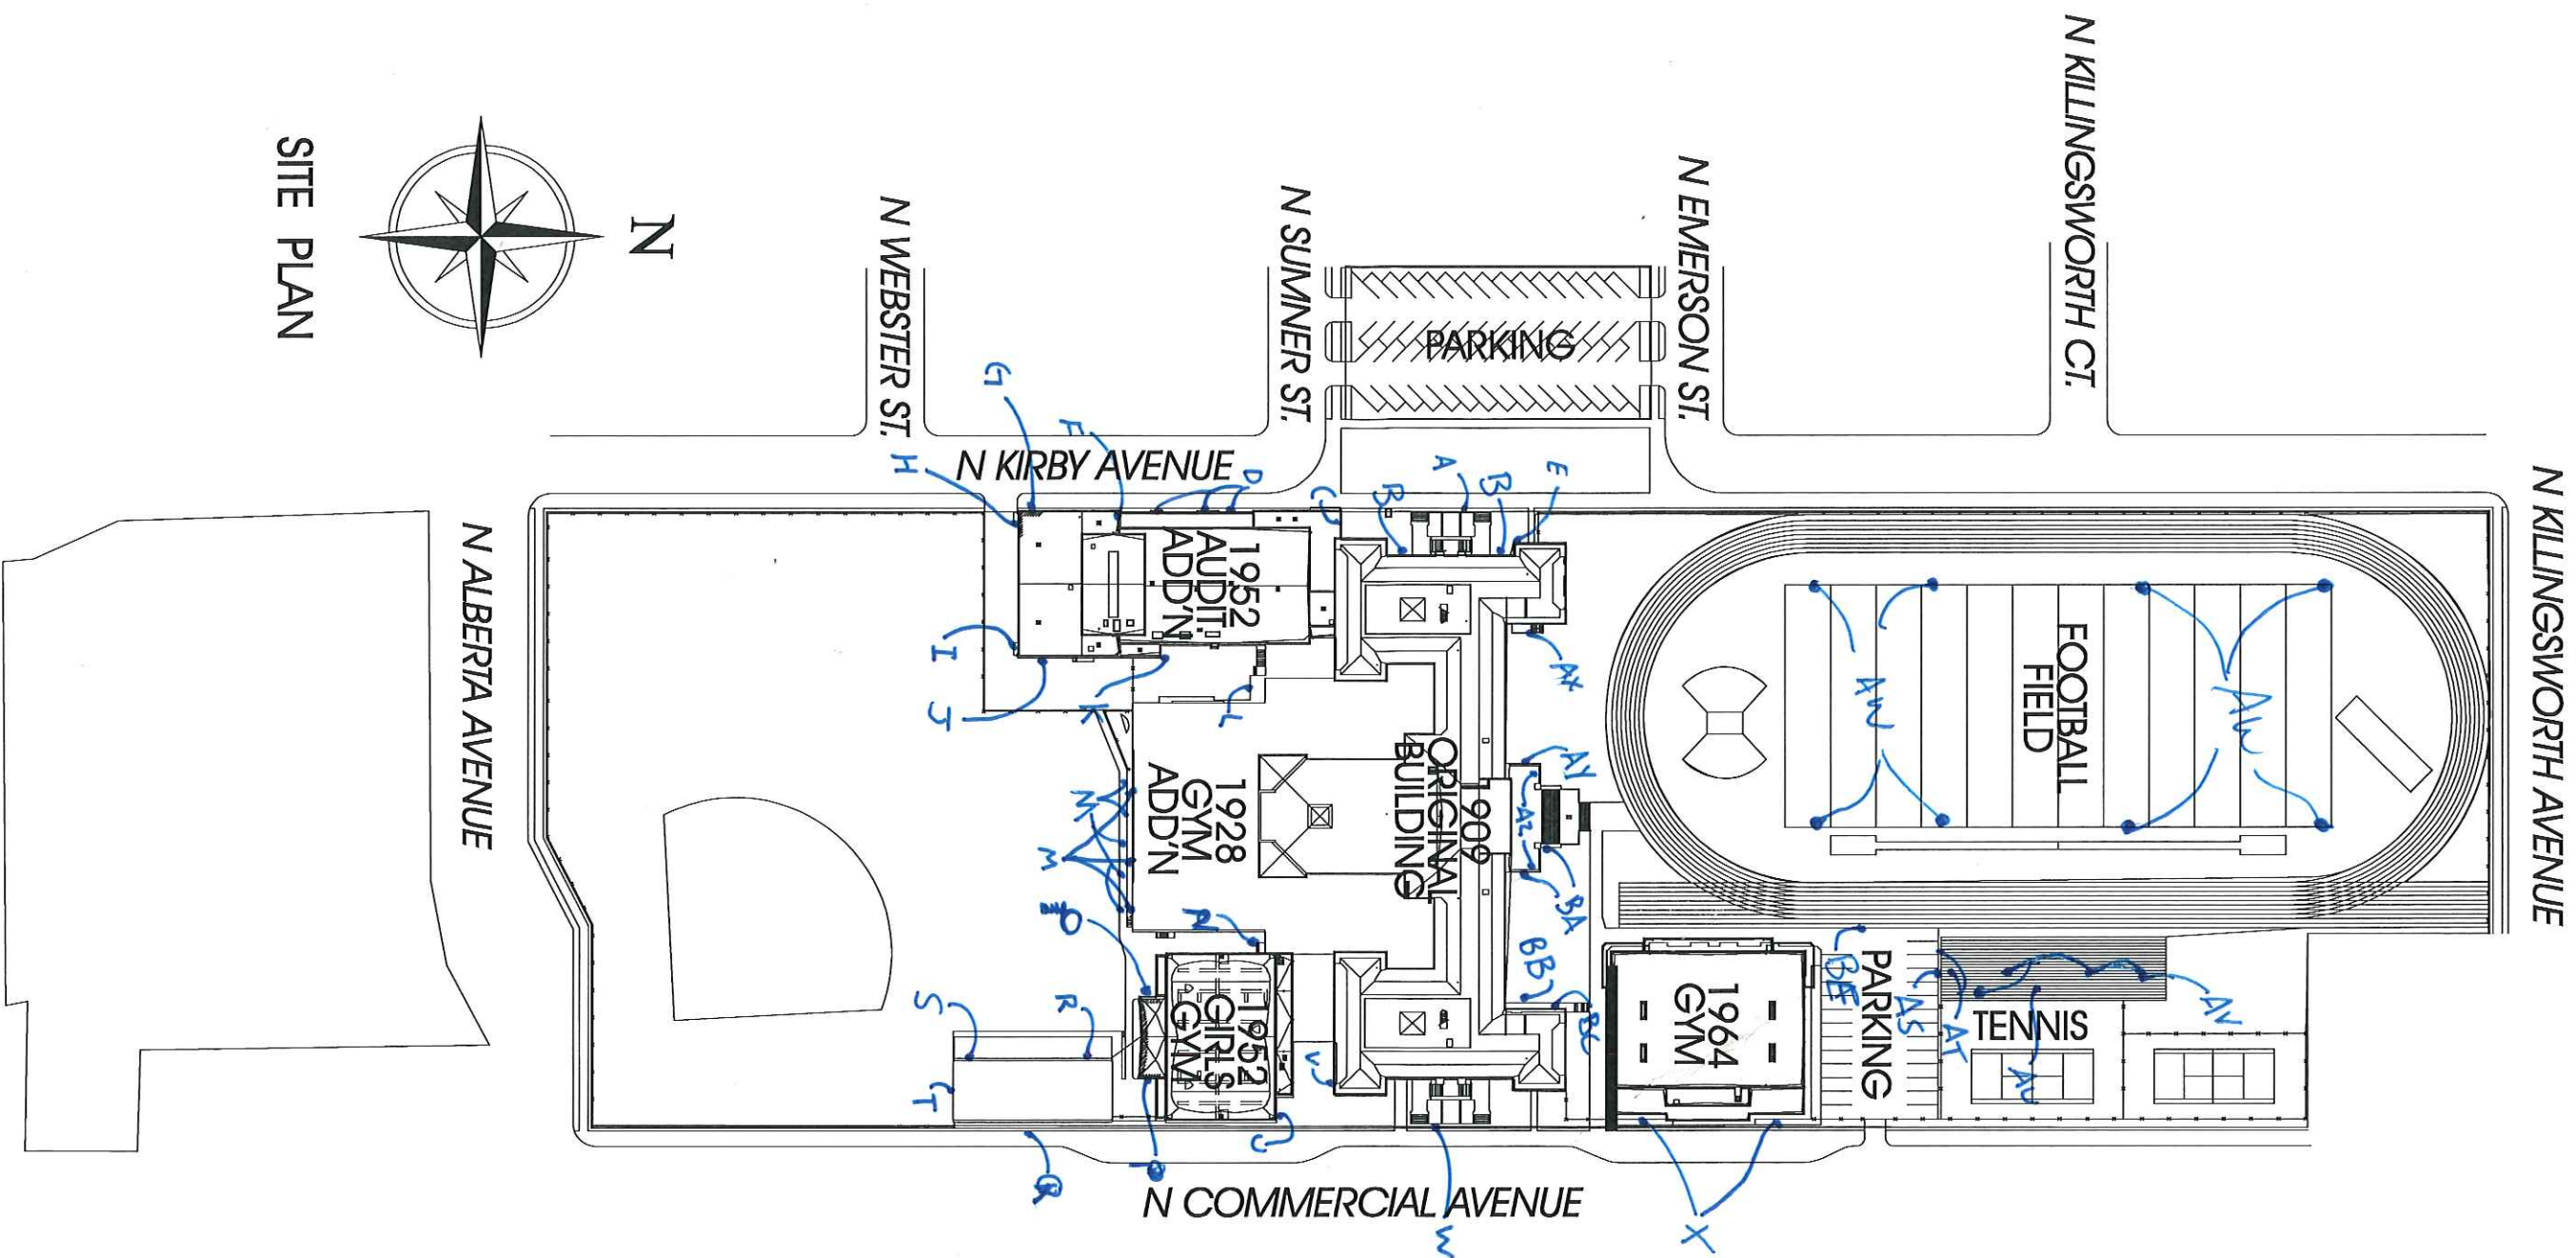
SITE PLAN

No paint chips were observed in the school's garden; however, paint chips were noted in soil on the southeast exterior of the auditorium, the south exterior of the gym, and near the east and west fire escapes on the north side of the main building. Paint chips were also observed on concrete on the building's west exterior at the east entrance.

PBS recommends that all painted or varnished surfaces in deteriorated condition noted on the attached table be stabilized. All paint chips noted in this report should be removed. Dirty wooden window troughs should be cleaned.
