Regarding: Lead Paint Condition Assessment  
Lent Elementary School  
5105 SE 97th Avenue  
Portland, Oregon 97266  
PBS Project: 6500.721 Phase 0031

**Lent Elementary School**  
**Assessment of Paint/Varnish in Deteriorated Condition**

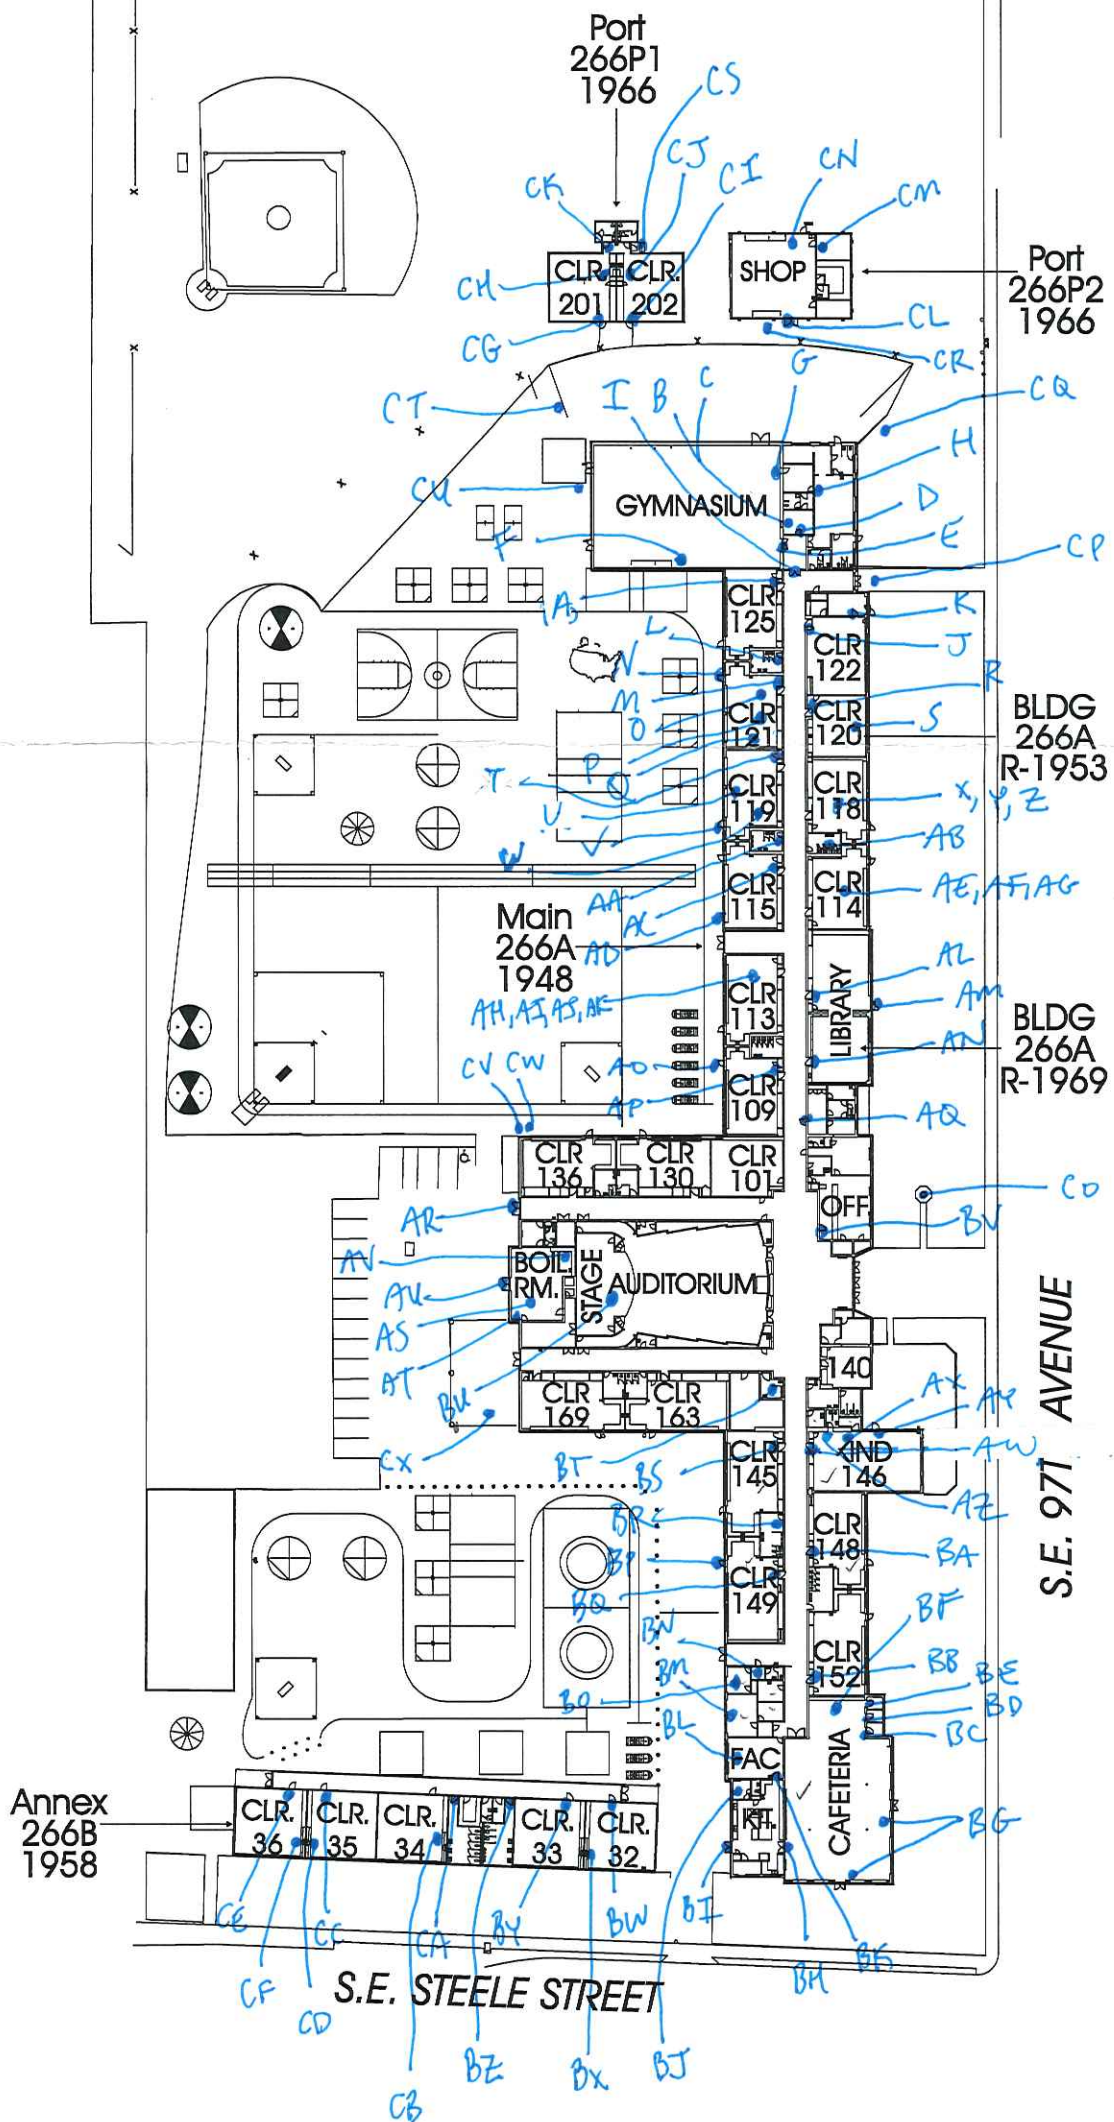
SITE / FLOOR PLAN

Overall, the building's painted and varnished surfaces were found to be in intact condition with areas of fair and deteriorated conditions. A table listing the locations and quantity of surfaces in deteriorated condition is attached to this report.

The school's garden spaces did not reveal any paint chips; however paint chips were observed on concrete outside classroom 136 near deteriorated paint conditions.

PBS recommends that all painted or varnished surfaces in deteriorated condition noted on the attached table be stabilized. All paint chips noted in this report should be removed.
