Regarding: Lead Paint Condition Assessment
Vestal Elementary School
161 NE 82nd Avenue
Portland, Oregon 97220
PBS Project: 6500.721 Phase 0053

Vestal Elementary School
Assessment of Paint/Varnish in Deteriorated Condition

Facility Plan

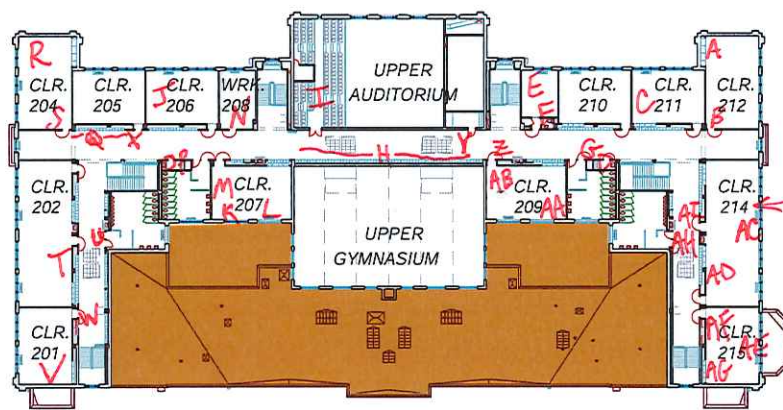
SECOND FLOOR PLAN

*WALL ON 2ND FLOOR
ALONG SOUTH SIDE
ALL POOR CONDITION
(BELOW WINDOWS)

*PAINT CHIPS ON
FLOOR IN 214 ALONG SOUTH WALL

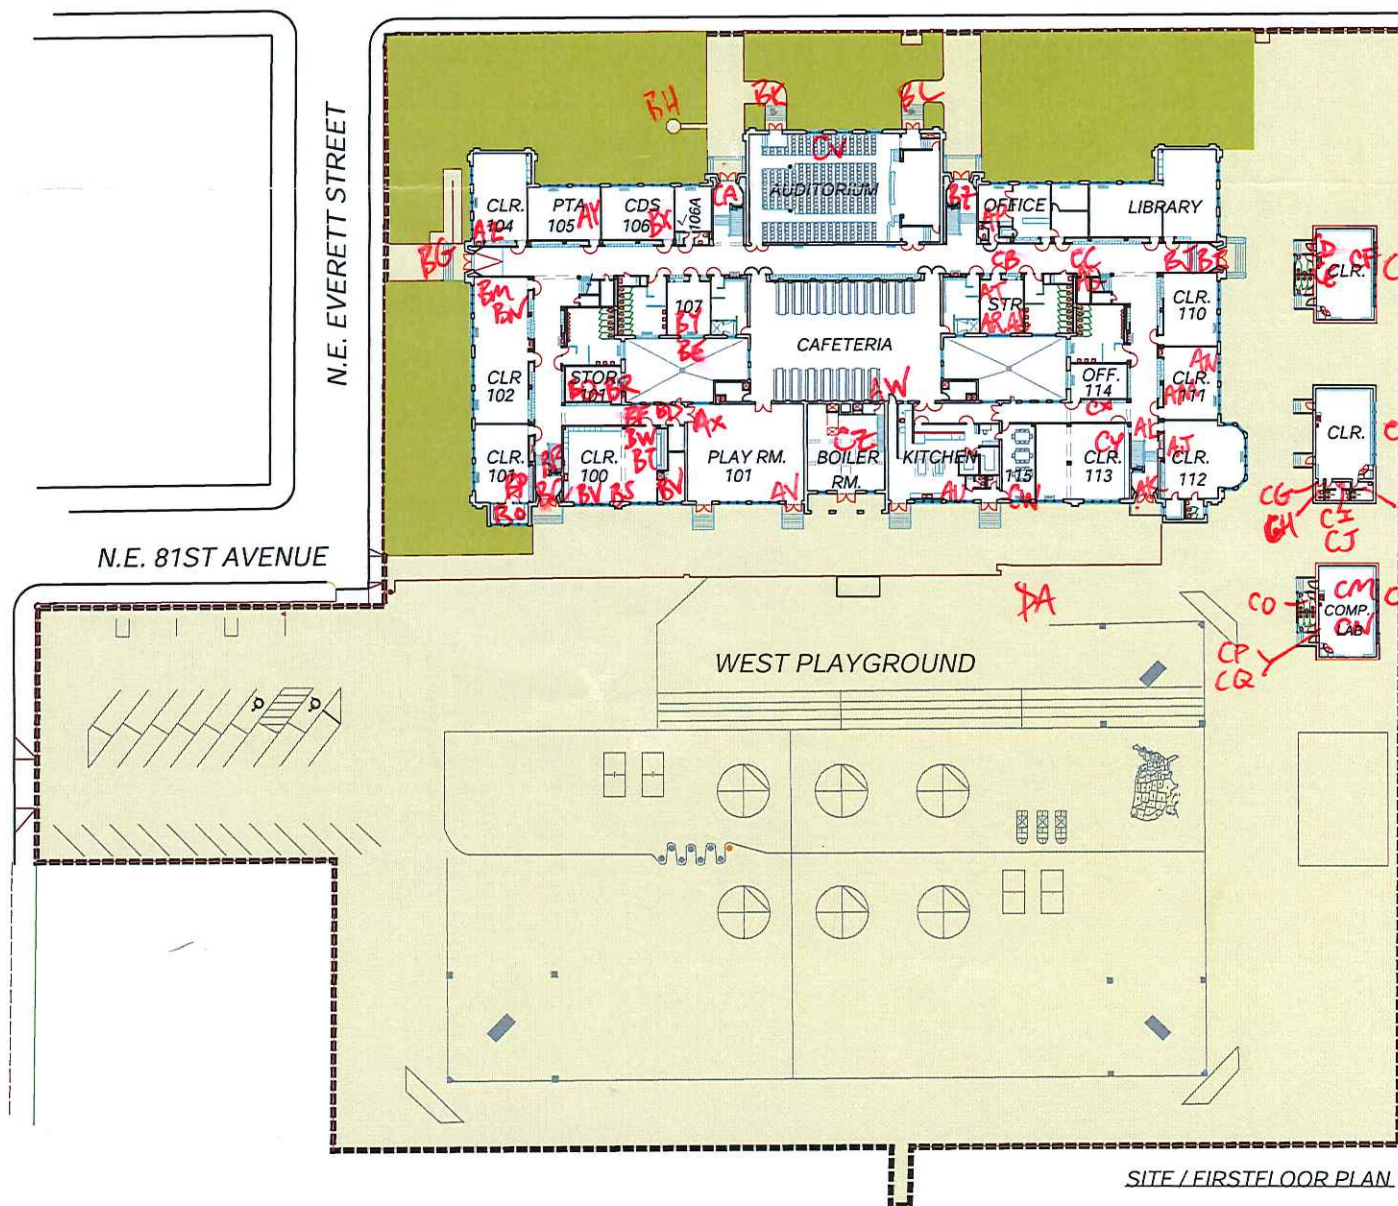
SITE / FIRST FLOOR PLAN

*WINDOW FRAMES / TROUGH
IN POOR CONDITION
IN PORTABLES

*CW IS ALL HANDRAILS (WOOD) INSIDE MAIN BLDG.
