Regarding: Lead Paint Condition Assessment
Astor Elementary School
5601 N Yale Street
Portland, Oregon 97203
PBS Project: 6500.721 Phase 0005

On November 4, 2016, PBS Engineering and Environmental Inc. conducted a visual inspection and assessment of painted and varnished surfaces on the interior and exterior of Astor Elementary School located at 5601 N Yale Street in Portland, Oregon.

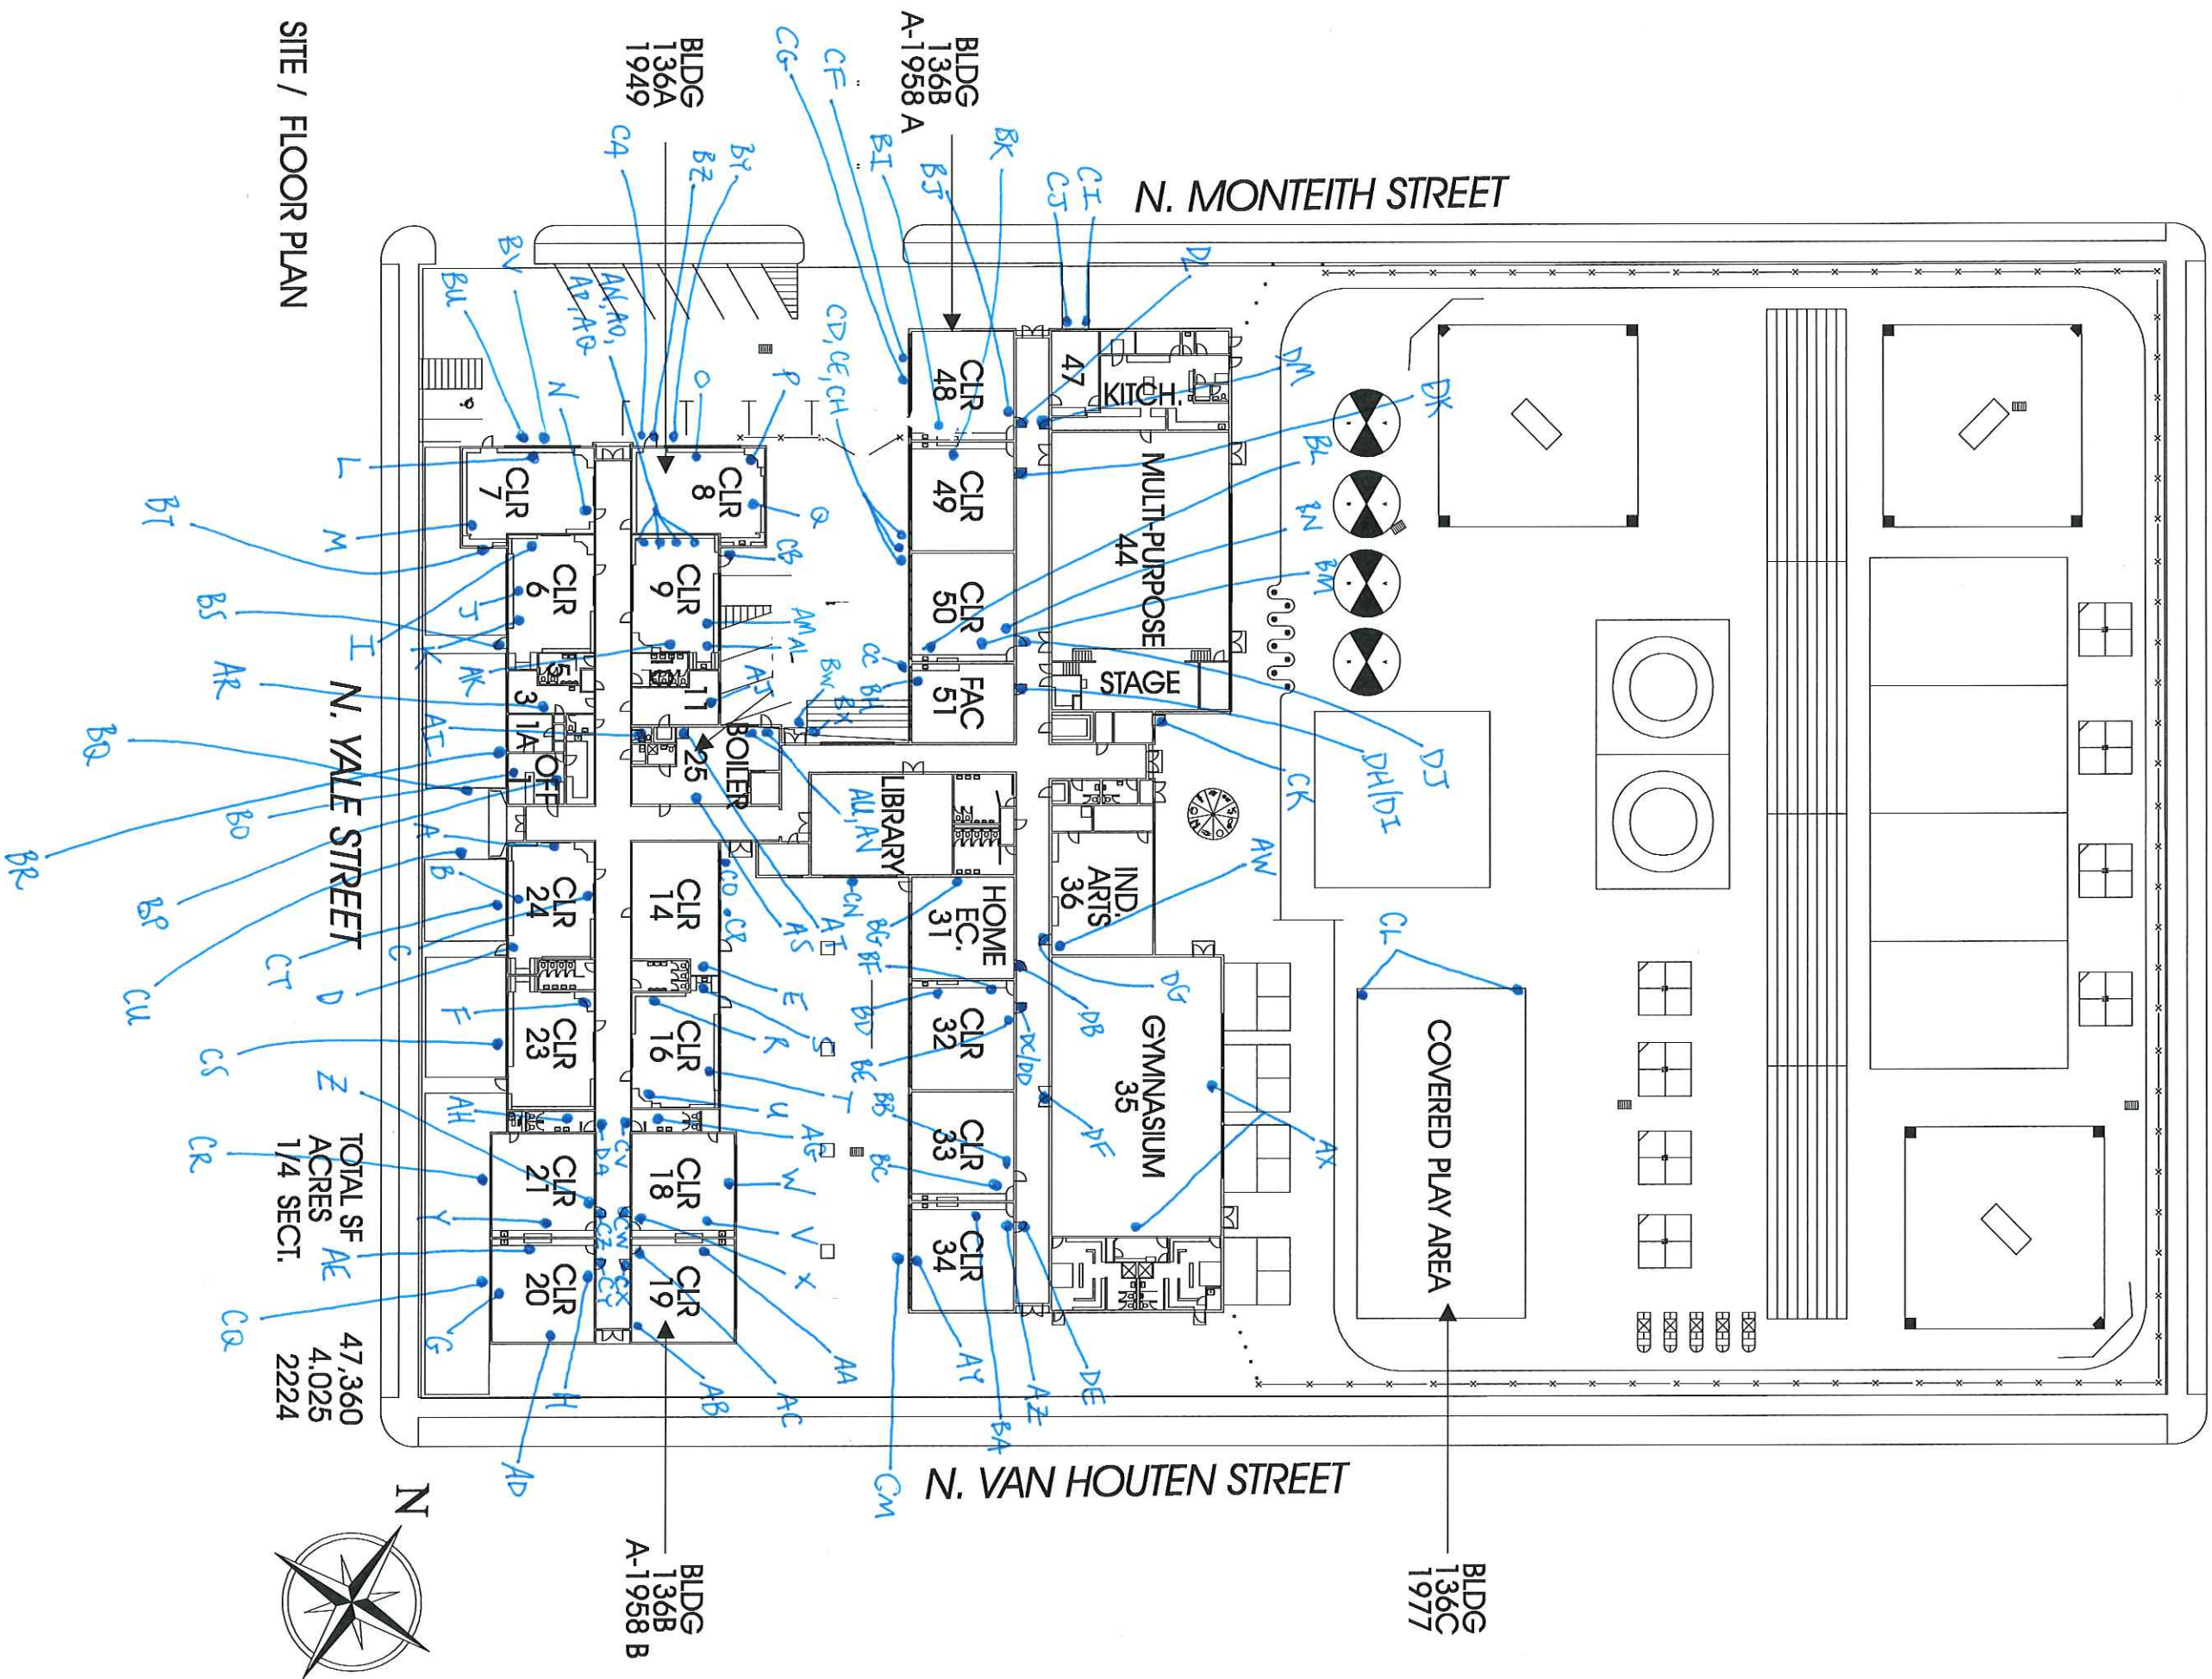
SITE / FLOOR PLAN

PBS observed paint chips in the "rain garden" on the east side of the building, one to two feet from the closest painted surface, which was observed to be in fair condition.

Paint chips were also observed on the exterior of classrooms 7, 8, 47, 48, 49, and 50, and faculty room 51, and on the building's northwest corner parking area near dumpsters and the boiler-room entrance. Paint chips were observed within two feet of painted surfaces, which were in fair to deteriorated condition in multiple locations of the parking area.

Areas of high concern noted during PBS' site visit were the paint debris fields previously mentioned. PBS recommends that all painted or varnished surfaces in deteriorated condition be stabilized, and that paint chips in the locations mentioned be removed.
