Regarding: Lead Paint Condition Assessment
Boise-Eliot Elementary School
620 N Fremont Street
Portland, Oregon 97227
PBS Project: 6500.721 Phase 0009

Boise-Eliot Elementary School
Assessment of Paint and Varnish in Deteriorated Condition

Boise Eliot Elementary School 620 N Fremont 97227 Facility Plan

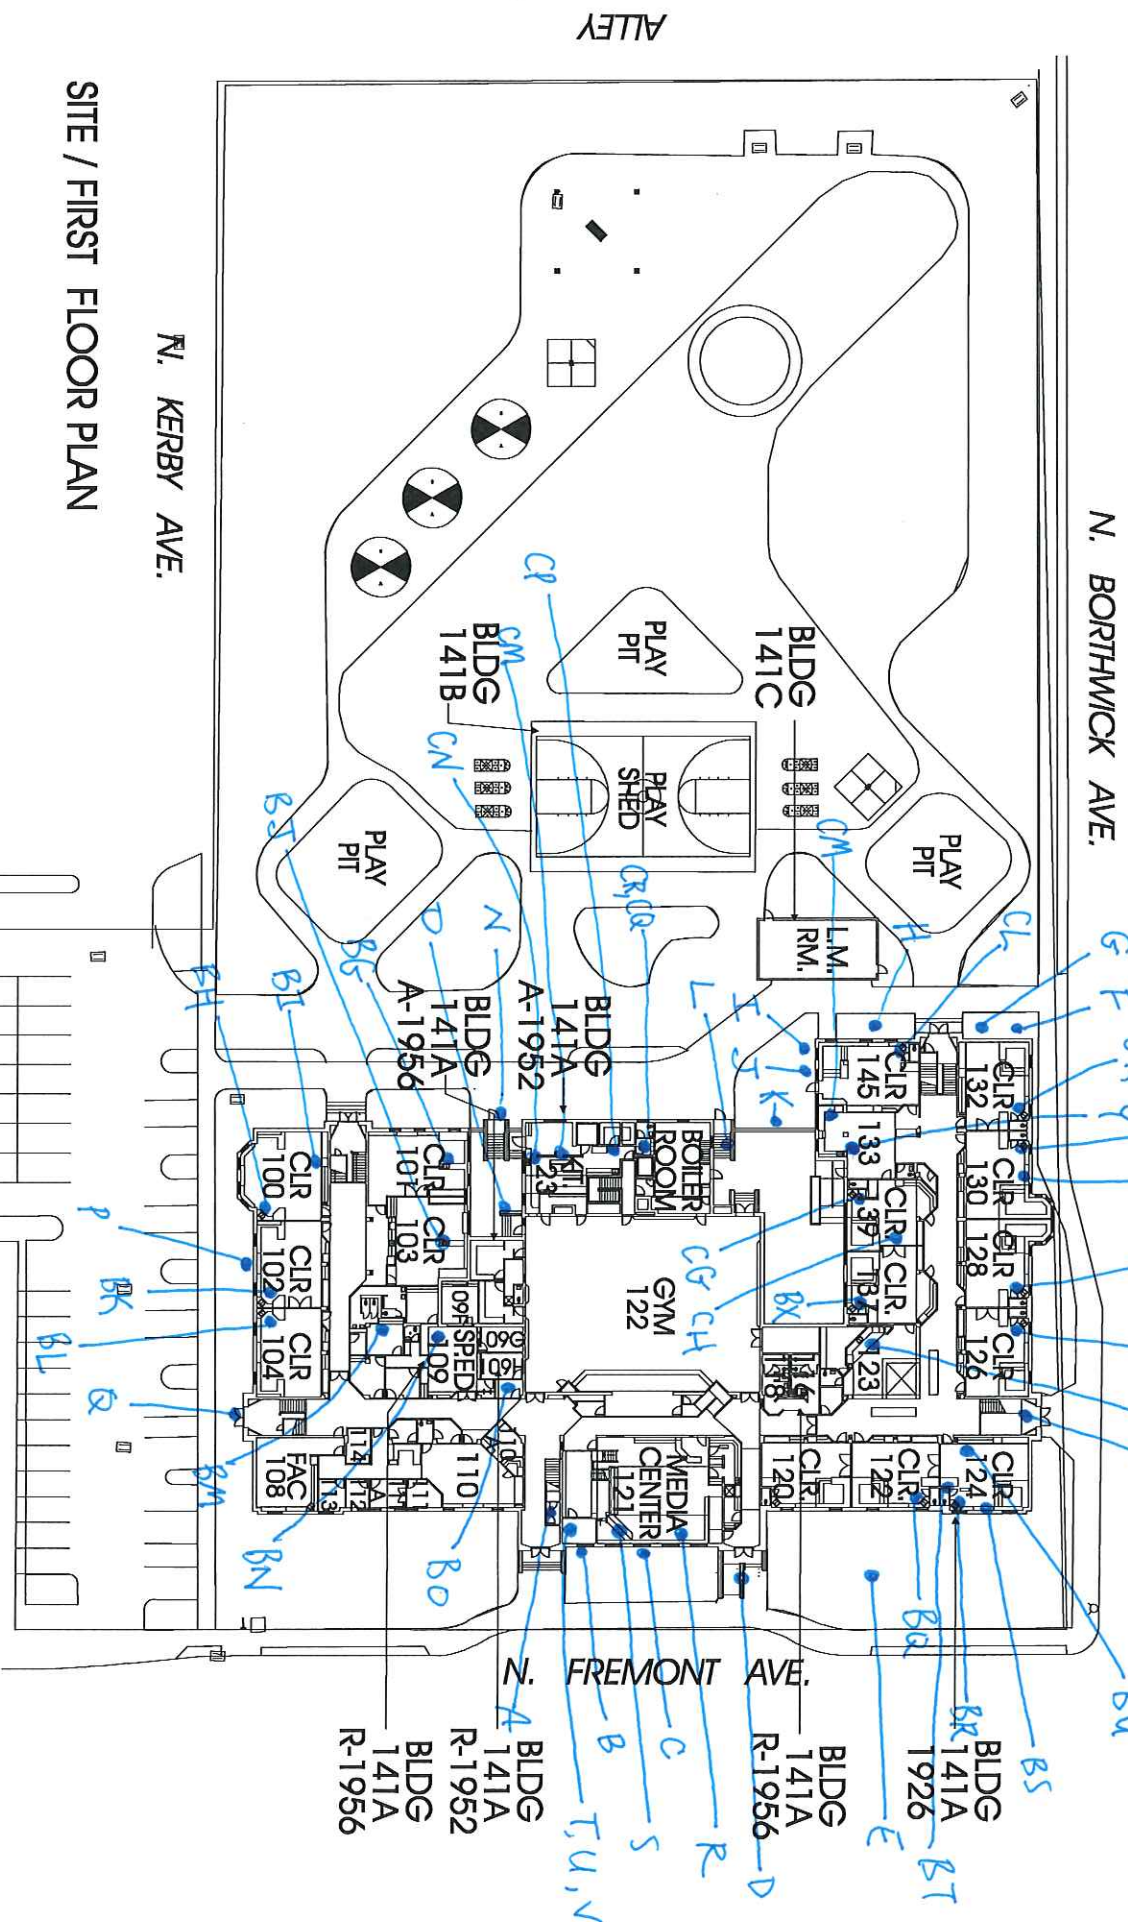
SITE / FIRST FLOOR PLAN

Overall, the building's painted and varnished surfaces were found to be in fair and intact condition with areas of deteriorated conditions. A table listing the locations and quantity of surfaces in deteriorated condition is attached to this report.

PBS recommends that all painted or varnished surfaces in deteriorated condition be stabilized. Paint chips in the garden should be removed. The window trough in room 220 should be cleaned.

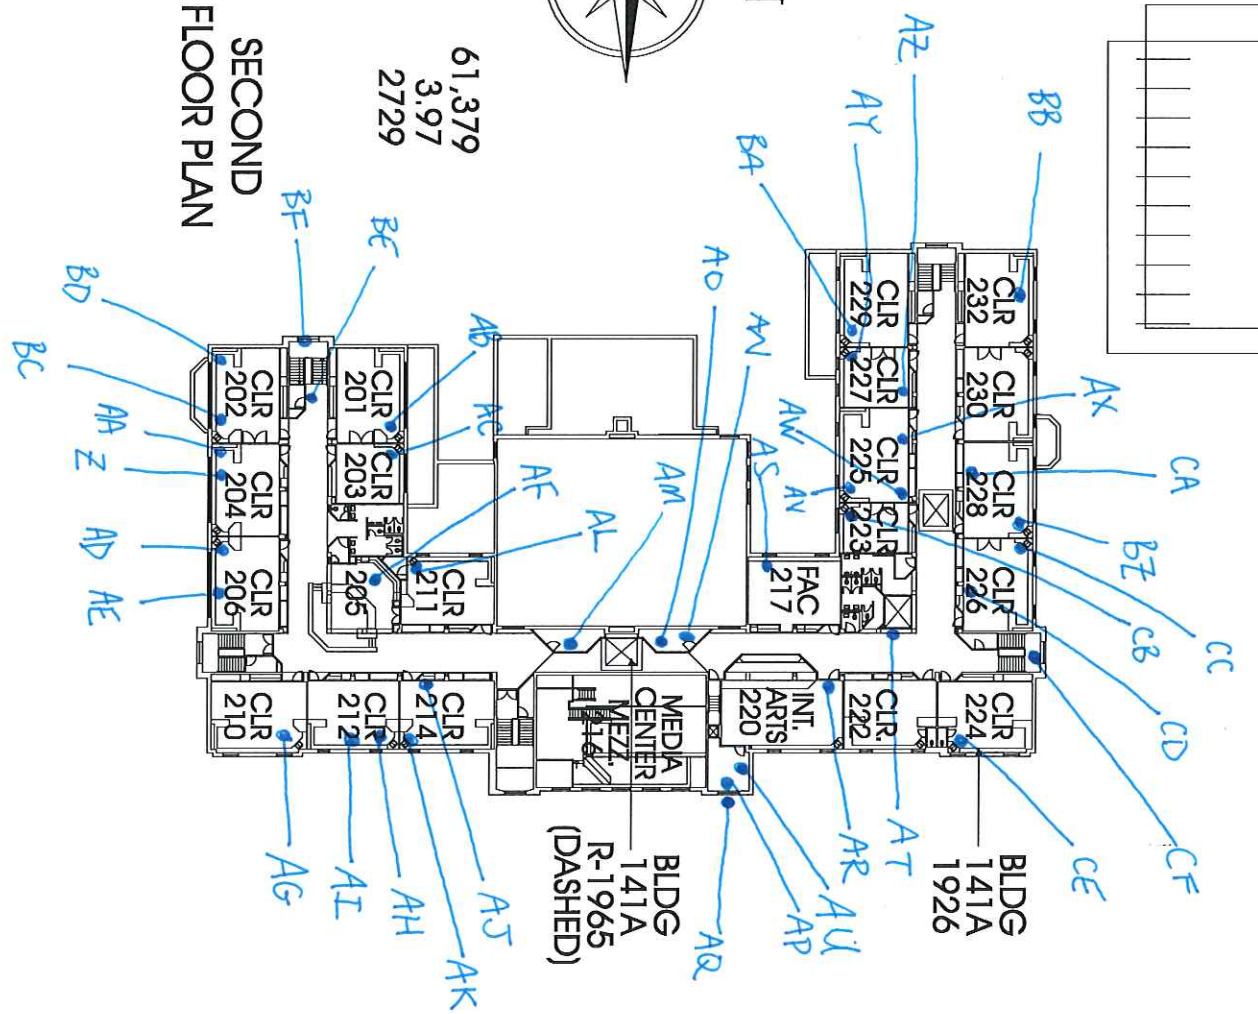
SECOND FLOOR PLAN

Windows were observed to be made of newer plastic and older wood. Wood window troughs in room 220 office were observed to be dirty with paint chips.
