Regarding: Lead Paint Condition Assessment
César Chávez School
5103 N Willis Boulevard
Portland, Oregon 97203
PBS Project: 6500.721 Phase 0015

Cesar Chavez School
Assessment of Paint/Varnish in Deteriorated Condition

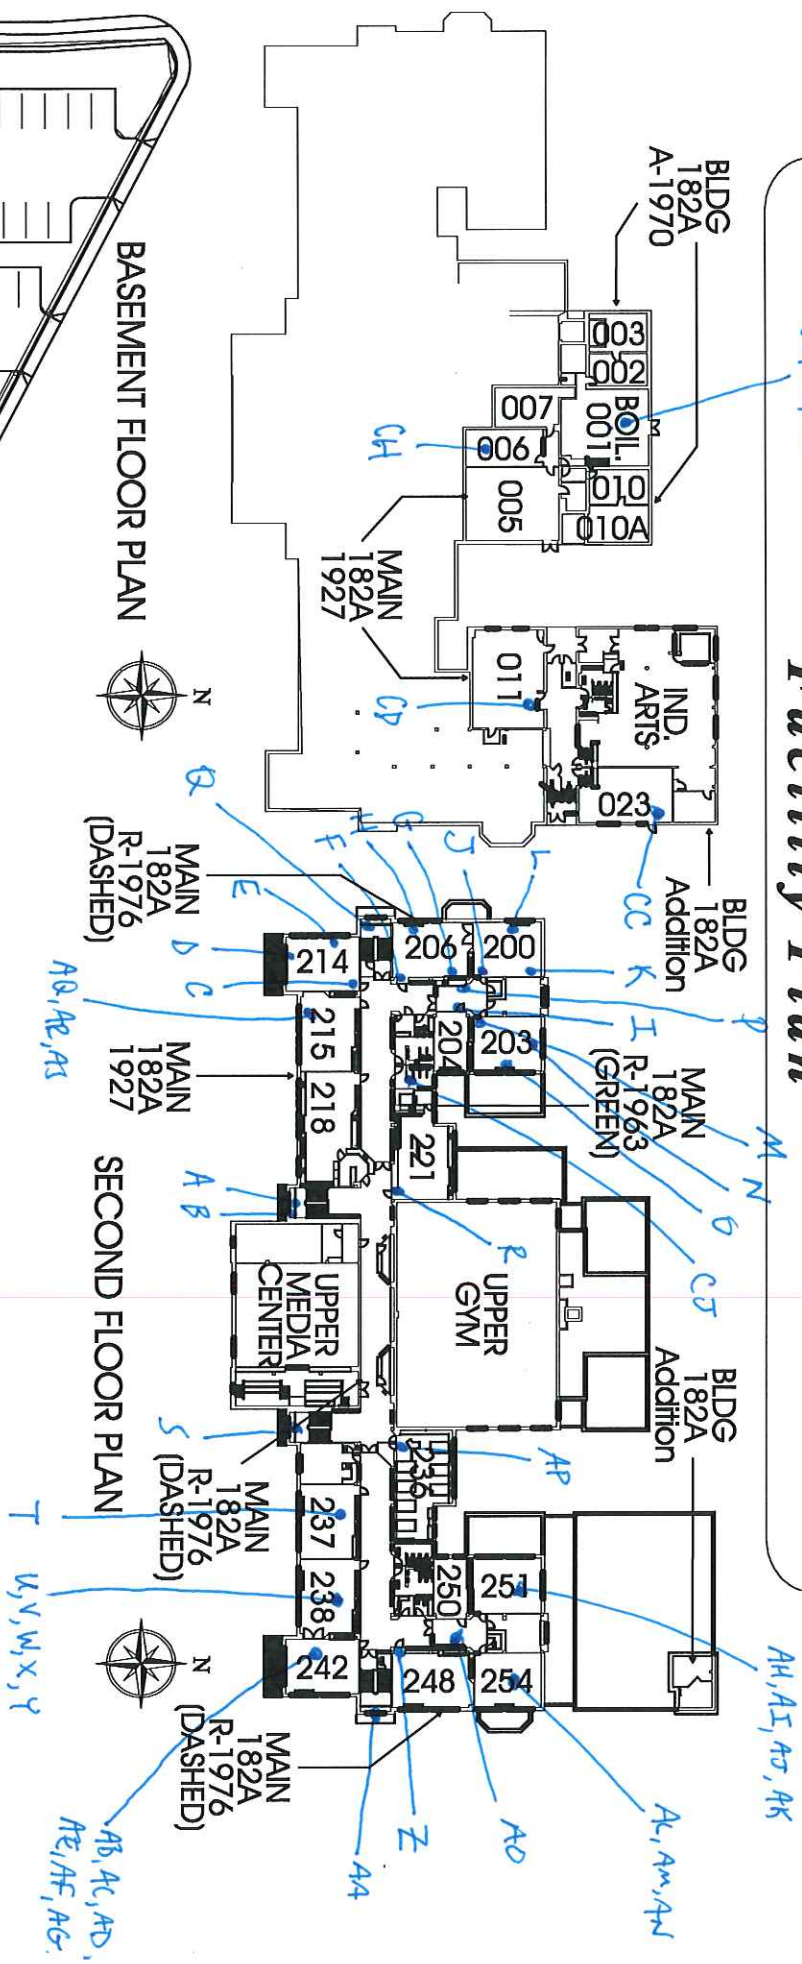
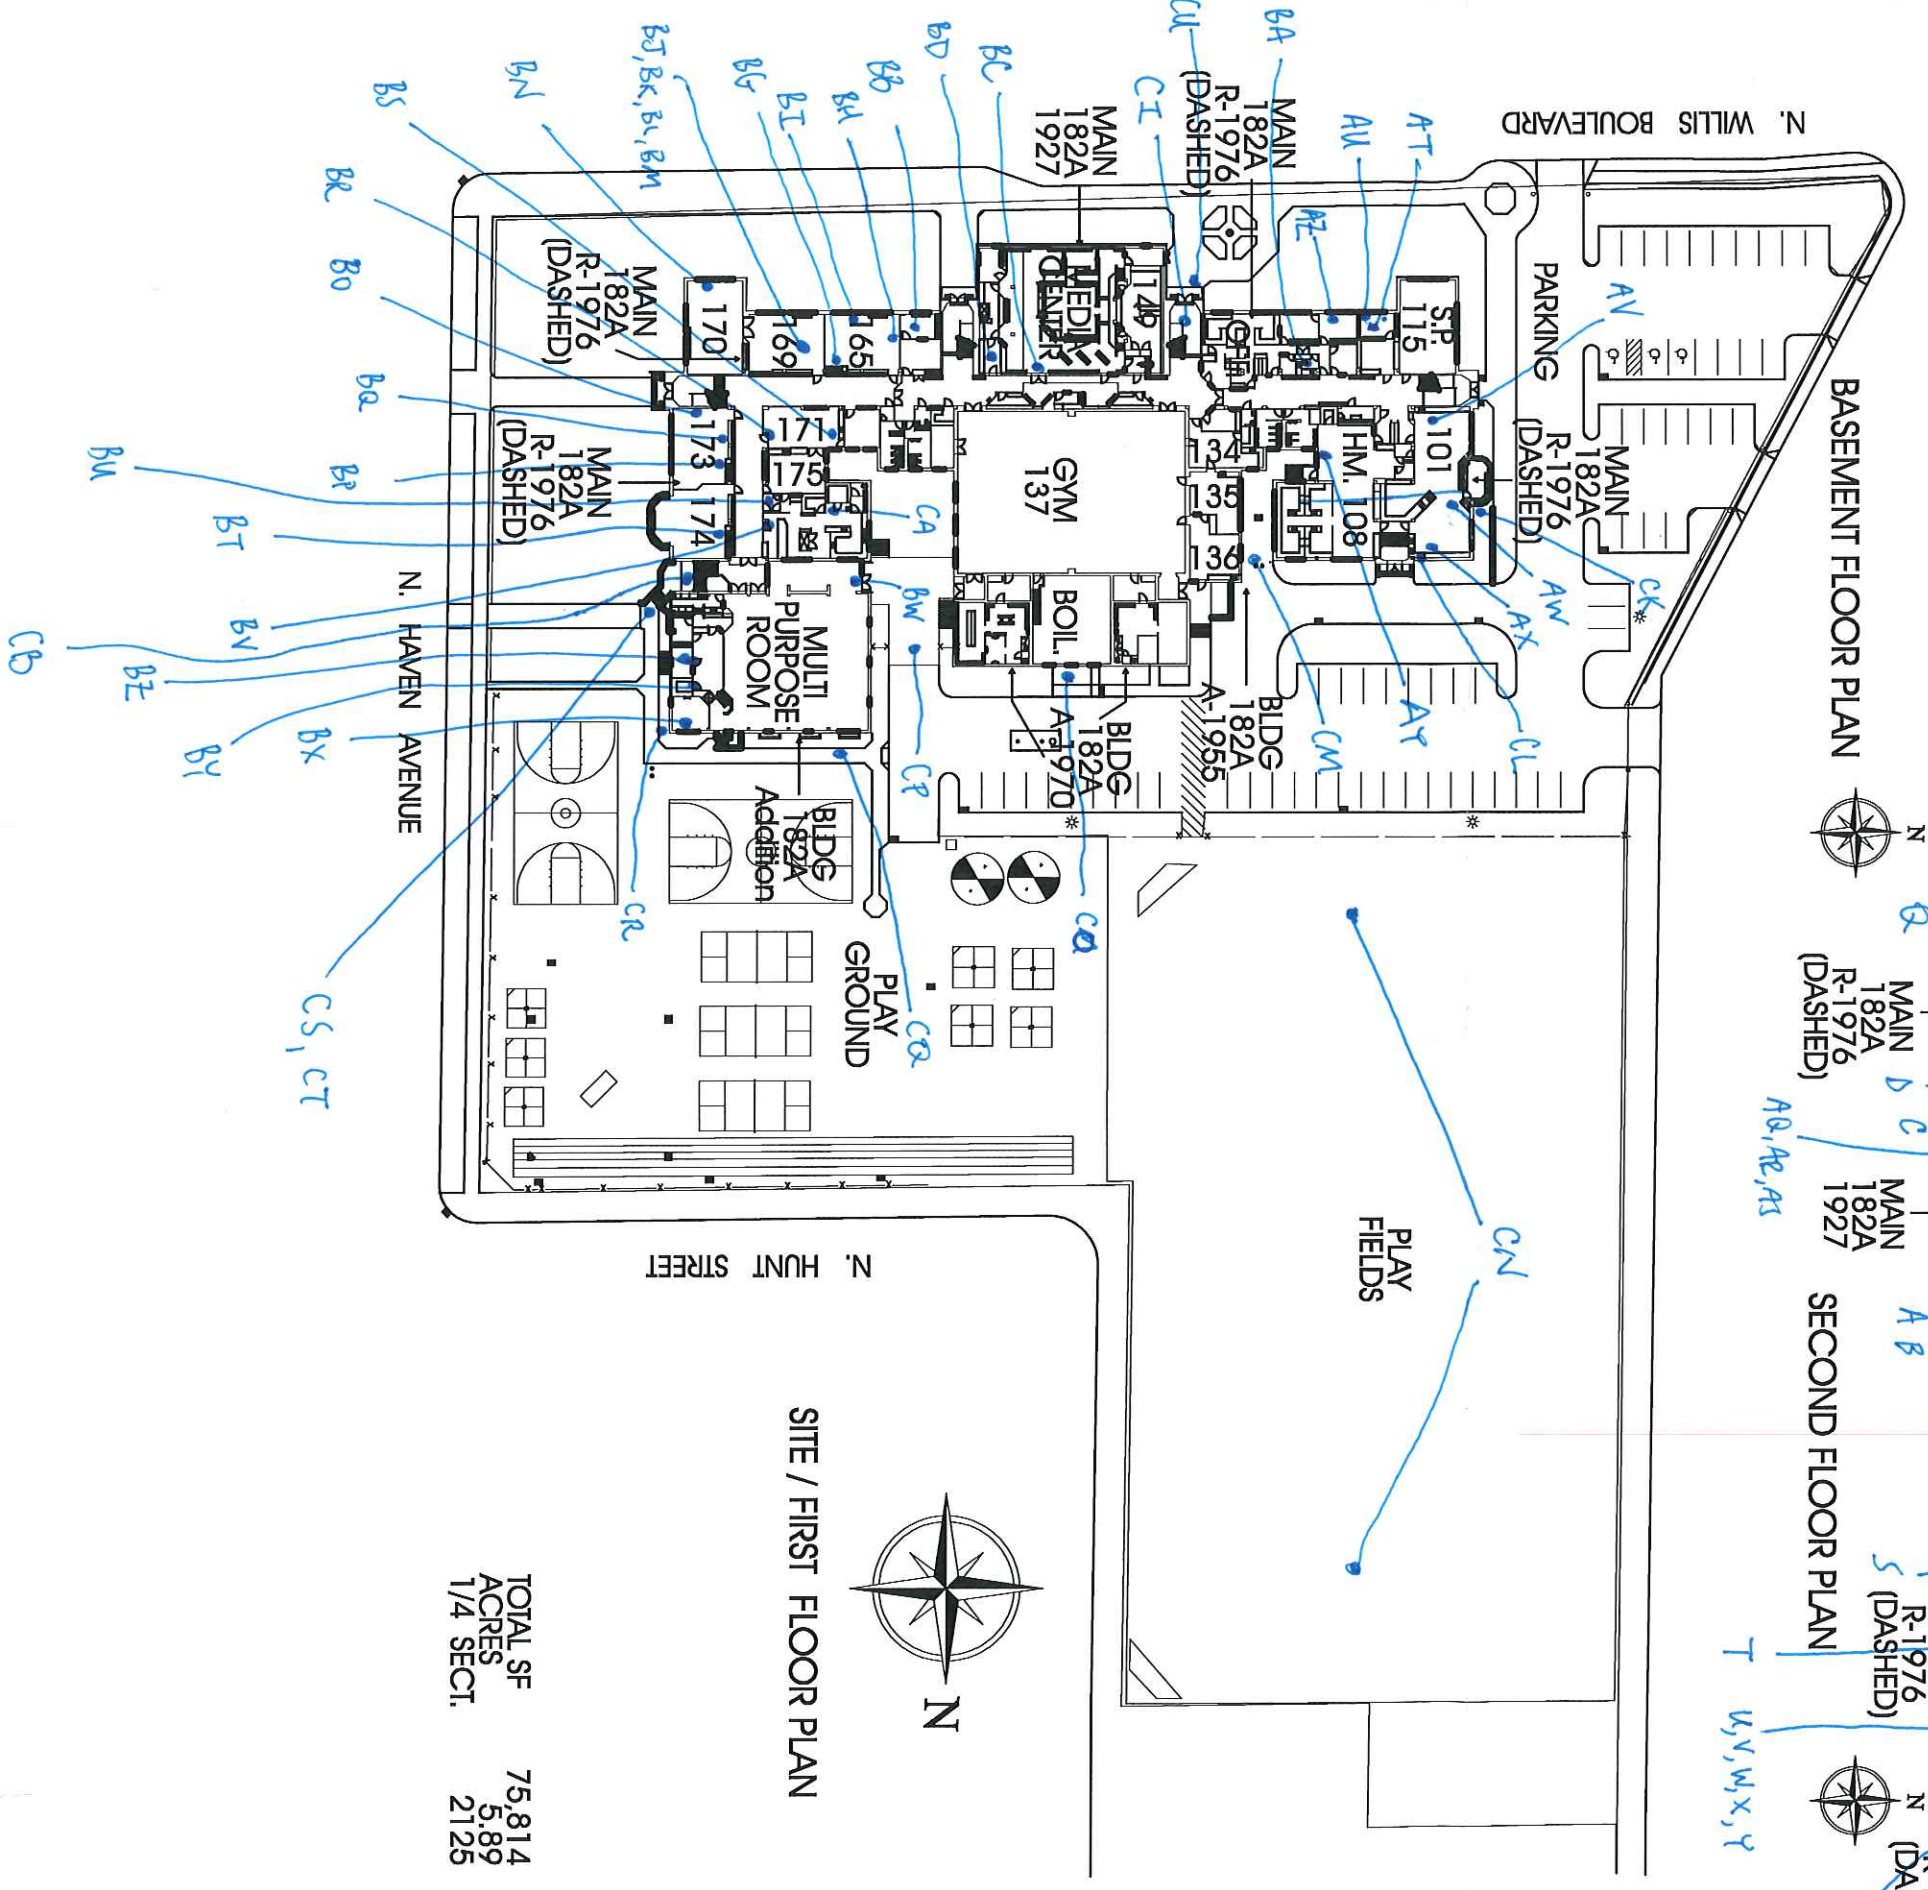
Portsmouth Middle School 5103 N Willis Blvd. 97203 Facility Plan

Overall, the building's painted and varnished surfaces were found to be in fair and intact condition with areas of deteriorated conditions. A table listing the locations and quantity of surfaces in deteriorated condition is attached to this report.

PBS recommends that all painted or varnished surfaces in deteriorated condition noted on the attached table be stabilized.
