Regarding: Lead Paint Condition Assessment  
Buckman Elementary School  
320 SE 16th Avenue  
Portland, Oregon 97214  
PBS Project: 6500.721 Phase 0012

**Buckman Elementary**  
**Assessment of Paint/Varnish in Deteriorated Condition**

# Buckman Elementary School 320 SE 16th Street 97214 Facility Plan

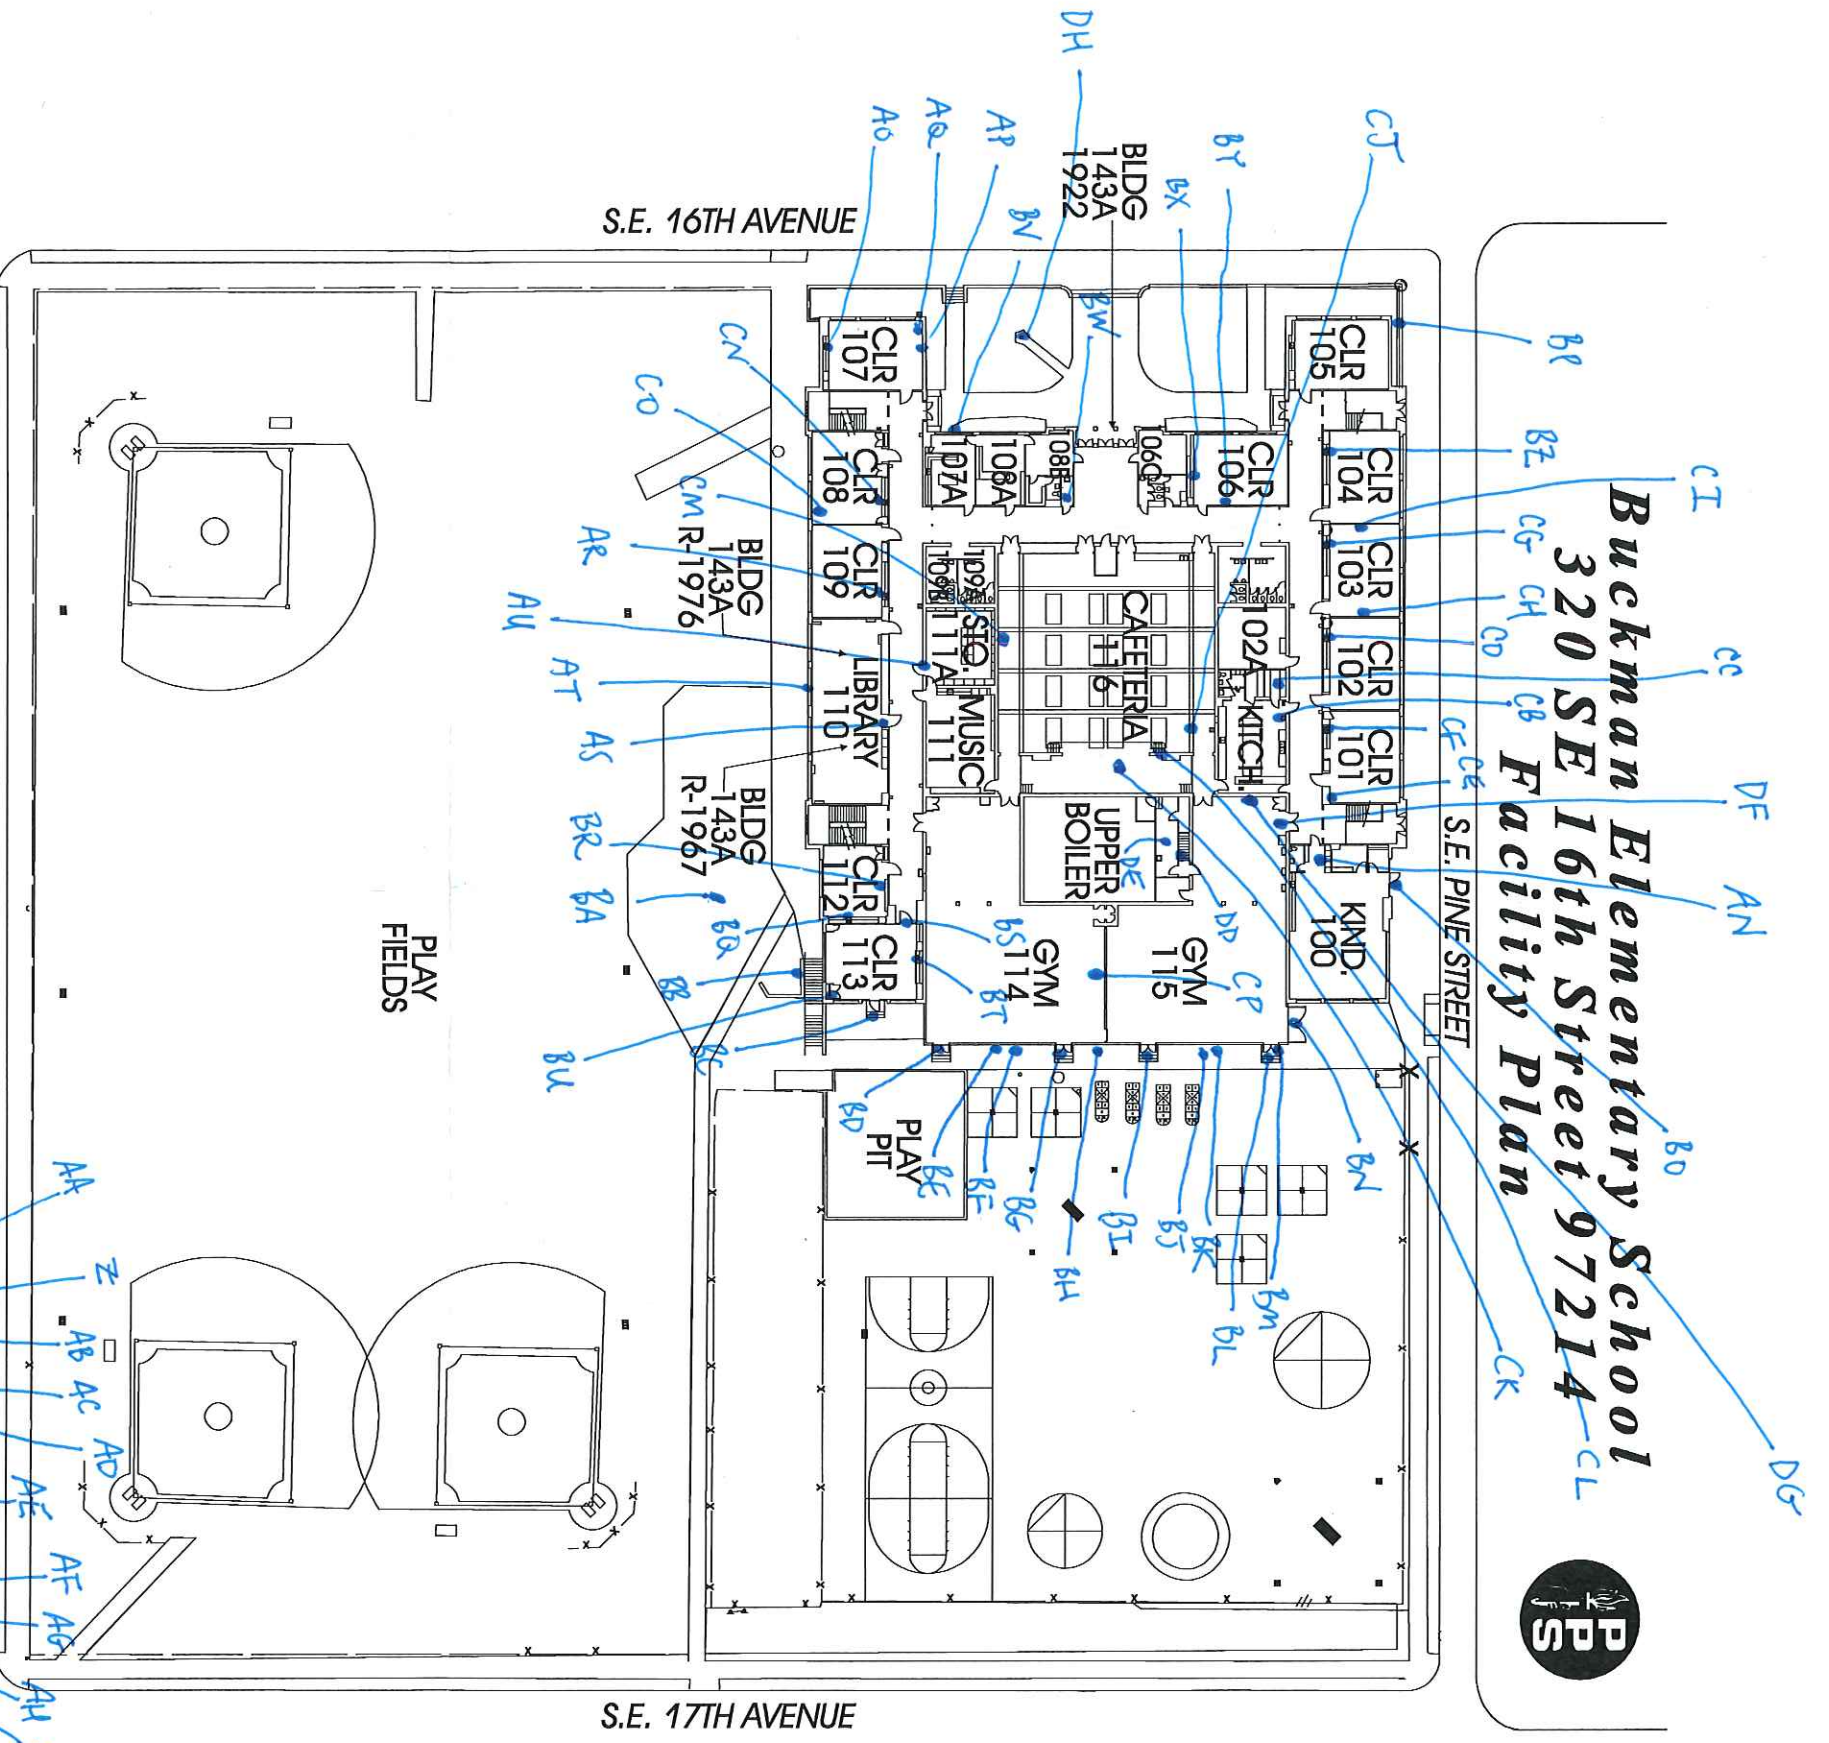
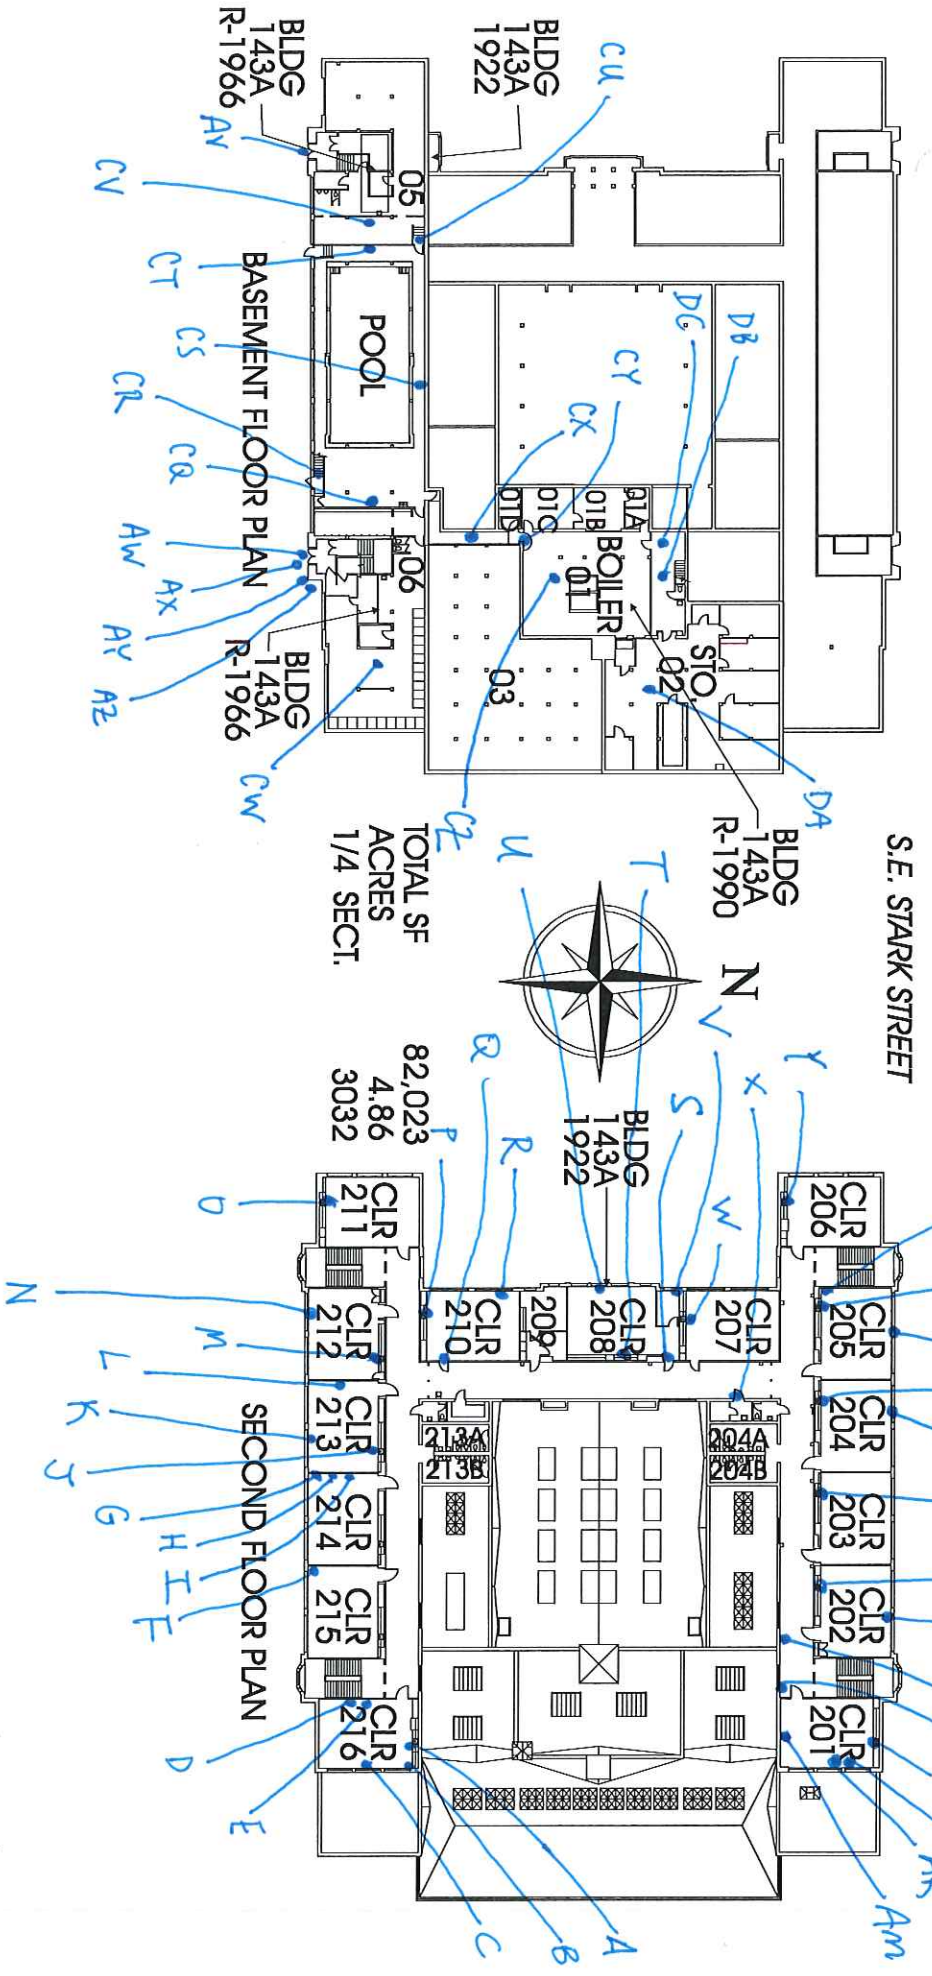
ID	Interior / Exterior	Location	Structure	Above / Below five feet	K-2nd Grade	Substrate	Quantity
A	Interior	Classroom 216	Built-in cabinets and trim under sink	Below	Yes	Wood	30
B	Interior	Classroom 216	Northeast corner wall	Above	Yes	Plaster	6
C	Interior	Classroom 216	windowsills	Below	Yes	Wood	30
D	Interior	Classroom 216	Baseboards, west wall	Below	Yes	Wood	25
E	Interior	Classroom 216	Chalkboard frame	Above and below	Yes	Wood	50
F	Interior	Classroom 215	Southwest corner wall	Above and below	No	Plaster	24
G	Interior	Classroom 214	Under chalkboard rail	Below	No	Wood	20
H	Interior	Classroom 214	Baseboards, west wall	Below	No	Wood	20
I	Interior	Classroom 214	Chalkboard rail	Below	No	Wood	20
J	Interior	Classroom 213	Built-in cabinets and trim under sink	Below	No	Wood	30
K	Interior	Classroom 213	Windowsill where radiator makes contact	Below	No	Wood	30
L	Interior	Classroom 213	Baseboards, west wall	Below	No	Wood	25

M	Interior	Classroom 212	Built-in cabinets and trim under sink	Below	Yes	Wood	18
N	Interior	Classroom 212	Windowsills	Below	Yes	Wood	25
O	Interior	Classroom 211	Built-in cabinets and trim under sink	Below	No	Wood	20
P	Interior	Classroom 210	Built-in cabinets and trim under sink	Below	No	Wood	30
Q	Interior	Classroom 210	Doorframe	Above and below	No	Wood	15
R	Interior	Classroom 210	windowsills	Below	No	Wood	25
S	Interior	Classroom 208	Doorframe	Above and below	No	Wood	15
T	Interior	Classroom 208	Built-in cabinets and trim under sink	N/A	No	Wood	30
U	Interior	Classroom 208	Second windowsill from right	Below	No	Wood	5
V	Interior	Classroom 208 office	Northwest corner wall	Above and below	No	Plaster	18
W	Interior	Classroom 207	Built-in cabinets and trim under sink	Below	No	Wood	30

ID	Interior / Exterior	Location	Structure	Above / Below five feet	K-2nd Grade	Substrate	Quantity
X	Interior	Custodial across from classroom 207	Doorframe	Above and below	No	Wood	15
Y	Interior	Classroom 206	Built-in cabinets and trim under sink	Below	No	Wood	30
Z	Interior	Classroom 205	Built-in cabinets and trim under sink	Below	No	Wood	36
AA	Interior	Classroom 205	Southwest corner wall	Above	No	Plaster	10
AB	Interior	Classroom 205	Windowsills	Below	No	Wood	40
AC	Interior	Classroom 204	Built-in cabinets and trim under sink	Below	No	Wood	20
AD	Interior	Classroom 204	Windowsills	Below	No	Wood	40
AE	Interior	Classroom 203	Built-in cabinets and trim under sink	Below	No	Wood	45
AF	Interior	Classroom 202	Built-in cabinets and trim under sink	Below	No	Wood	45
AG	Interior	Classroom 202	Windowsills	Below	No	Wood	40
AH	Interior	Hallway across from classroom 202	Wall	Above and below	No	Plaster	20
AI	Interior	Hallway outside classroom 201	Wall	Above	No	Plaster	15

AJ	Interior	Classroom 201	Built-in cabinets and trim under sink	Below	No	Wood	30
AK	Interior	Classroom 201	Windowsills	Below	No	Wood	40
AL	Interior	Classroom 201	Wall between second loft most windows	Above and below	No	Plaster	25
AM	Interior	Classroom 201	South window	Above	No	Plaster	120
AN	Interior	Classroom 100	Built-in shelving and cabinets at entrance	Above and below	Yes	Wood	100
AO	Interior	Classroom 107	Built-in cabinets and trim under sink	Below	Yes	Wood	30
AP	Interior	Classroom 107	North wall under board	Below	Yes	Plaster	30
AQ	Interior	Classroom 107	North wall baseboards	Below	Yes	Wood	20
AR	Interior	Classroom 109	Built-in cabinets and trim under sink	Below	Yes	Wood	30
AS	Interior	Library 110 east entrance	Doorframe	Above and below	Yes	Wood	15
AT	Interior	Library 110	windowsills	Below	Yes	Wood	60
AU	Interior	111A storage	Doorframe	Above and below	No	Wood	15

ID	Interior / Exterior	Location	Structure	Above / Below five feet	K-2nd Grade	Substrate	Quantity
AV	Exterior	Southwest entrance to building	Handrails	Below	No	Metal	30
AW	Exterior	Southeast entrance to building	Bike racks	Below	No	Metal	16
AX	Exterior	Southeast entrance to building	Door stop	Below	No	Metal	5
AY	Exterior	Southeast entrance to building	Paint chips on ground	Below	No	N/A	2
AZ	Exterior	Southeast entrance to building	Wall	Above and below	No	Plaster	50
BA	Exterior	Playground, south side of building	Playground equipment	Above and below	No	Metal	100
BB	Exterior	Southeast corner of building	Handrails	Below	No	Metal	80
BC	Exterior	East entrance to classroom 113	Handrails	Below	No	Metal	20
BD	Exterior	South entrance to gym 114	Handrails	Below	No	Metal	20
BE	Exterior	Between entryway to gym in 114	Wall	Above and below	No	Plaster	150
BF	Exterior	Between entryway to gym in 114	Paint chips on ground	Below	No	N/A	10

BG	Exterior	North entrance to gym 114	Handrails	Below	No	Metal	20
BH	Exterior	North of north entrance to gym 114	Wall	Above and below	No	Plaster	150
BI	Exterior	South entrance to gym 115	Handrails	Below	No	Metal	20
BJ	Exterior	Between entryways to gym 115	Wall	Above and below	No	Plaster	150
BK	Exterior	Between entryways to gym 115	Paint chips on ground	Below	No	N/A	10
BL	Exterior	North entrance to gym 115	Handrails	Below	No	Metal	20
BM	Exterior	North entrance to gym 115	Underside of roof overhang	Above	No	Wood	40
BN	Exterior	North exterior wall to gym 115	Underside of roof overhang	Above	No	Wood	20
BO	Exterior	North entrance to kindergarten 100	Door	Above and below	Yes	Metal	70
BP	Exterior	Northside of classroom 105	Handrails	Below	No	Metal	20
BQ	Interior	Classroom 112	Built-in cabinets and trim under sink	Below	No	Wood	30
BR	Interior	Classroom 112	Baseboards, north wall	Below	No	Wood	20
BS	Interior	Classroom 113	Doorframe	Above and below	Yes	Wood	15

ID	Interior / Exterior	Location	Structure	Above / Below five feet	K-2nd Grade	Substrate	Quantity
BT	Interior	Classroom 113	Built-in cabinets and trim under sink	Below	Yes	Wood	15
BU	Interior	Classroom 113	Built-in cabinets and trim under sink	Above and below	Yes	Wood	40
BV	Interior	107A, nurse	Windowsills	Below	Yes	Wood	20
BW	Interior	Custodial closet next to main office	Floor	Below	No	Concrete	30
BX	Interior	Classroom 106	Built-in cabinets and trim under sink	Below	Yes	Wood	30
BY	Interior	Classroom 106	East wall near door	Below	Yes	Plaster	25
BZ	Interior	Classroom 104	Built-in cabinets and trim under sink	Below	Yes	Wood	30
CA	Interior	Kitchen	Vertical water pipe near northwest entrance	Above and below	No	Metal	15
CB	Interior	Kitchen	Door and frame to walk-in refrigerator	Above and below	No	Wood	70
CC	Interior	Kitchen dry storage	Built-in shelving	Above and below	No	Wood	200
CD	Interior	Classroom 102	Built-in cabinets and trim under sink	Below	Yes	Wood	30

CE	Interior	Classroom 101	Wall, southeast corner next to entrance	Above and below	Yes	Plaster	20
CF	Interior	Classroom 101	Built-in cabinets and trim under sink	Below	Yes	Wood	10
CG	Interior	Classroom 103	Built-in cabinets and trim under sink	Below	Yes	Wood	30
CH	Interior	Classroom 103	Baseboard, east wall	Below	Yes	Wood	25
CI	Interior	Classroom 103	Baseboards, west wall	Below	Yes	Wood	25
CJ	Interior	Cafeteria	Beam in northeast corner	Above	Yes	Wood	20
CK	Interior	Cafeteria-stage	Stage floor	Below	Yes	Wood	1000
CL	Interior	Cafeteria-stage	Walls on either side of curtain	Above and below	Yes	Plaster	200
CM	Interior	Cafeteria	Beam along south wall	Above	Yes	Wood	100
CN	Interior	Classroom 108	Built-in cabinets and trim under sink	Below	No	Wood	30
CO	Interior	Classroom 108	Wall, southeast corner	Above and below	No	Plaster	30
CP	Interior	Gym 114	North wall above mirrors	Above	No	Wood	100
CQ	Interior	Pool	East wall near door	Above and below	No	Plaster	200

ID	Interior / Exterior	Location	Structure	Above / Below five feet	K-2nd Grade	Substrate	Quantity
CR	Interior	Pool, stairwell to balcony	Walls on either side of curtain	Above and below	No	Plaster	60
CS	Interior	Pool	North wall	Above and below	No	Plaster	400
CT	Interior	Pool	West wall	Above and below	No	Plaster	200
CU	Interior	Pool, hall to men's locker room	North wall	Above and below	No	Plaster	150
CV	Interior	Pool	Men's locker room: walls throughout	Above and below	No	Plaster	2000
CW	Interior	Women's locker room	Walls, throughout	Above and below	No	Plaster	2000
CX	Interior	Hallway to pool from boiler room	Walls	Above and below	No	Concrete	300
CY	Interior	Boiler room 01	Door and frame to pool	Above and below	No	Metal	60
CZ	Interior	Boiler room 01	Walls, throughout	Above and below	No	Concrete	3000
DA	Interior	Storage 02	Floor	Below	No	Concrete	3000
DB	Interior	Boiler room 01	Ceiling near staircase	Above	No	Wood	400

DC	Interior	Boiler room 01	Floor near staircase	Below	No	Concrete	400
DD	Interior	Stairwell to boiler room 01	Walls	Above and below	No	Wood	350
DE	Interior	Upper boiler	Floor	Below	No	Wood	400
DF	Interior	Gym 115	Beam above north entrance	Above	No	Wood	15
DG	Interior	Gym 115	West wall	Above	No	Plaster	100
DH	Exterior	Main entrance	Flagpole	Above and below	No	Metal	100

PBS recommends that all painted or varnished surfaces in deteriorated condition noted on the attached table be stabilized. Paint chips on concrete on the exterior east side of the building should be removed.
