Regarding: Lead Paint Condition Assessment  
Laurelhurst Elementary School  
840 NE 41st Avenue  
Portland, Oregon 97232  
PBS Project: 6500.721 Phase 0029

**Laurelhurst Elementary School**  
**Assessment of Paint/Varnish in Deteriorated Condition**

# Laurelhurst Elementary School 840 NE 41st 97232 Facility Plan

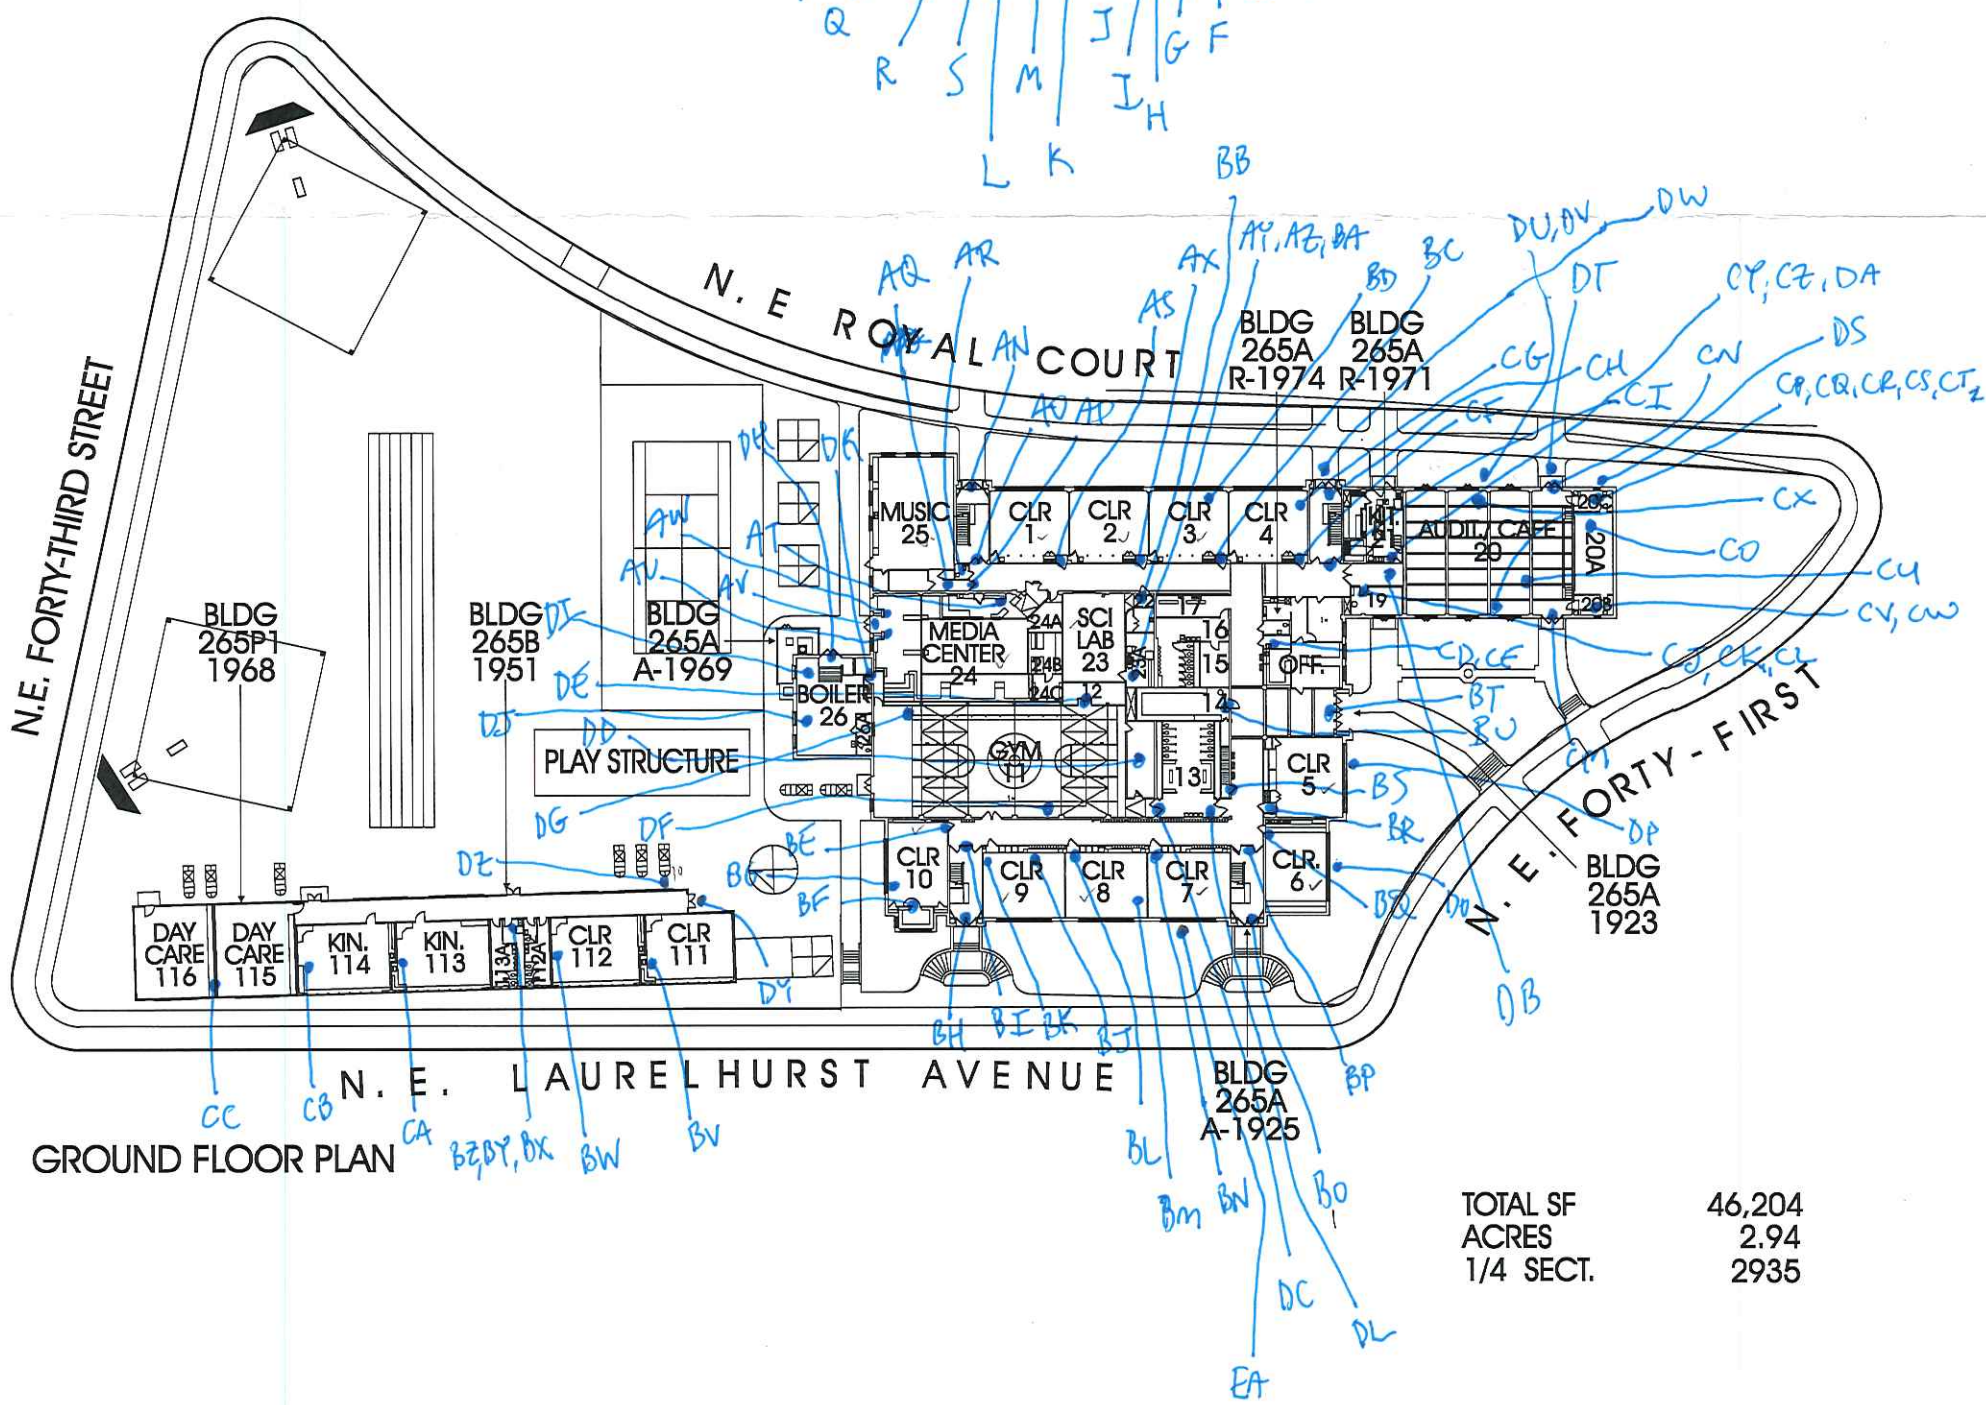
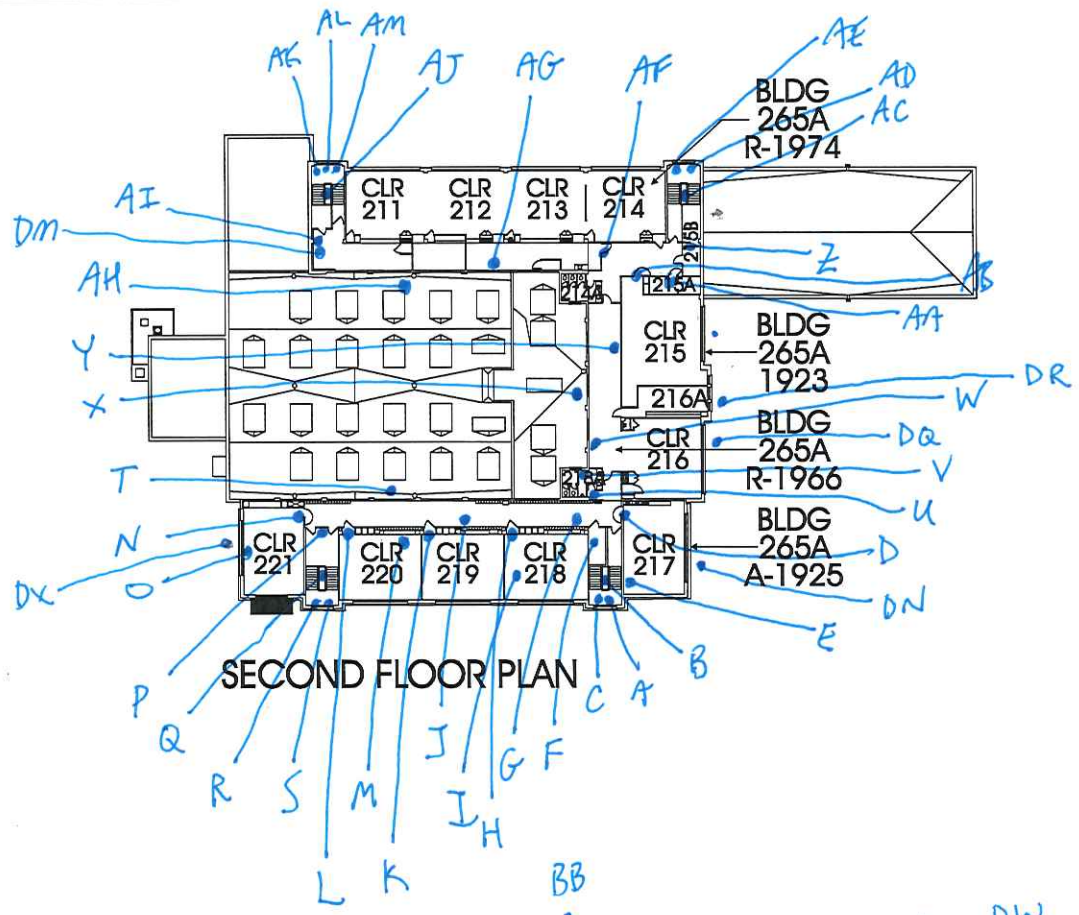
Overall, the building's painted and varnished surfaces were found to be in intact condition with areas of fair and deteriorated conditions. A table listing the locations and quantity of surfaces in deteriorated condition is attached to this report.

Paint chips were observed in the garden on the south side of the auditorium, near window frames with paint in deteriorated conditions.

PBS recommends that all painted or varnished surfaces in deteriorated condition noted on the attached table be stabilized. Paint chips noted in the garden and deteriorated paint on nearby auditorium window frames is anticipated to be removed and stabilized in the next week.
