Regarding: Lead Paint Condition Assessment
Kelly Elementary School
9030 SE Cooper Street
Portland, Oregon 97266
PBS Project: 6500.721 Phase 0027

Kelly Elementary School
Assessment of Paint/Varnish in Deteriorated Condition

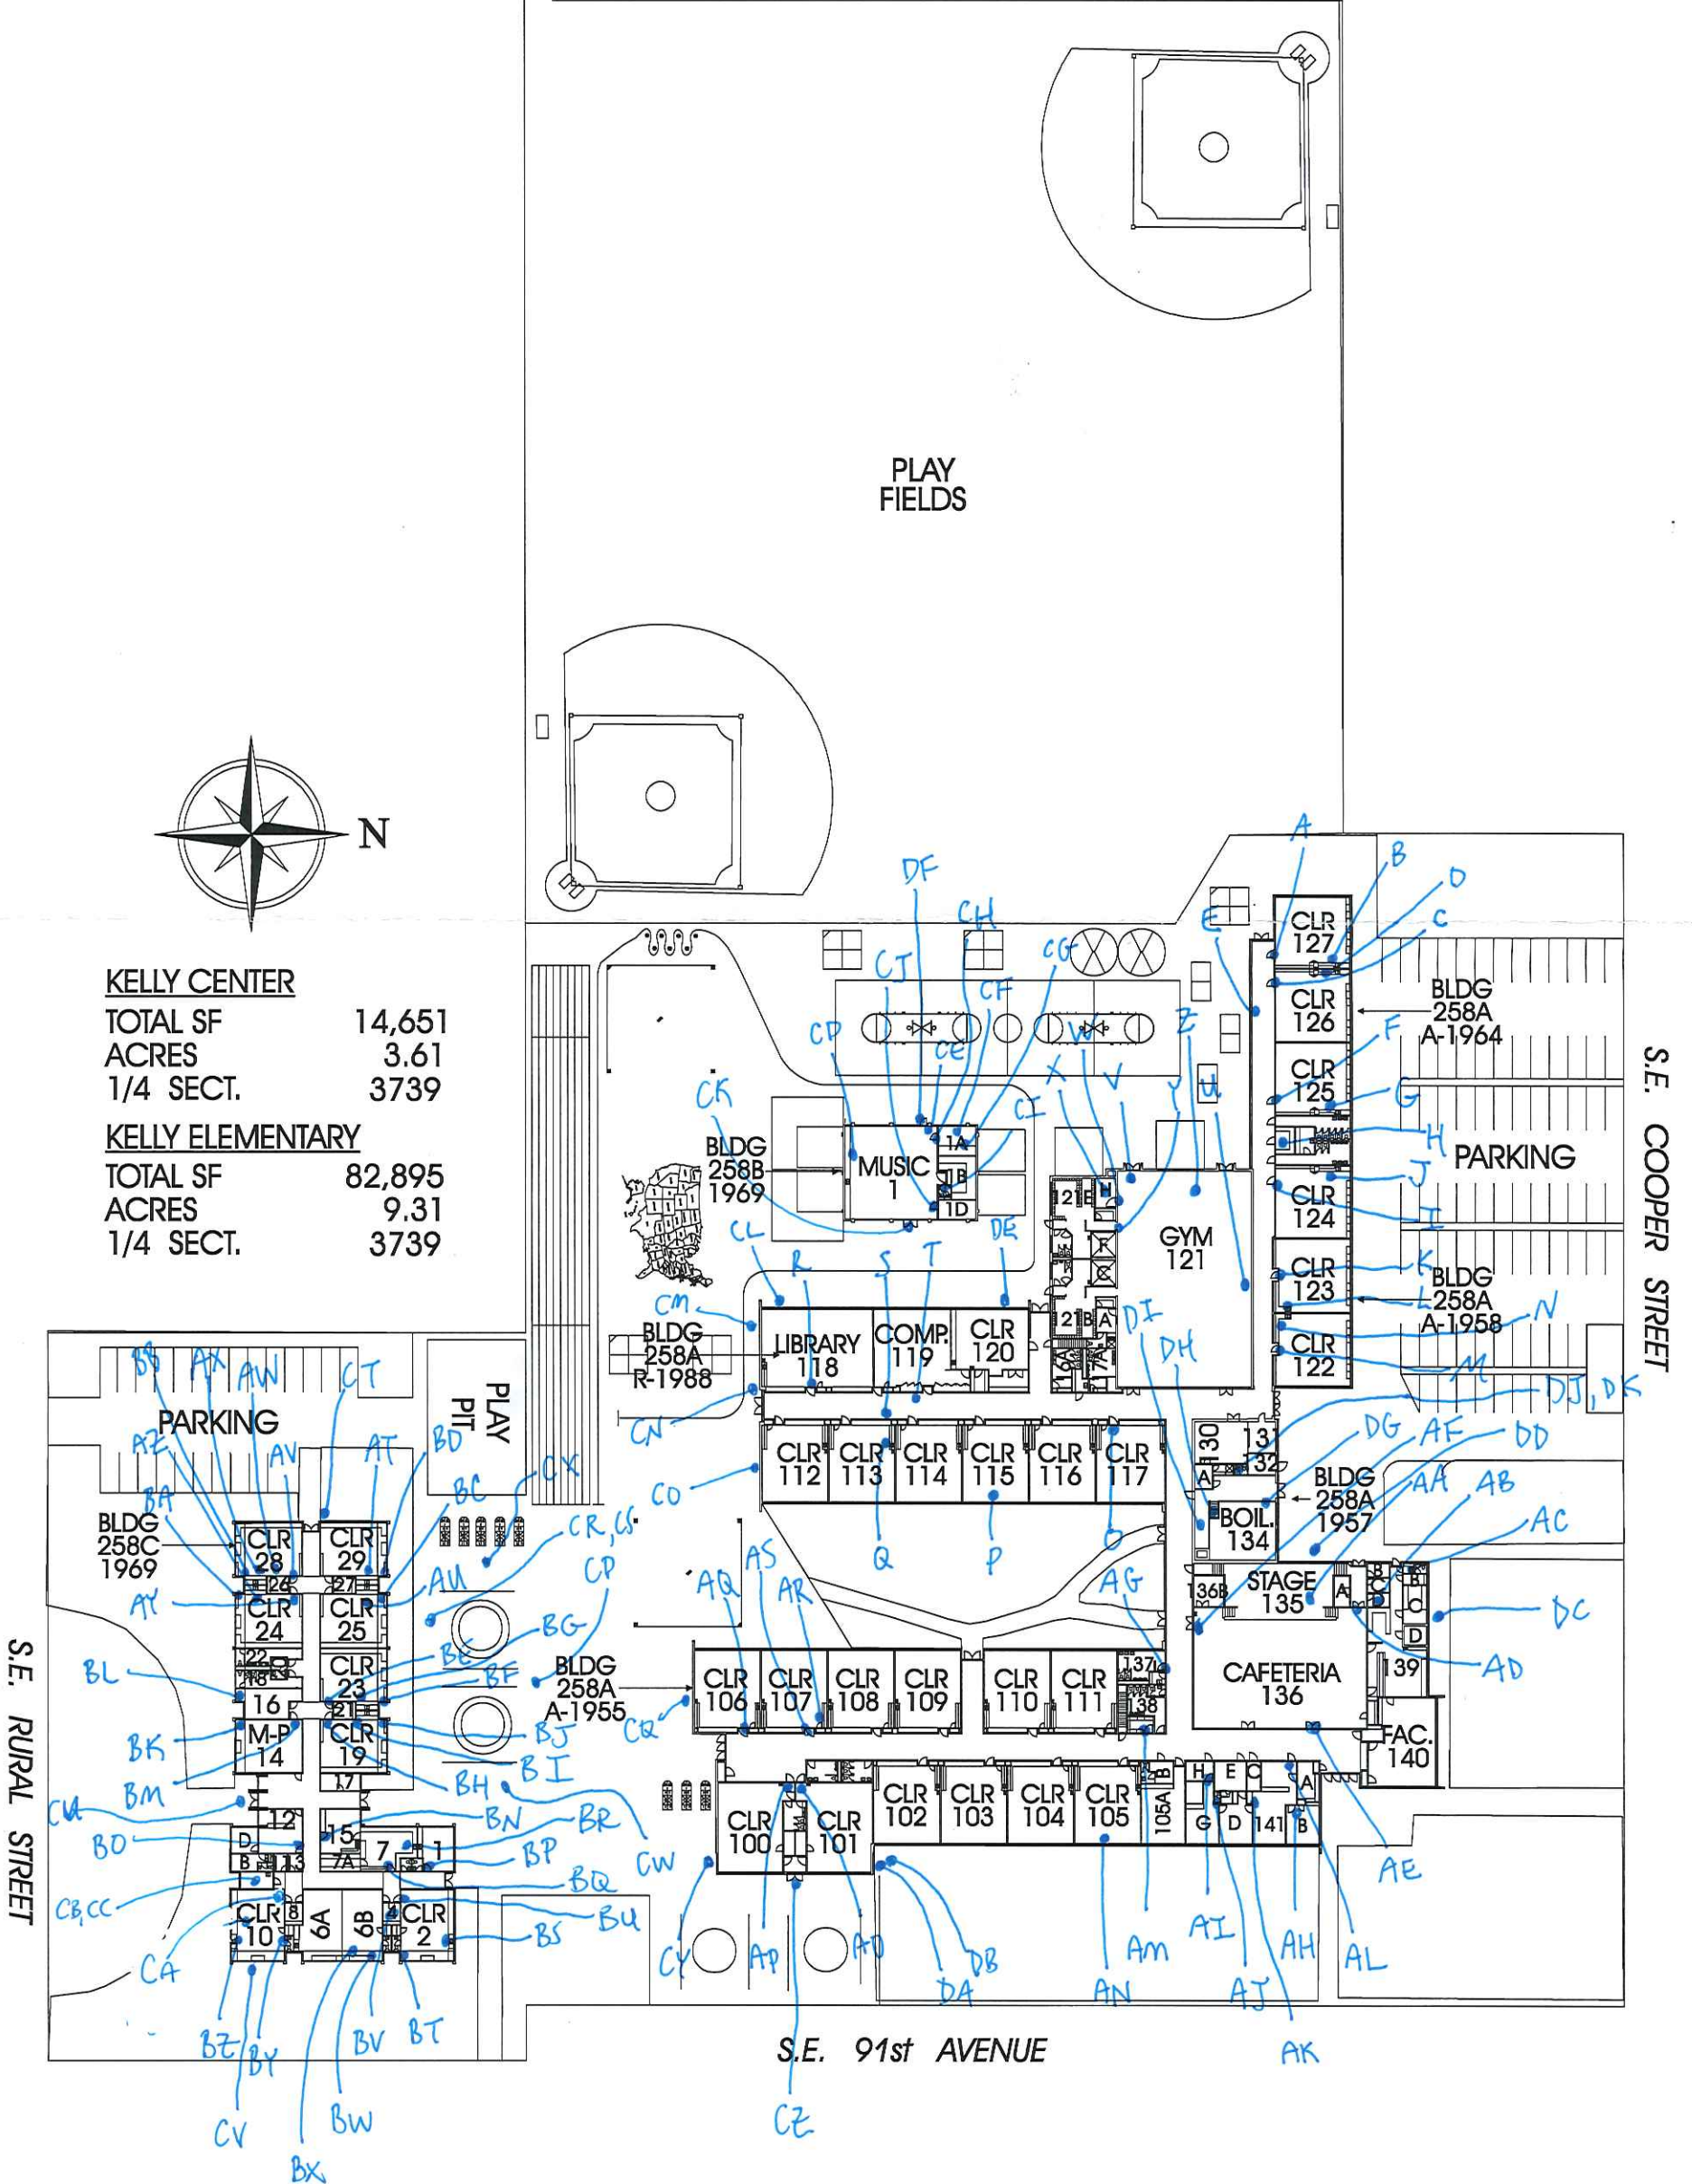
Kelly Elementary School 9030 SE Cooper 97266 Facility Plan

Overall, the building's painted and varnished surfaces were found to be in intact condition with areas of fair and deteriorated conditions. A table listing the locations and quantity of surfaces in deteriorated condition is attached to this report.

No paint chips were observed in the school's garden; however, paint chips resulting from deteriorated paint conditions were observed near the garden, as well as in soil at the northeast exterior of classroom 101.

PBS recommends that all painted or varnished surfaces in deteriorated condition noted on the attached table be stabilized. All paint chips noted in this report should be removed.
