Regarding: Lead Paint Condition Assessment
Stephenson Elementary School
2627 SW Stephenson Street
Portland, Oregon 97219
PBS Project: 6500.721 Phase 0050

**Stephenson Elementary School
Assessment of Paint/Varnish in Deteriorated Condition**

Stephenson Elementary School
2627 SW Stephenson 97219
Facility Plan

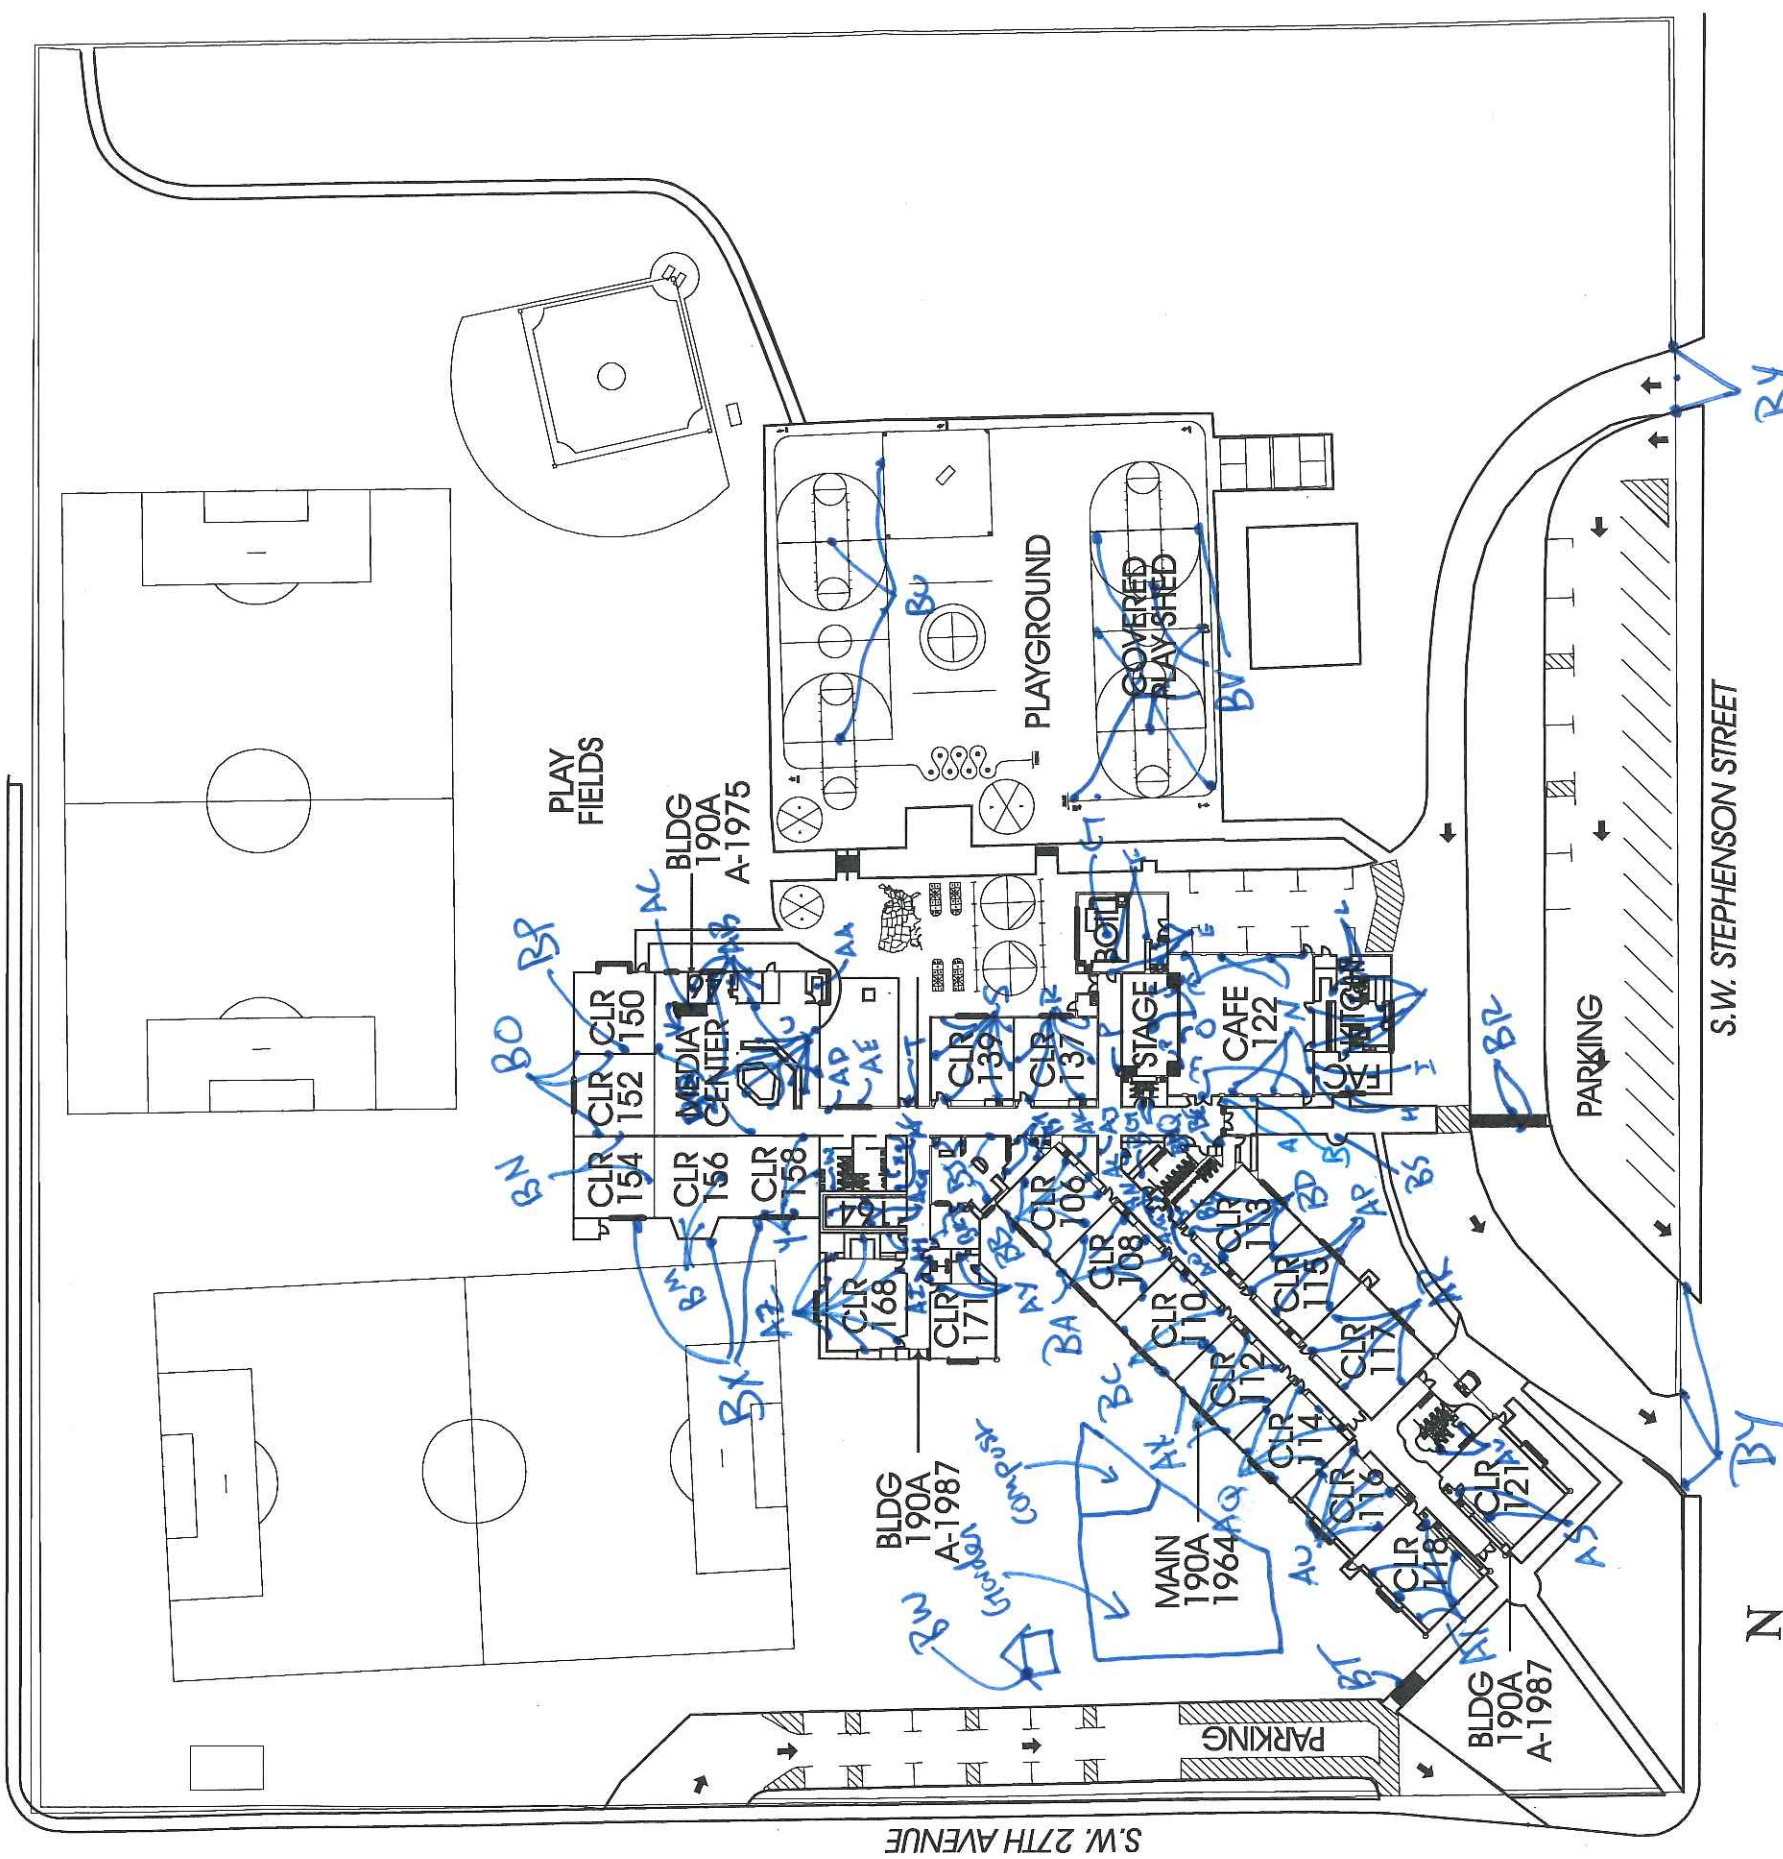
SITE / FIRST FLOOR PLAN

Overall, the building's painted and varnished surfaces were found to be in intact condition with areas of fair and deteriorated conditions. A table listing the locations and quantity of surfaces in deteriorated condition is attached to this report.

Paint chips were observed in soil on the west side of the school. Paint chips from the building were also observed on blacktop by the boiler room.

PBS recommends that all painted or varnished surfaces in deteriorated condition noted on the attached table be stabilized. All paint chips should be removed.
