Regarding: Lead Paint Condition Assessment  
Columbia Transportation  
716 NE Marine Drive  
Portland, Oregon 97211  
PBS Project: 6500.721 Phase 0083

**Columbia Transportation  
Assessment of Paint/Varnish in Deteriorated Condition**

# Columbia Transportation 716 NE Marine Dr. Facility Plan

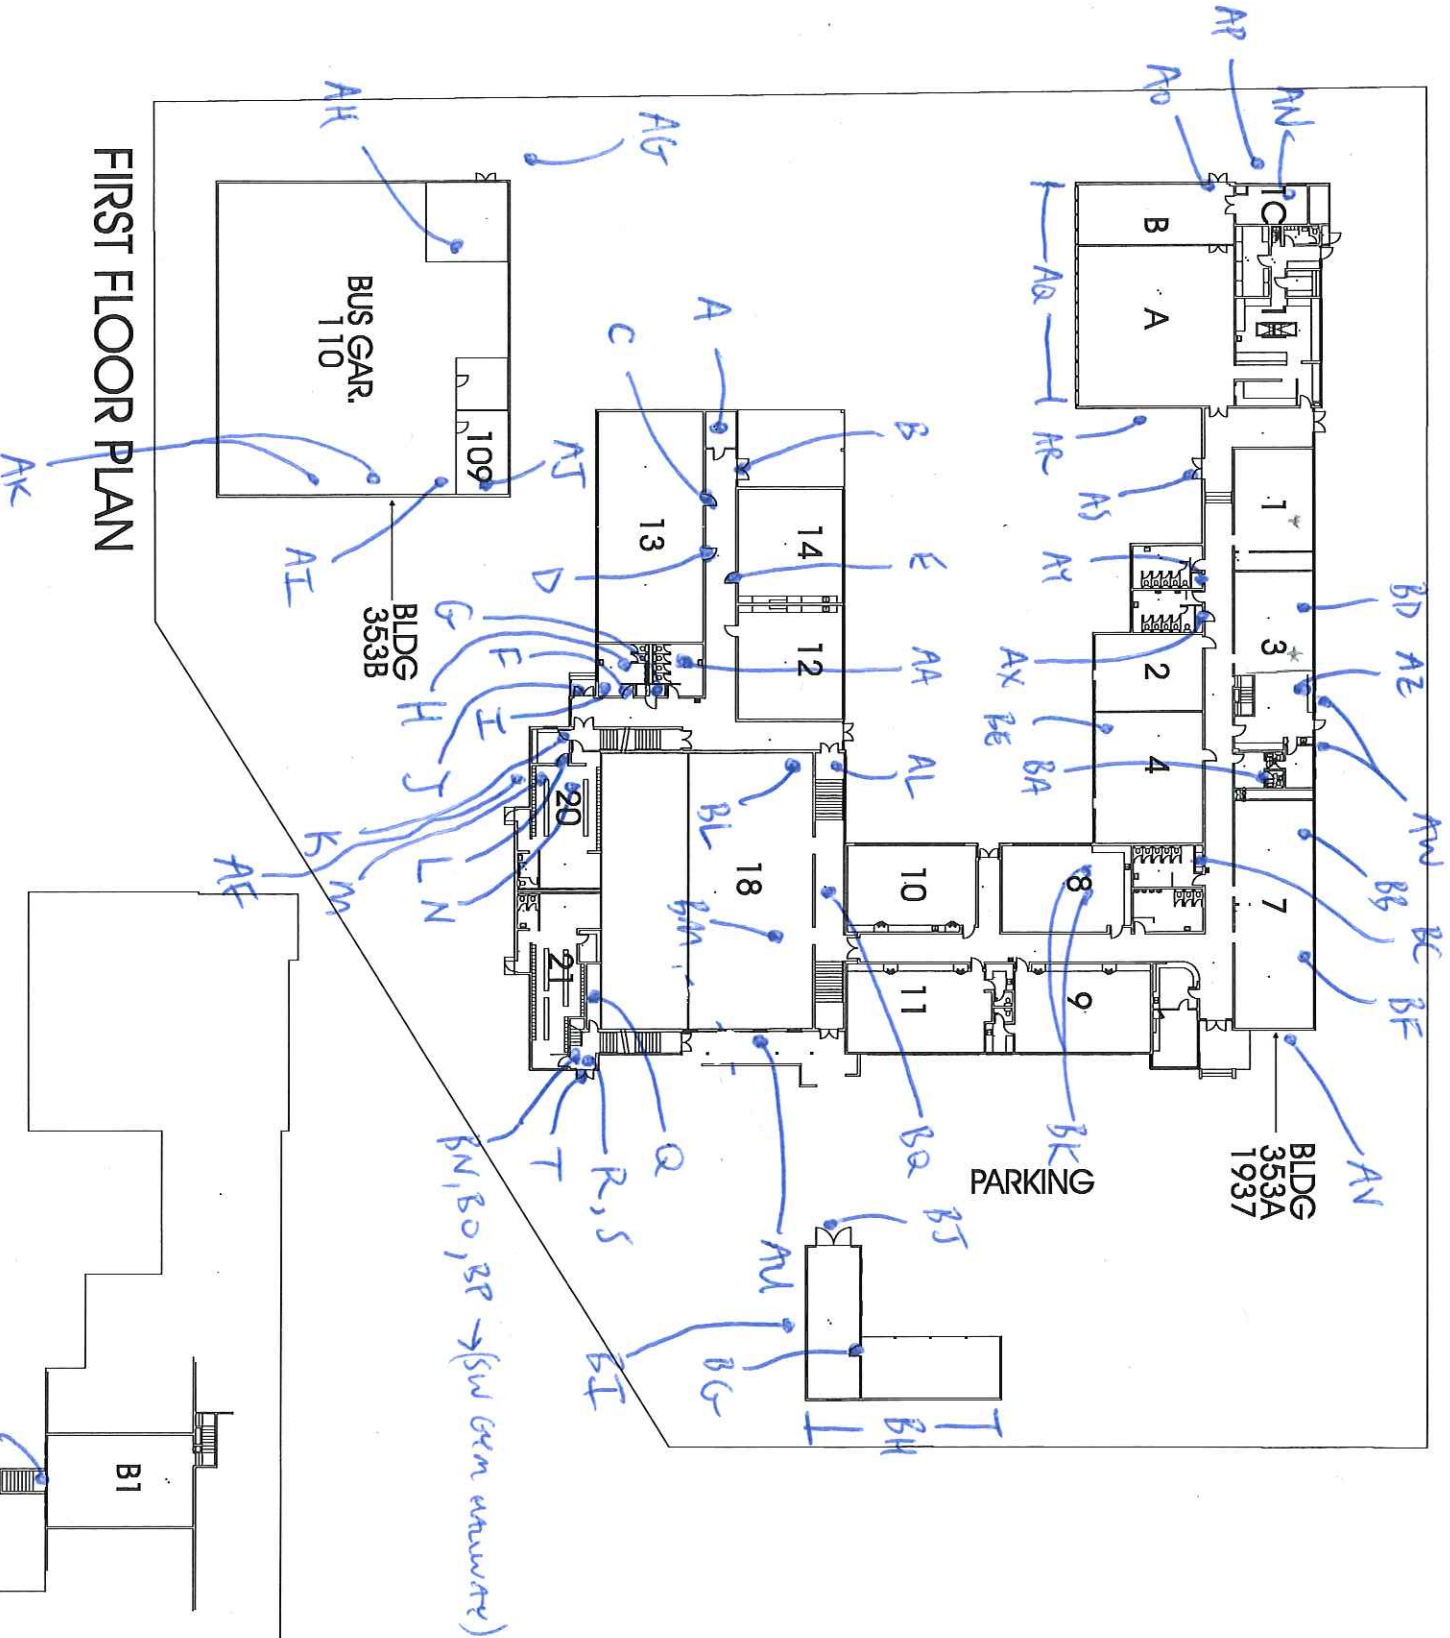
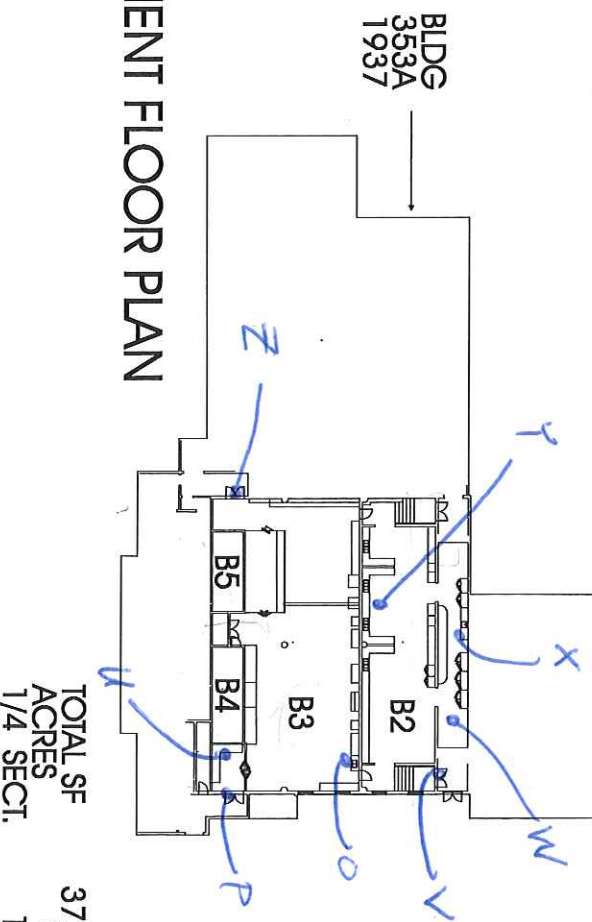
Overall, the building's painted and varnished surfaces were found to be in intact condition with areas of fair and deteriorated conditions. A table listing the locations and quantity of surfaces in deteriorated condition is attached to this report.

Paint chips were observed on concrete on the exterior of room 20, and the west exterior of room 16. Paint chips were also observed in soil by the east wall of the east storage building.

Windows are older painted and varnished wood-frame with abrasion occurring. Paint chips were observed in some window troughs, and all window troughs were dirty. Paint chips were also observed on windowsills of the back hallway of the upstairs office, the northeast corner of the bus garage, and in the southwest gym stairwell.

PBS recommends that all painted or varnished surfaces in deteriorated condition noted on the attached table be stabilized. All paint chips noted in this report, including those observed in window troughs, should be removed, and windows troughs should be cleaned.
