Regarding: Lead Paint Condition Assessment
Madison High School
2735 NE 82nd Avenue
Portland, Oregon 97220
PBS Project: 6500.721 Phase 0078

Madison High School
Assessment of Paint/Varnish in Deteriorated Condition

Madison High School
2735 NE 82nd
Facility Plan

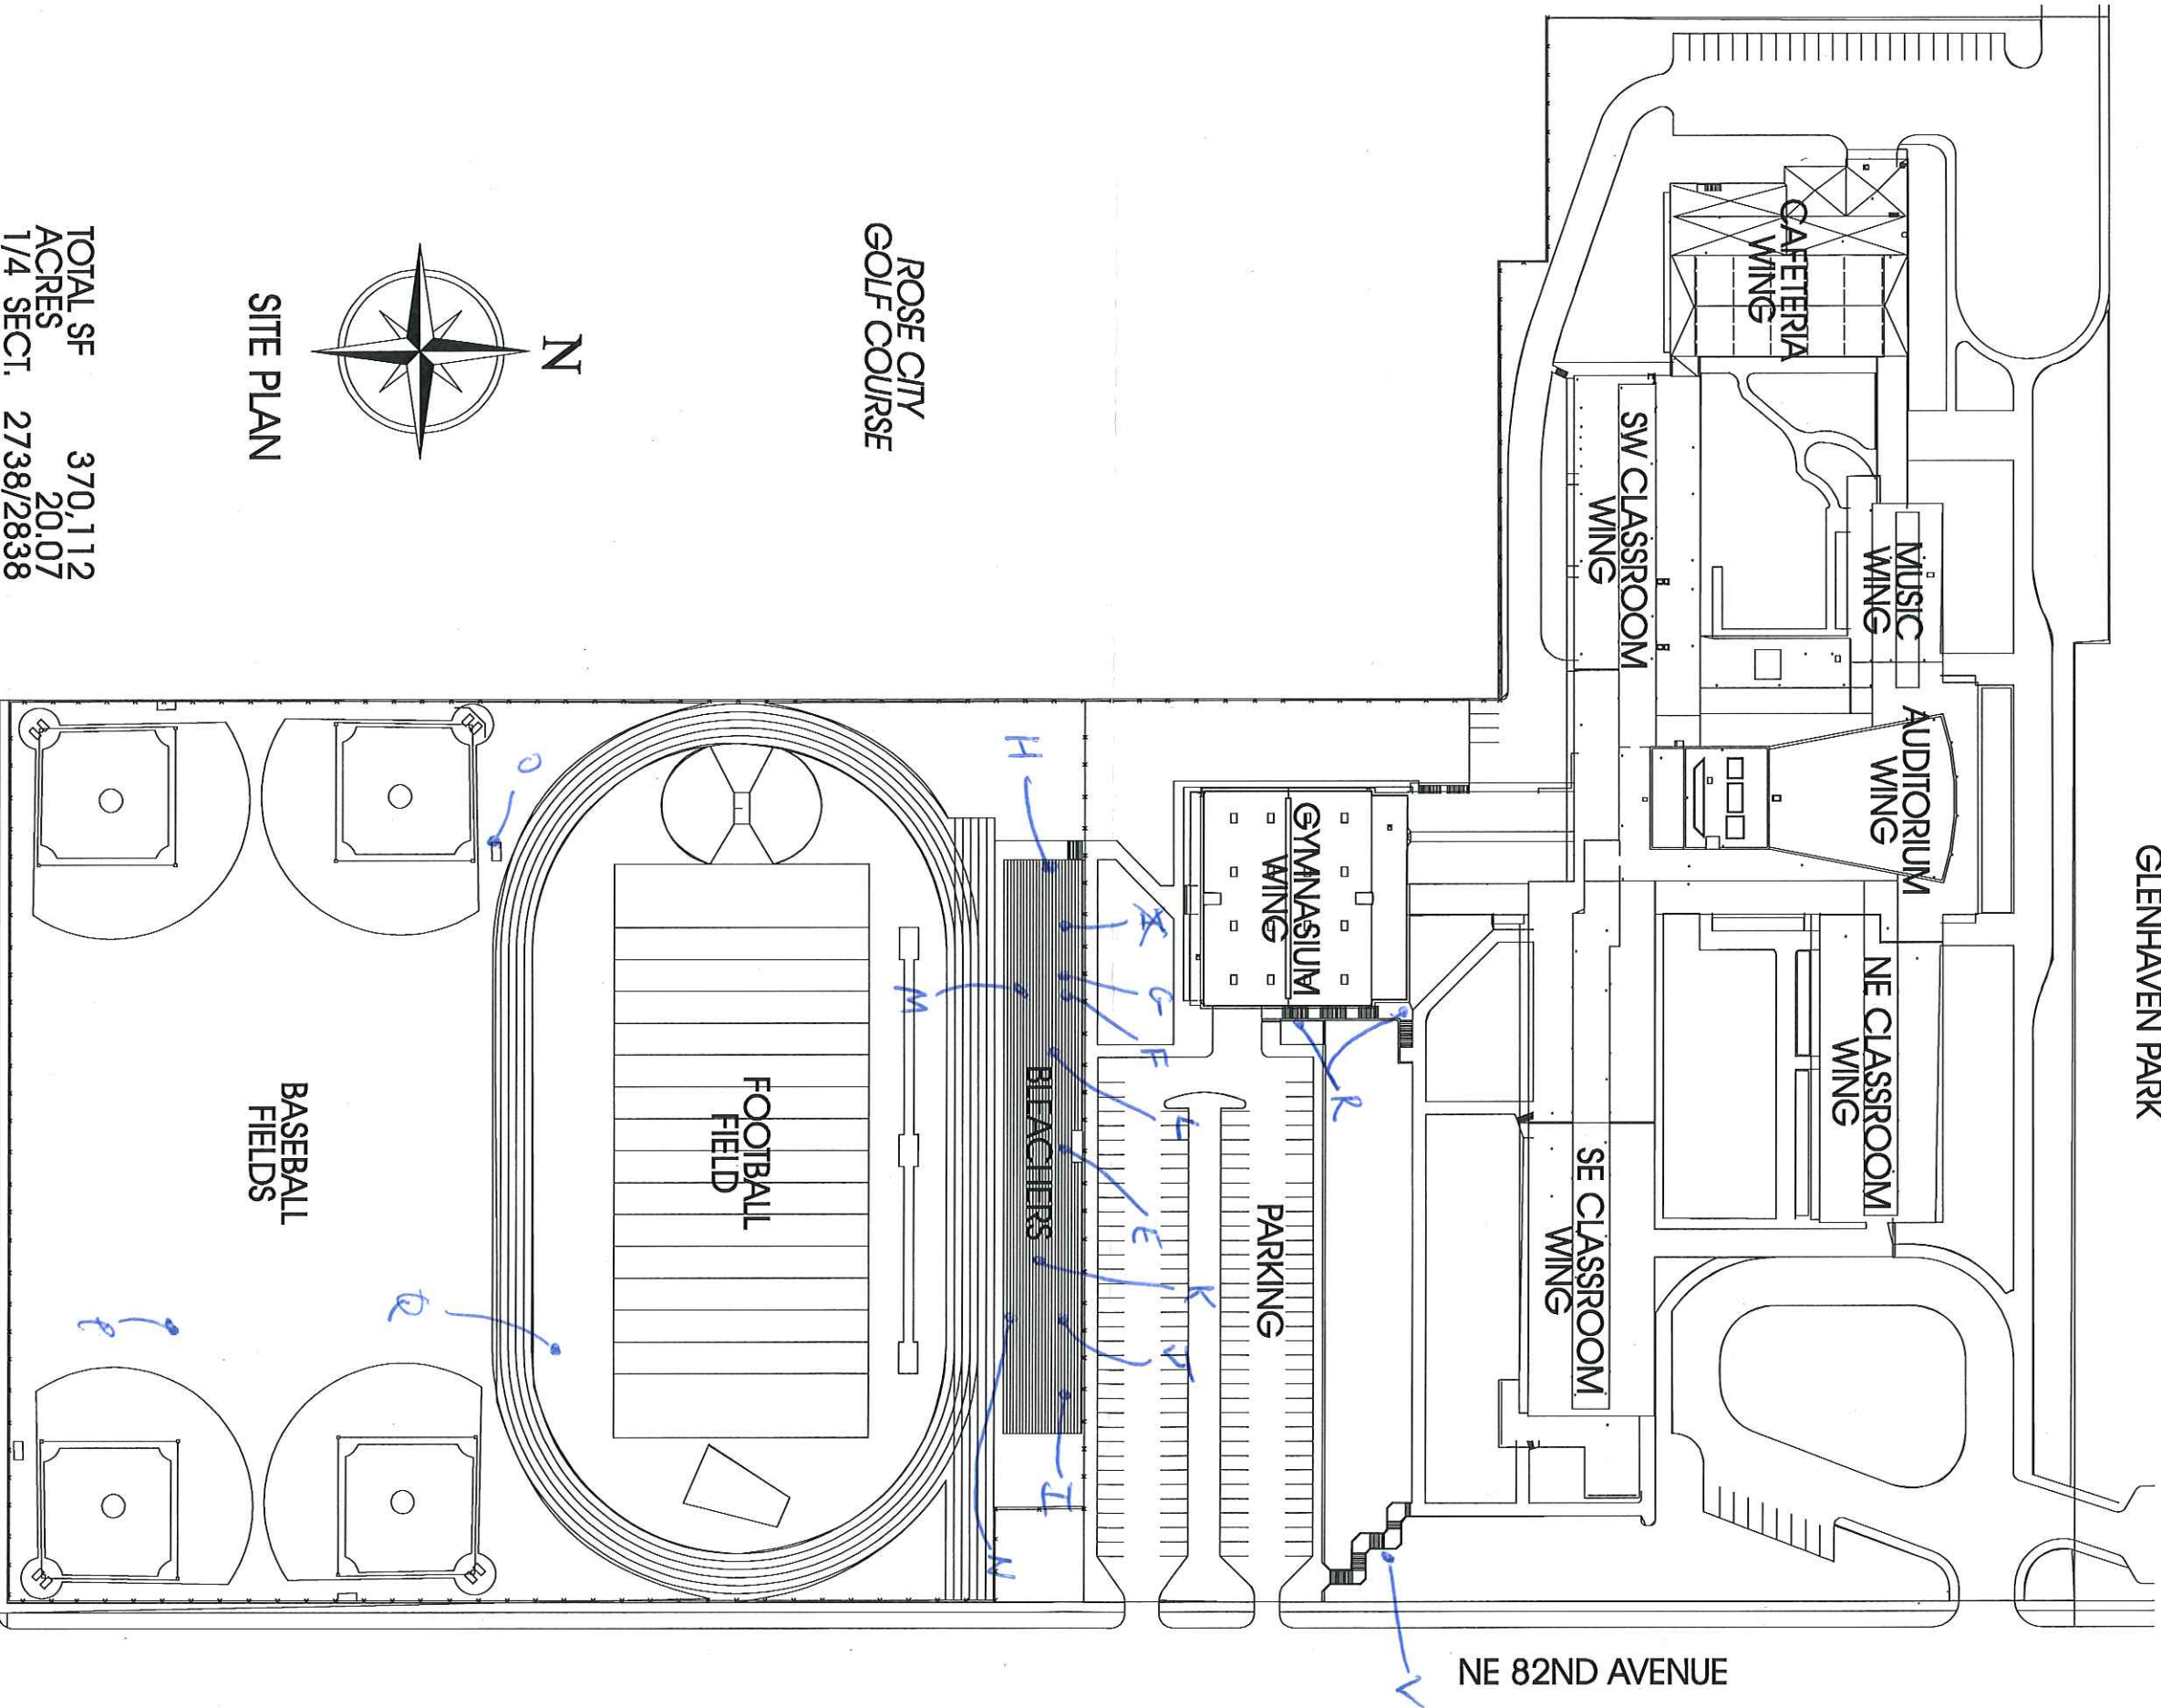
SITE PLAN

The school's metal pull-in windows displayed nothing of concern, and no paint chips were observed in the school's garden or compost pile; however, paint chips were observed in soil on the exterior of the main office, and the south exterior of the cafeteria.

PBS recommends that all painted or varnished surfaces in deteriorated condition noted on the attached table be stabilized. All paint chips noted in this report should be removed.
