Regarding: Lead Paint Condition Assessment  
Wilson High School  
1151 SW Vermont Street  
Portland, Oregon 97219  
PBS Project: 6500.721 Phase 0085

**Wilson High School**  
**Assessment of Paint/Varnish in Deteriorated Condition**

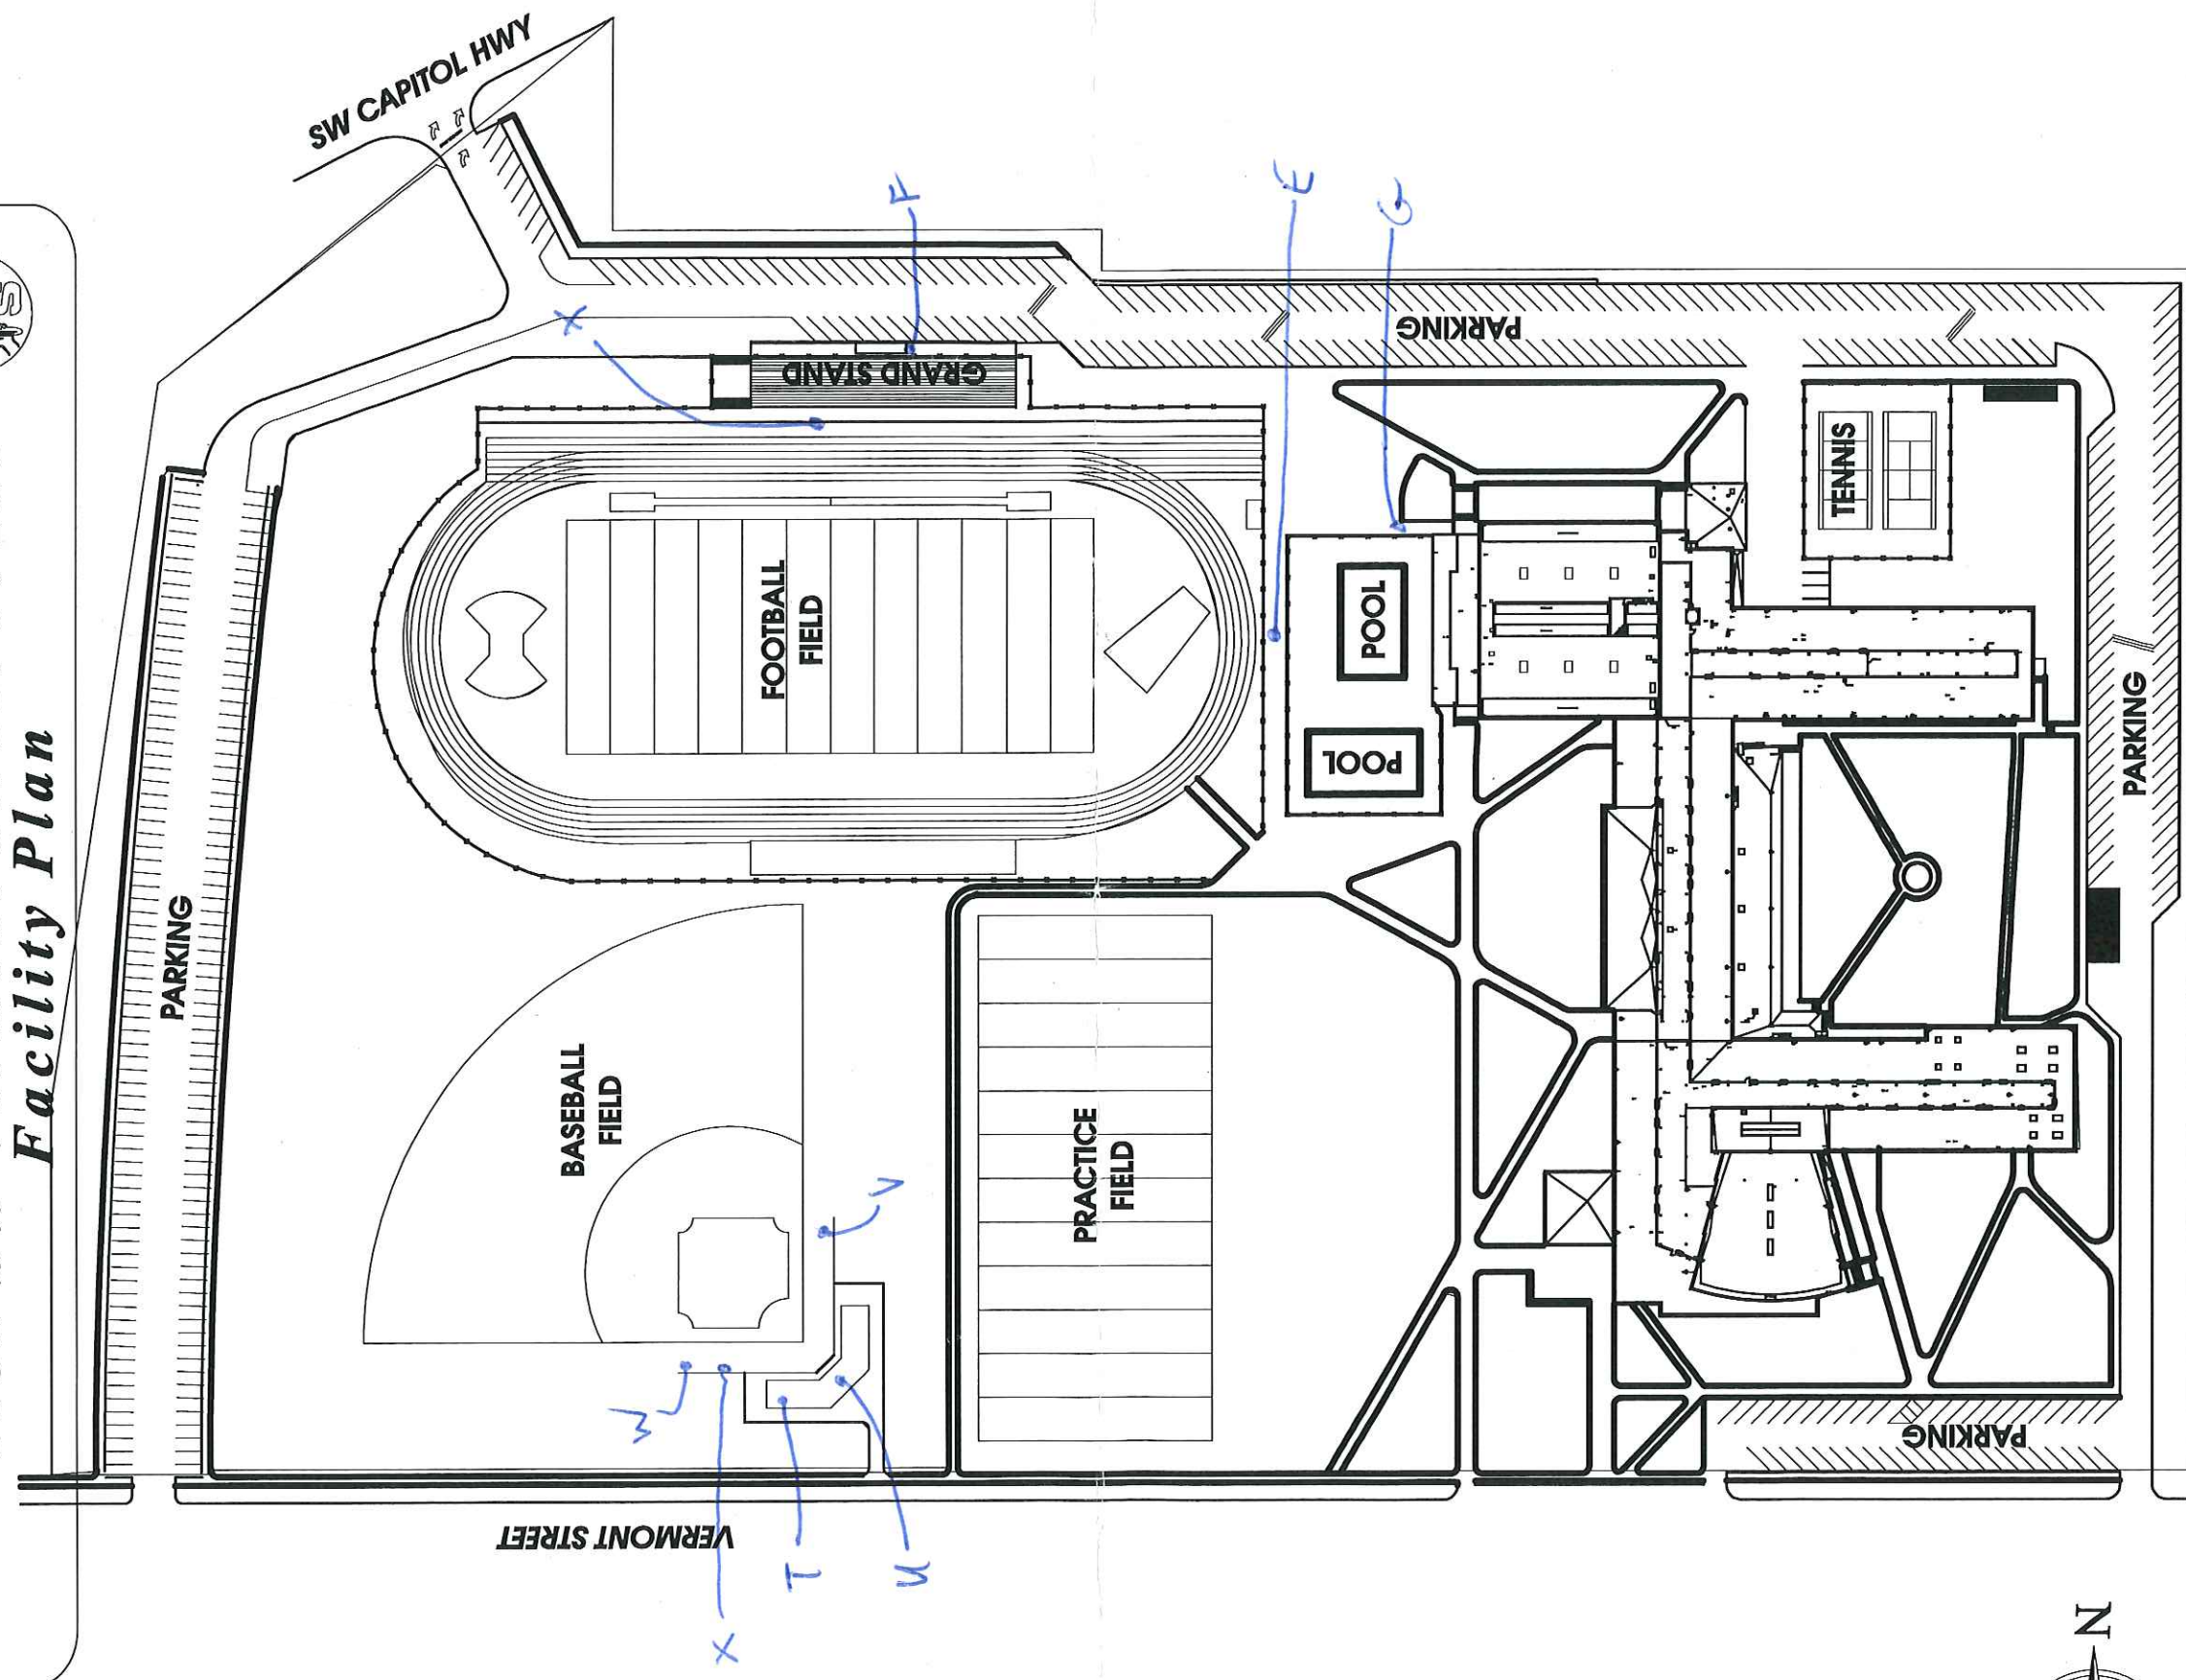
**SITE / ROOF PLAN**

No paint chips were observed in the school's garden or compost pile; however, paint chips were observed in soil on the east and south exteriors of the photographic arts room, and on exterior concrete outside faculty 145 and the north side of the gym. Paint chips were also observed on the floor inside custodial room 211.

PBS recommends that all painted or varnished surfaces in deteriorated condition noted on the attached table be stabilized. All paint chips noted in this report should be removed.
