March 1, 2017

Regarding: Lead Paint Condition Assessment  
Richmond Elementary School  
2276 SE 41st Avenue  
Portland, Oregon 97214  
PBS Project: 6500.721 Phase 0041

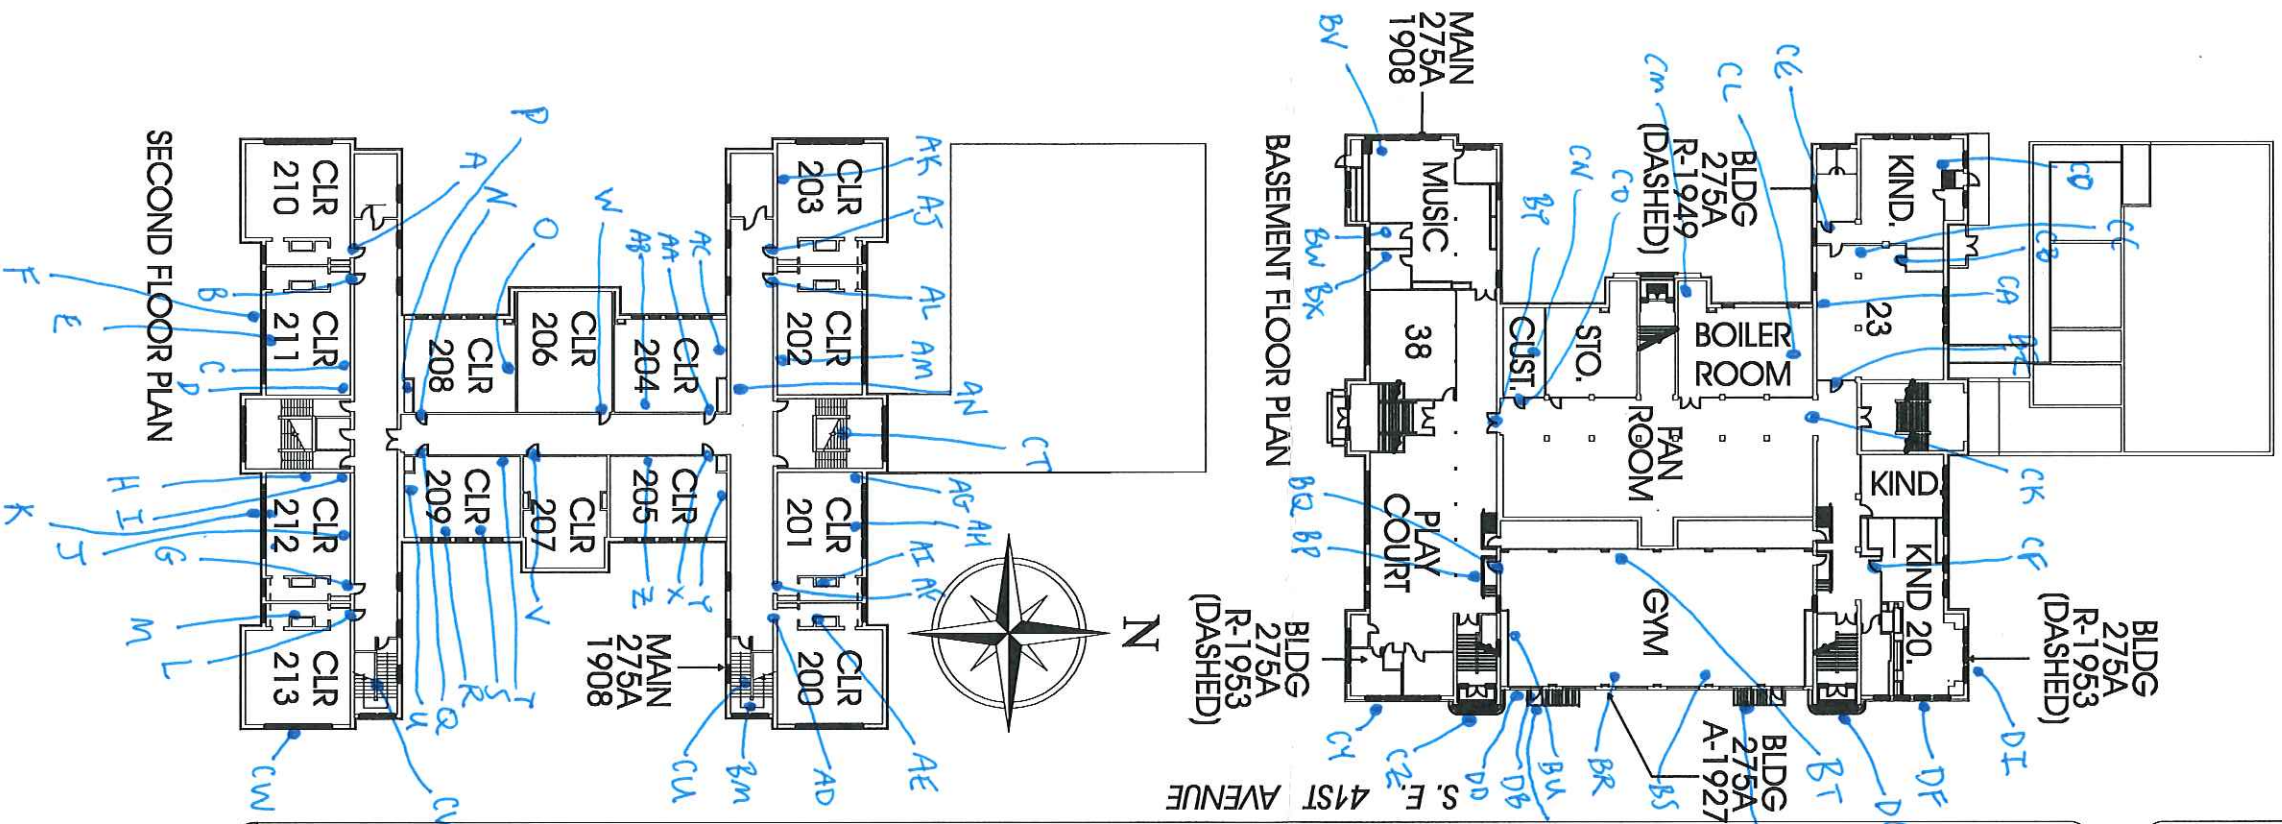
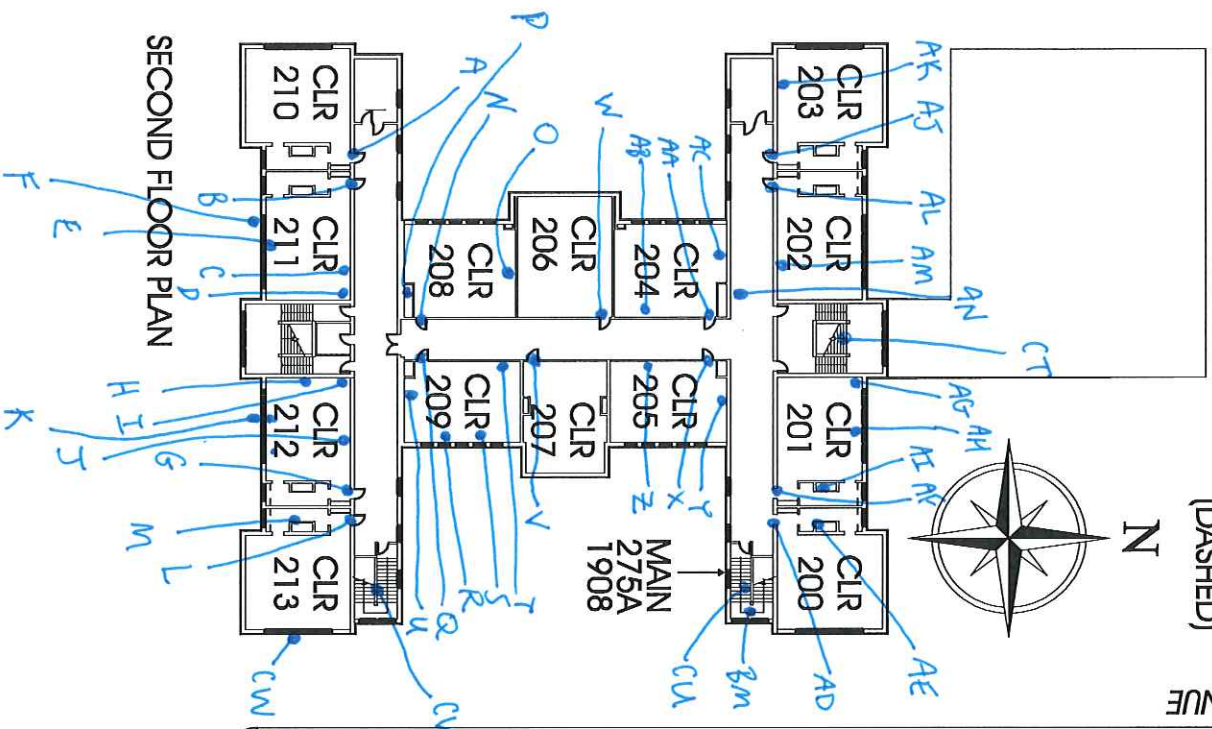
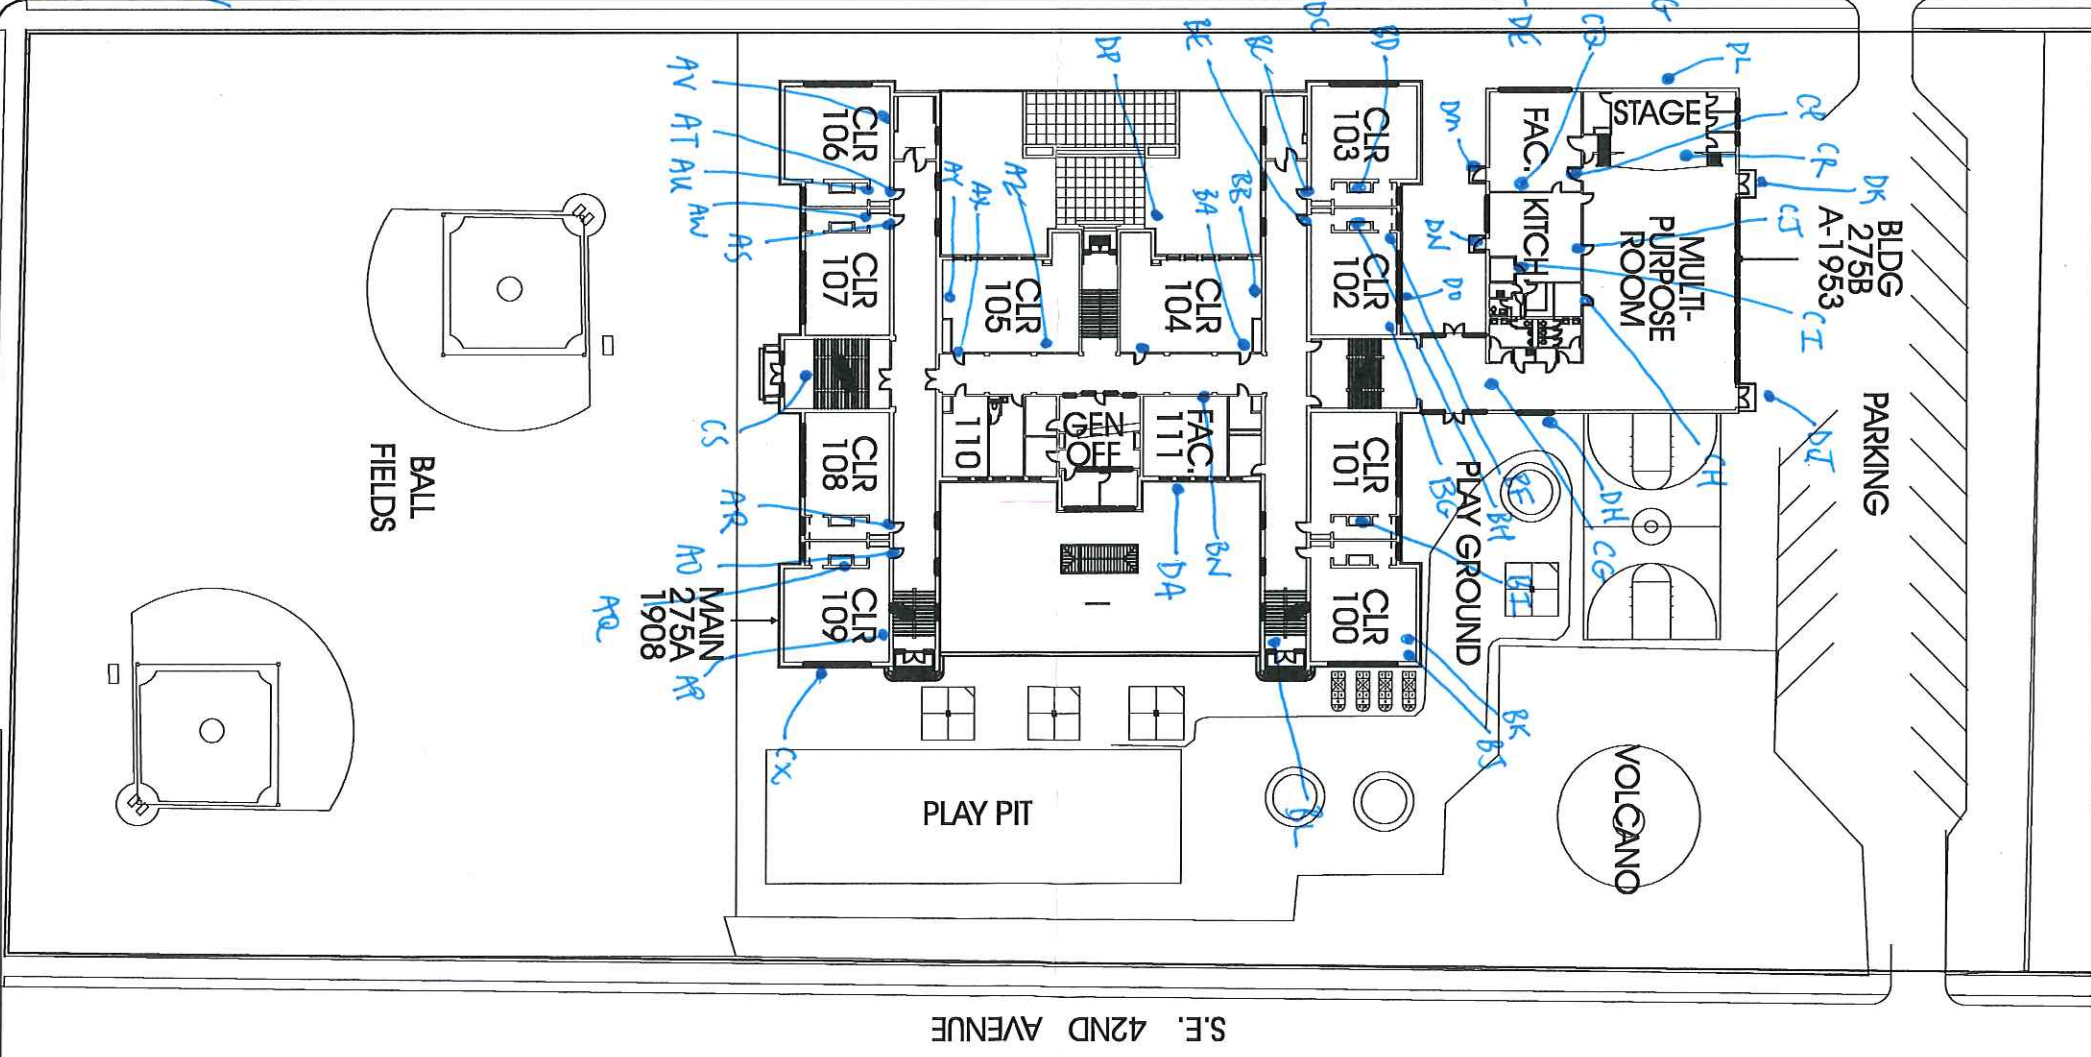
# Richmond Elementary School 2276 SE 41st 97214 Facility Plan

Overall, the building's painted and varnished surfaces were found to be in intact condition with areas of fair and deteriorated conditions. A table listing the locations and quantity of surfaces in deteriorated condition is attached to this report.

PBS recommends that all other painted or varnished surfaces in deteriorated condition noted on the attached table be stabilized.
