Regarding: Lead Paint Condition Assessment
James John Elementary School
7439 N Charleston Avenue
Portland, Oregon 97203
PBS Project: 6500.721 Phase 0026

**James John Elementary School
Assessment of Paint/Varnish in Deteriorated Condition**

James John Elementary School 7439 N Charleston 97203 Facility Plan

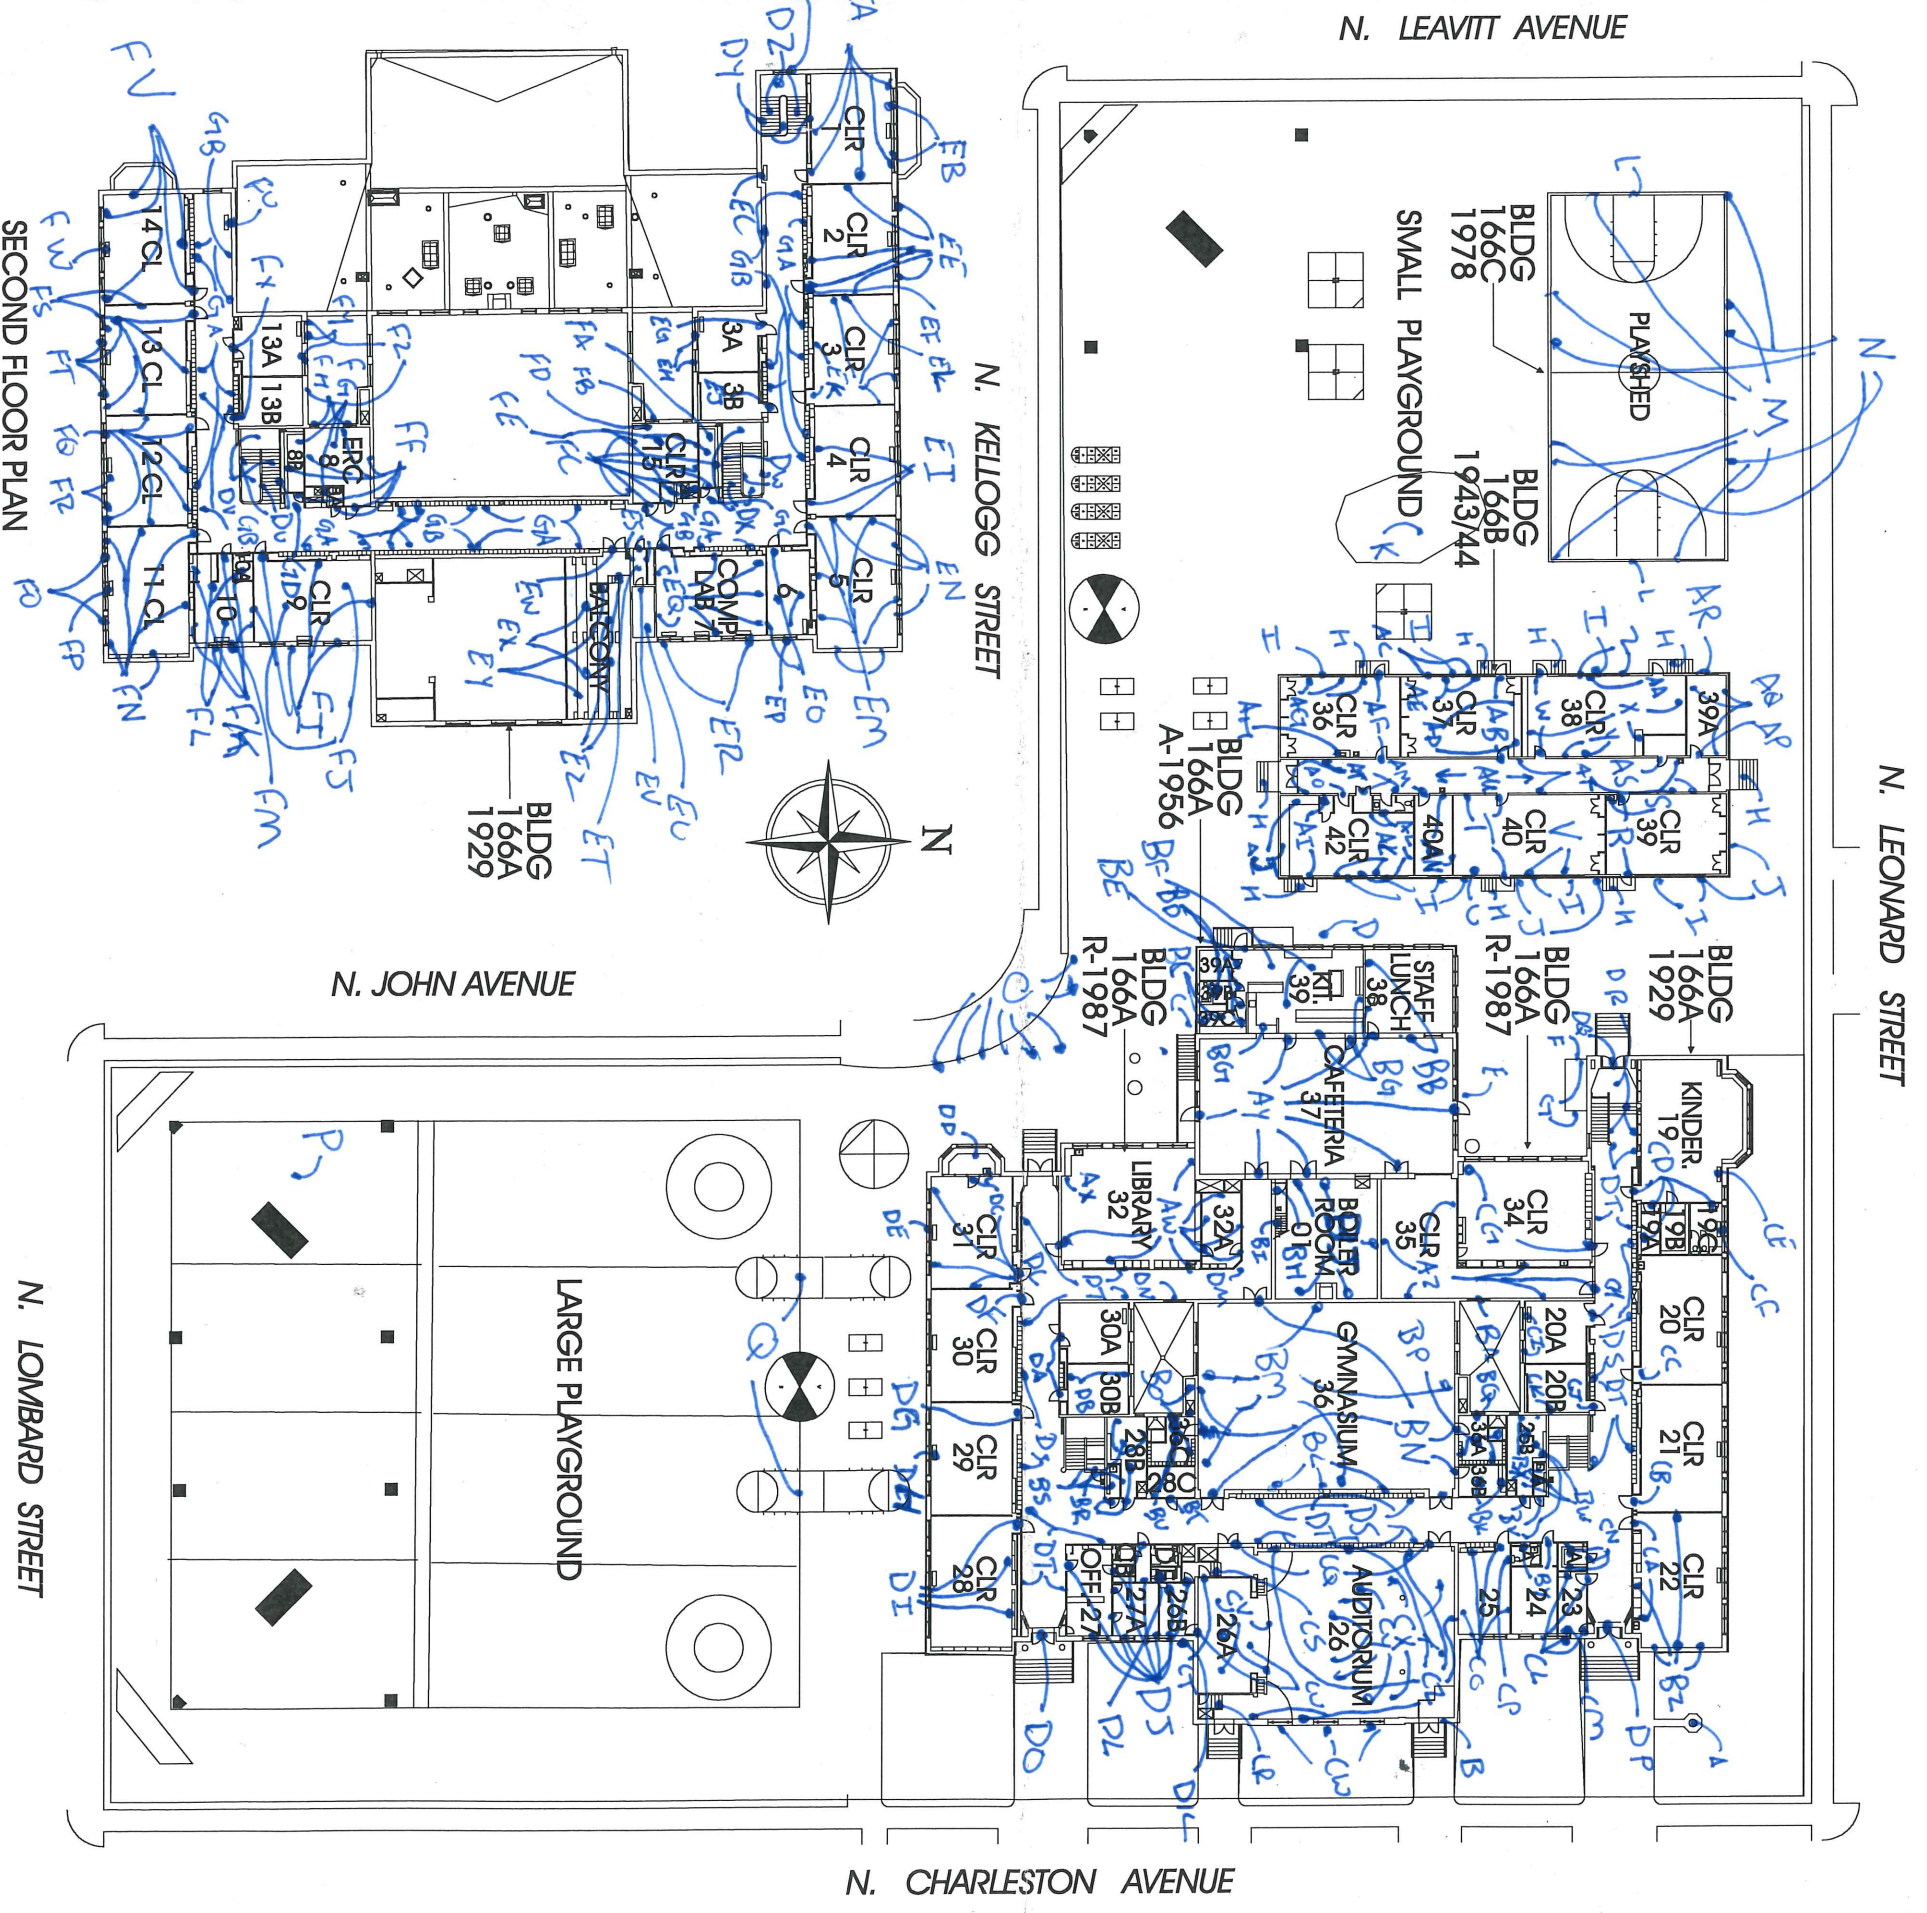
SECOND FLOOR PLAN

Overall, the building's painted and varnished surfaces were found to be in intact condition with areas of deteriorated conditions. A table listing the locations and quantity of surfaces in deteriorated condition is attached to this report.

Windows in the school's main building were mostly new metal-frame with some old wood and metal frame windows located in the hallways, restrooms, main exterior doors, and windows facing the courtyard. Paint chips were observed in old painted metal and wood framed window troughs. It should be assumed all old painted metal and wood framed window troughs contain pain chips.

Windows in the older northwest building were old wood and metal frame. Paint chips were observed in representative windows assessed in this building, and it should be assumed that they exist in all of its windows.

Paint chips were also observed in soil on the east side of the school.

PBS recommends that all painted or varnished surfaces in deteriorated condition noted on the attached table be stabilized. Paint chips in windowsills of the older northwest building, and in soil on the east side of the school, should be removed.
