Regarding: Lead Paint Condition Assessment  
Rose City Park Elementary School  
2334 NE 57th Avenue  
Portland, Oregon 97213  
PBS Project: 6500.721, Phase 0017

**Rose City Park Elementary School  
Assessment of Paint/Varnish in Deteriorated Condition**

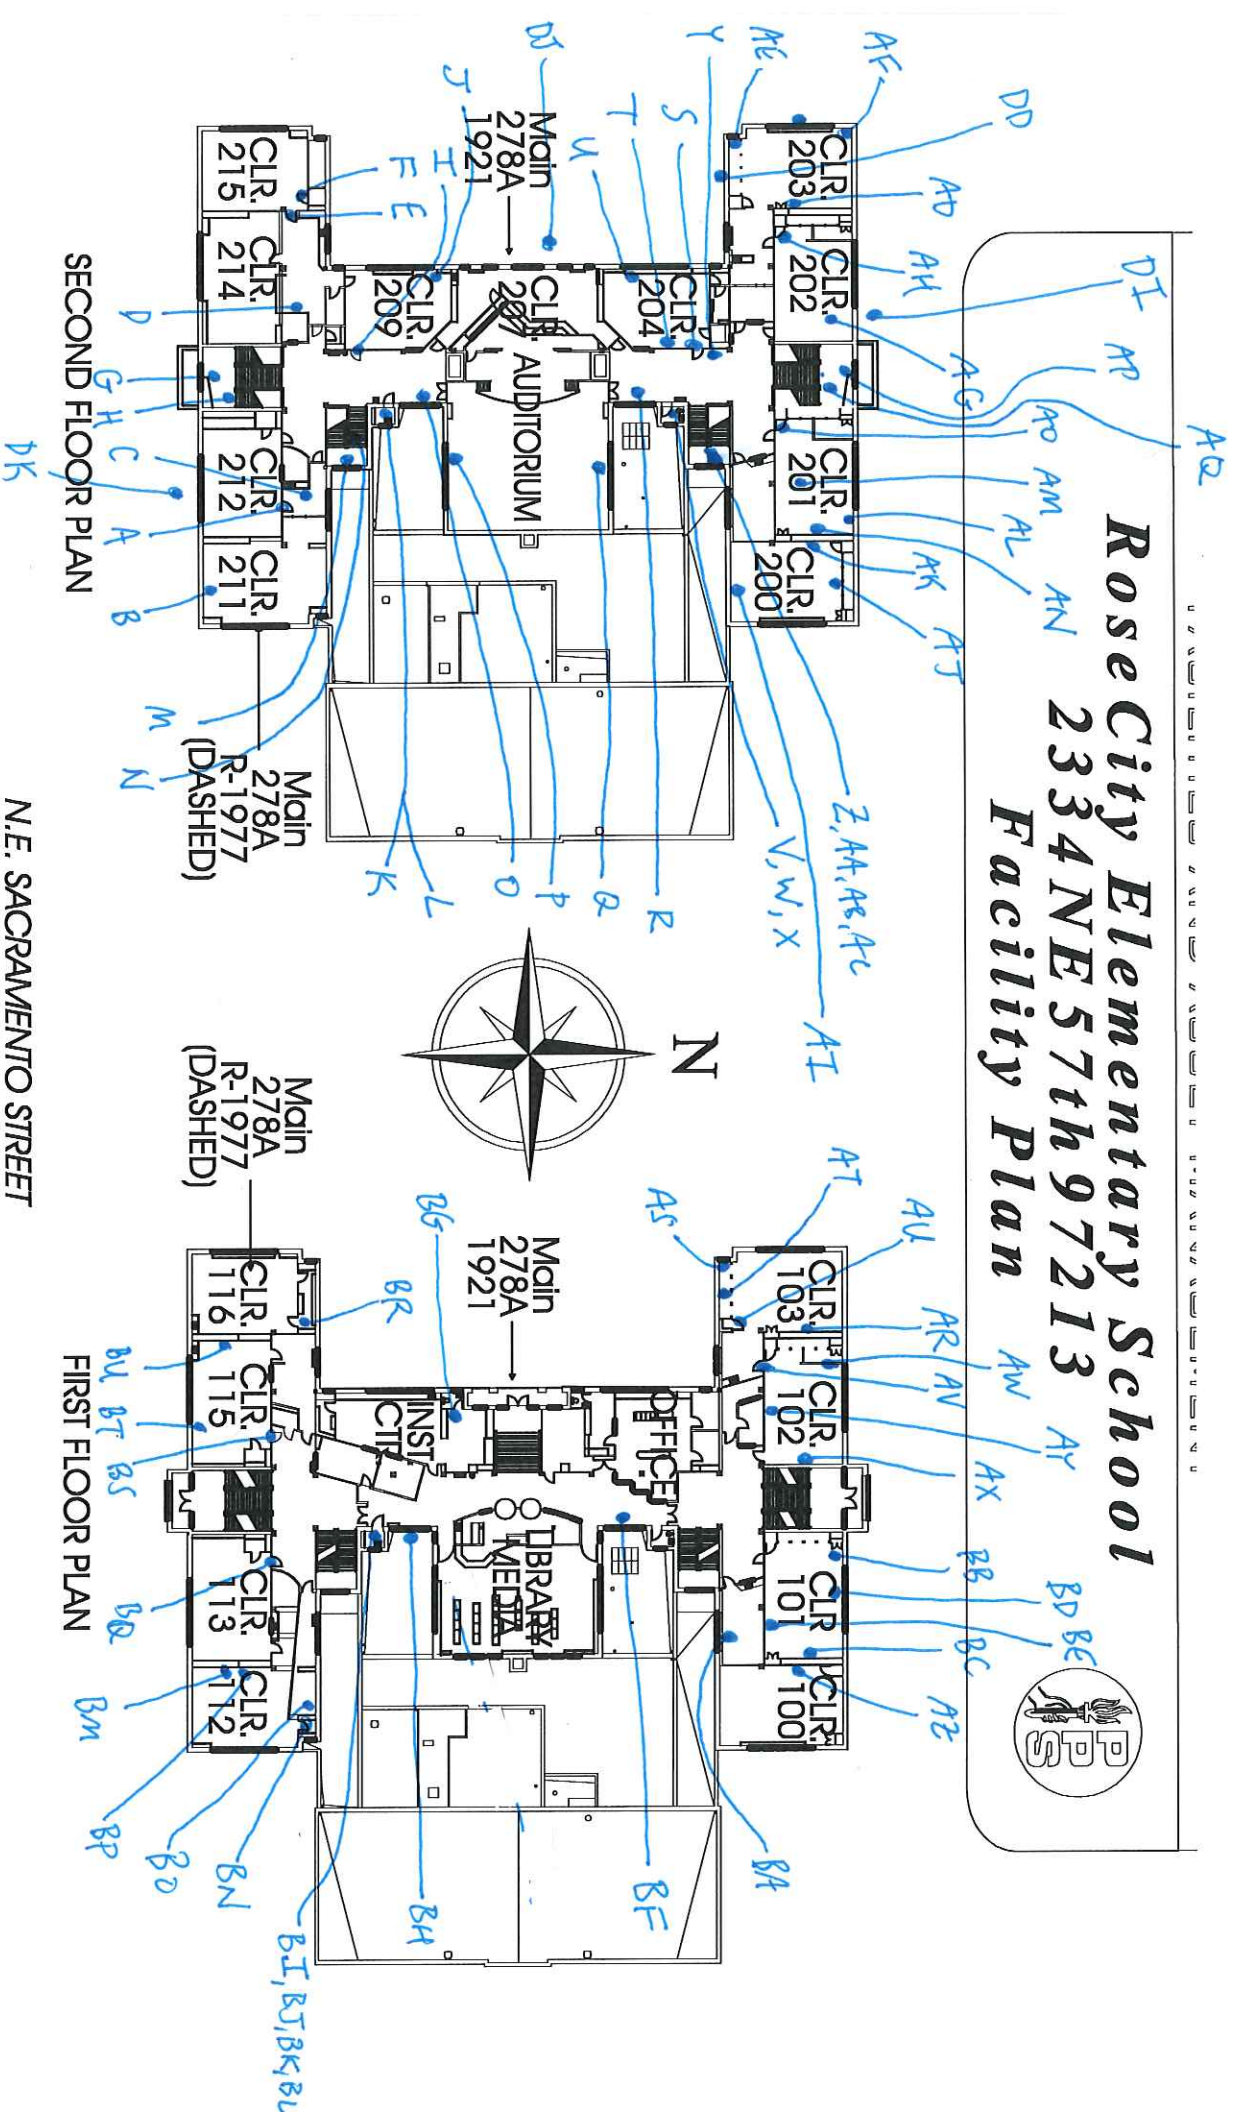
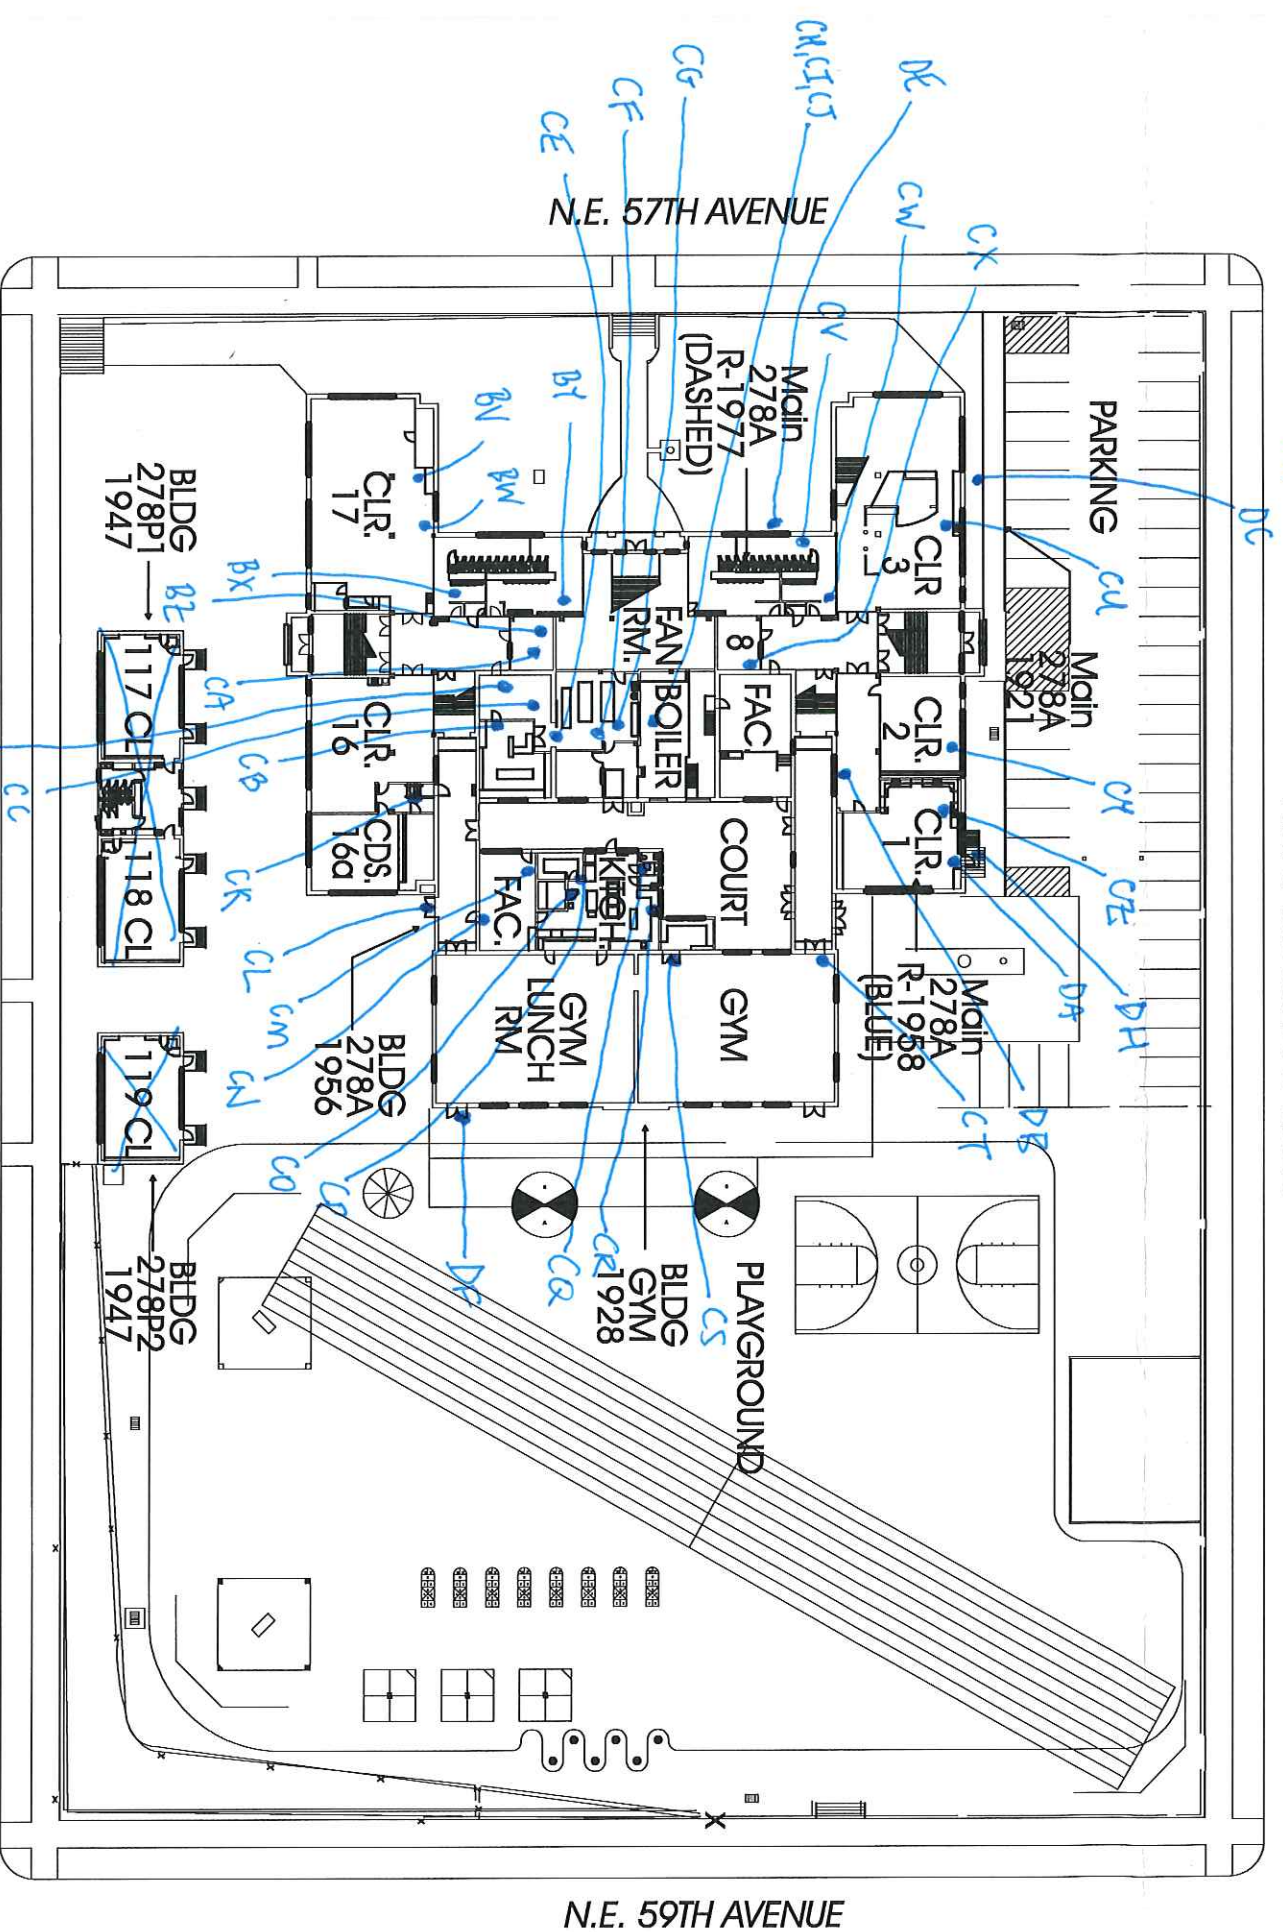
SITE / GROUND FLOOR PLAN

Overall, the building's painted and varnished surfaces were found to be in intact condition with areas of fair and deteriorated conditions. A table listing the locations and quantity of surfaces in deteriorated condition is attached to this report.

PBS recommends that all painted or varnished surfaces in deteriorated condition noted on the attached table be stabilized.
