Regarding: Lead Paint Condition Assessment  
Sabin School  
4013 NE 18th Avenue  
Portland, Oregon 97212  
PBS Project: 6500.721 Phase 0046

**Sabin School**  
**Assessment of Paint/Varnish in Deteriorated Condition**

# Sabin Elementary School 4013 NE 18th Street Facility Plan

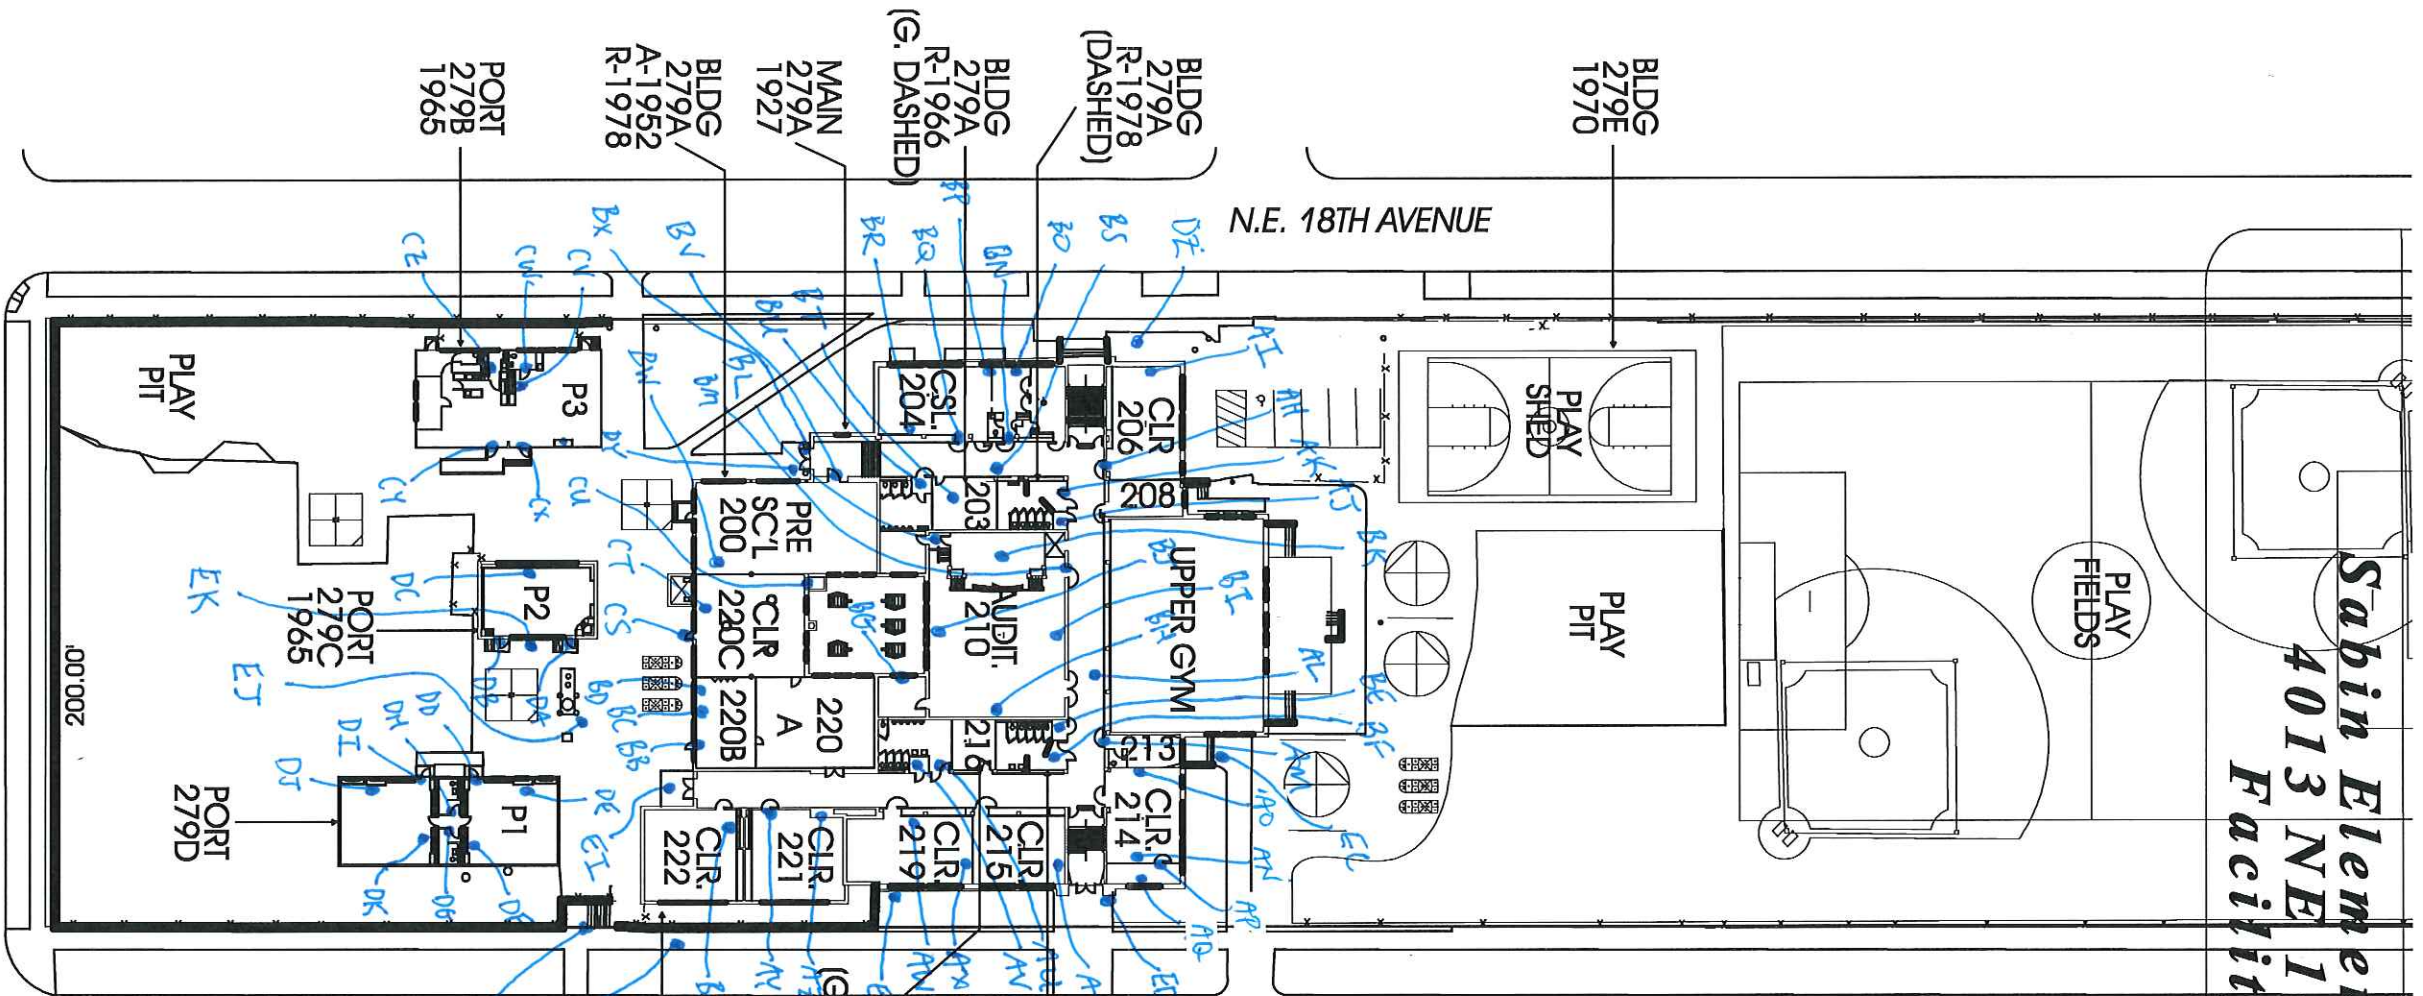
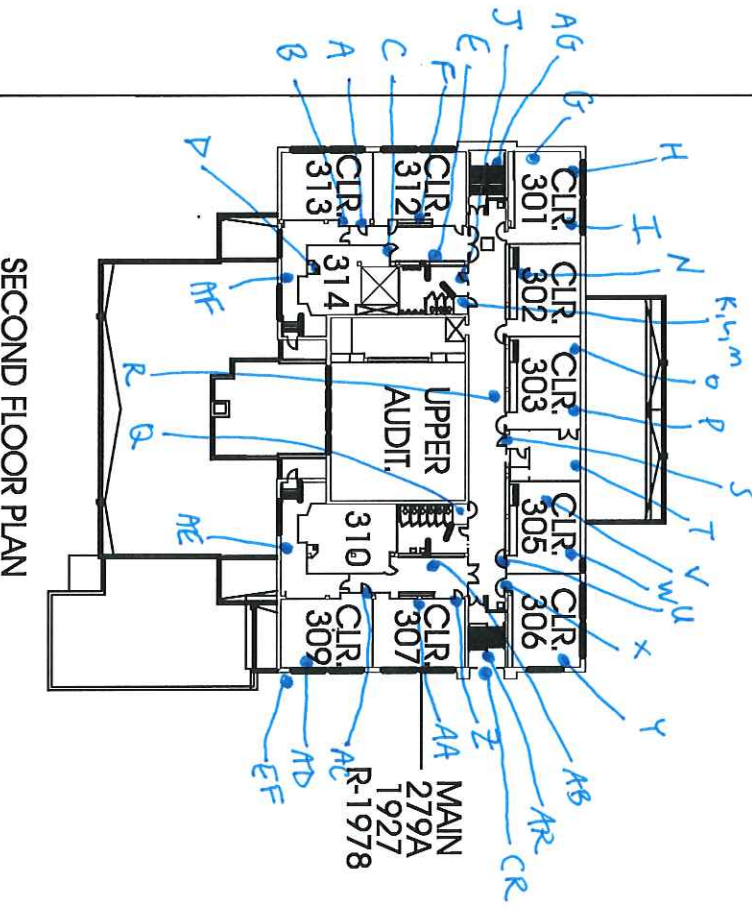
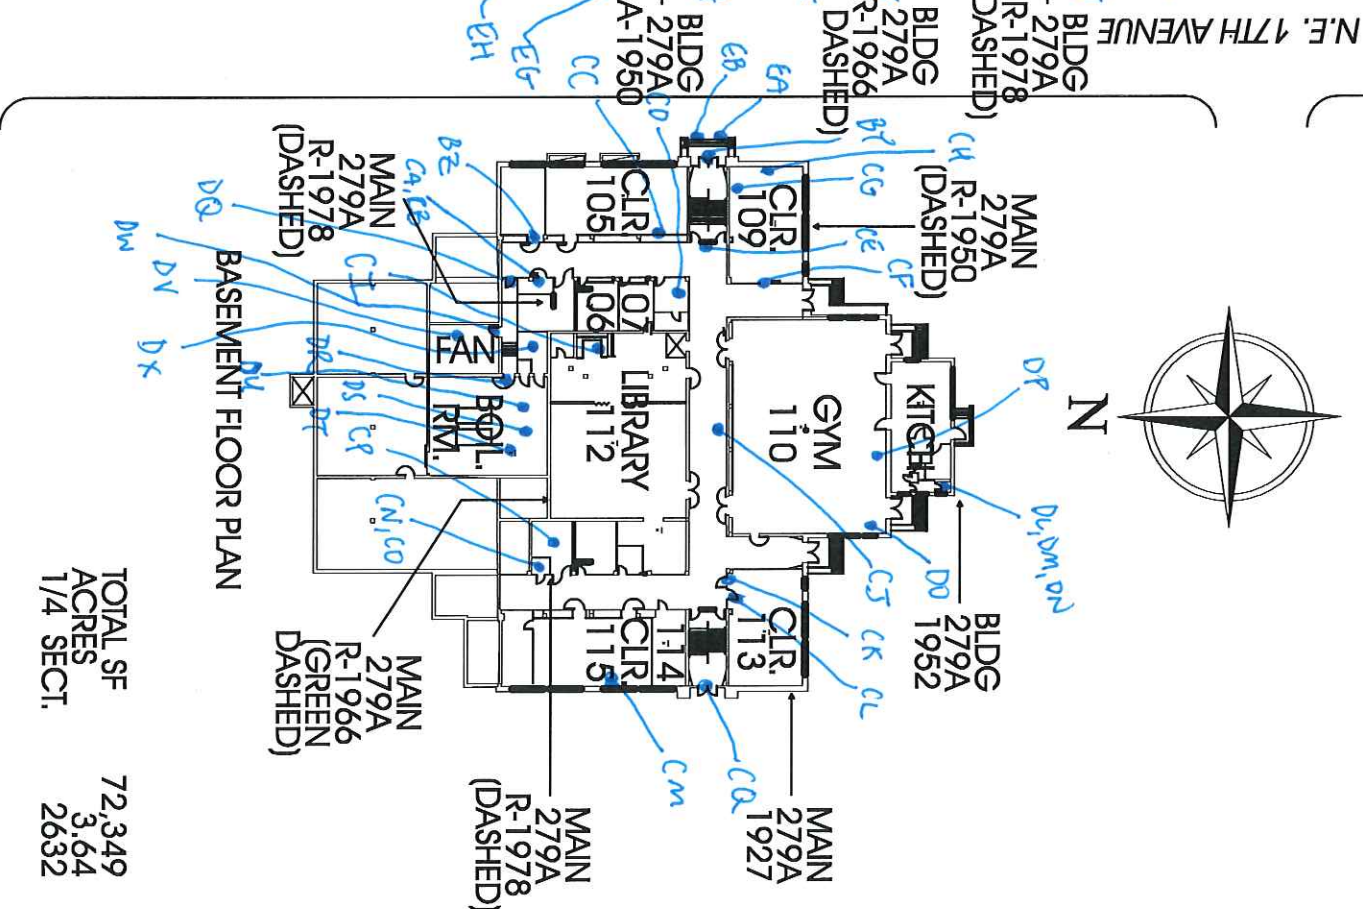
Overall, the building's painted and varnished surfaces were found to be in intact condition with areas of fair and deteriorated conditions. A table listing the locations and quantity of surfaces in deteriorated condition is attached to this report.

PBS recommends that all painted or varnished surfaces in deteriorated condition noted on the attached table be stabilized.
