Regarding: Lead Paint Condition Assessment
Ockley Green Middle School
6031 N Montana Avenue
Portland, Oregon 97217
PBS Project: 6500.721 Phase 0066

Ockley Green
Assessment of Paint/Varnish in Deteriorated Condition

Oakley Green Middle School 6031 N Montana 97217 Facility Plan

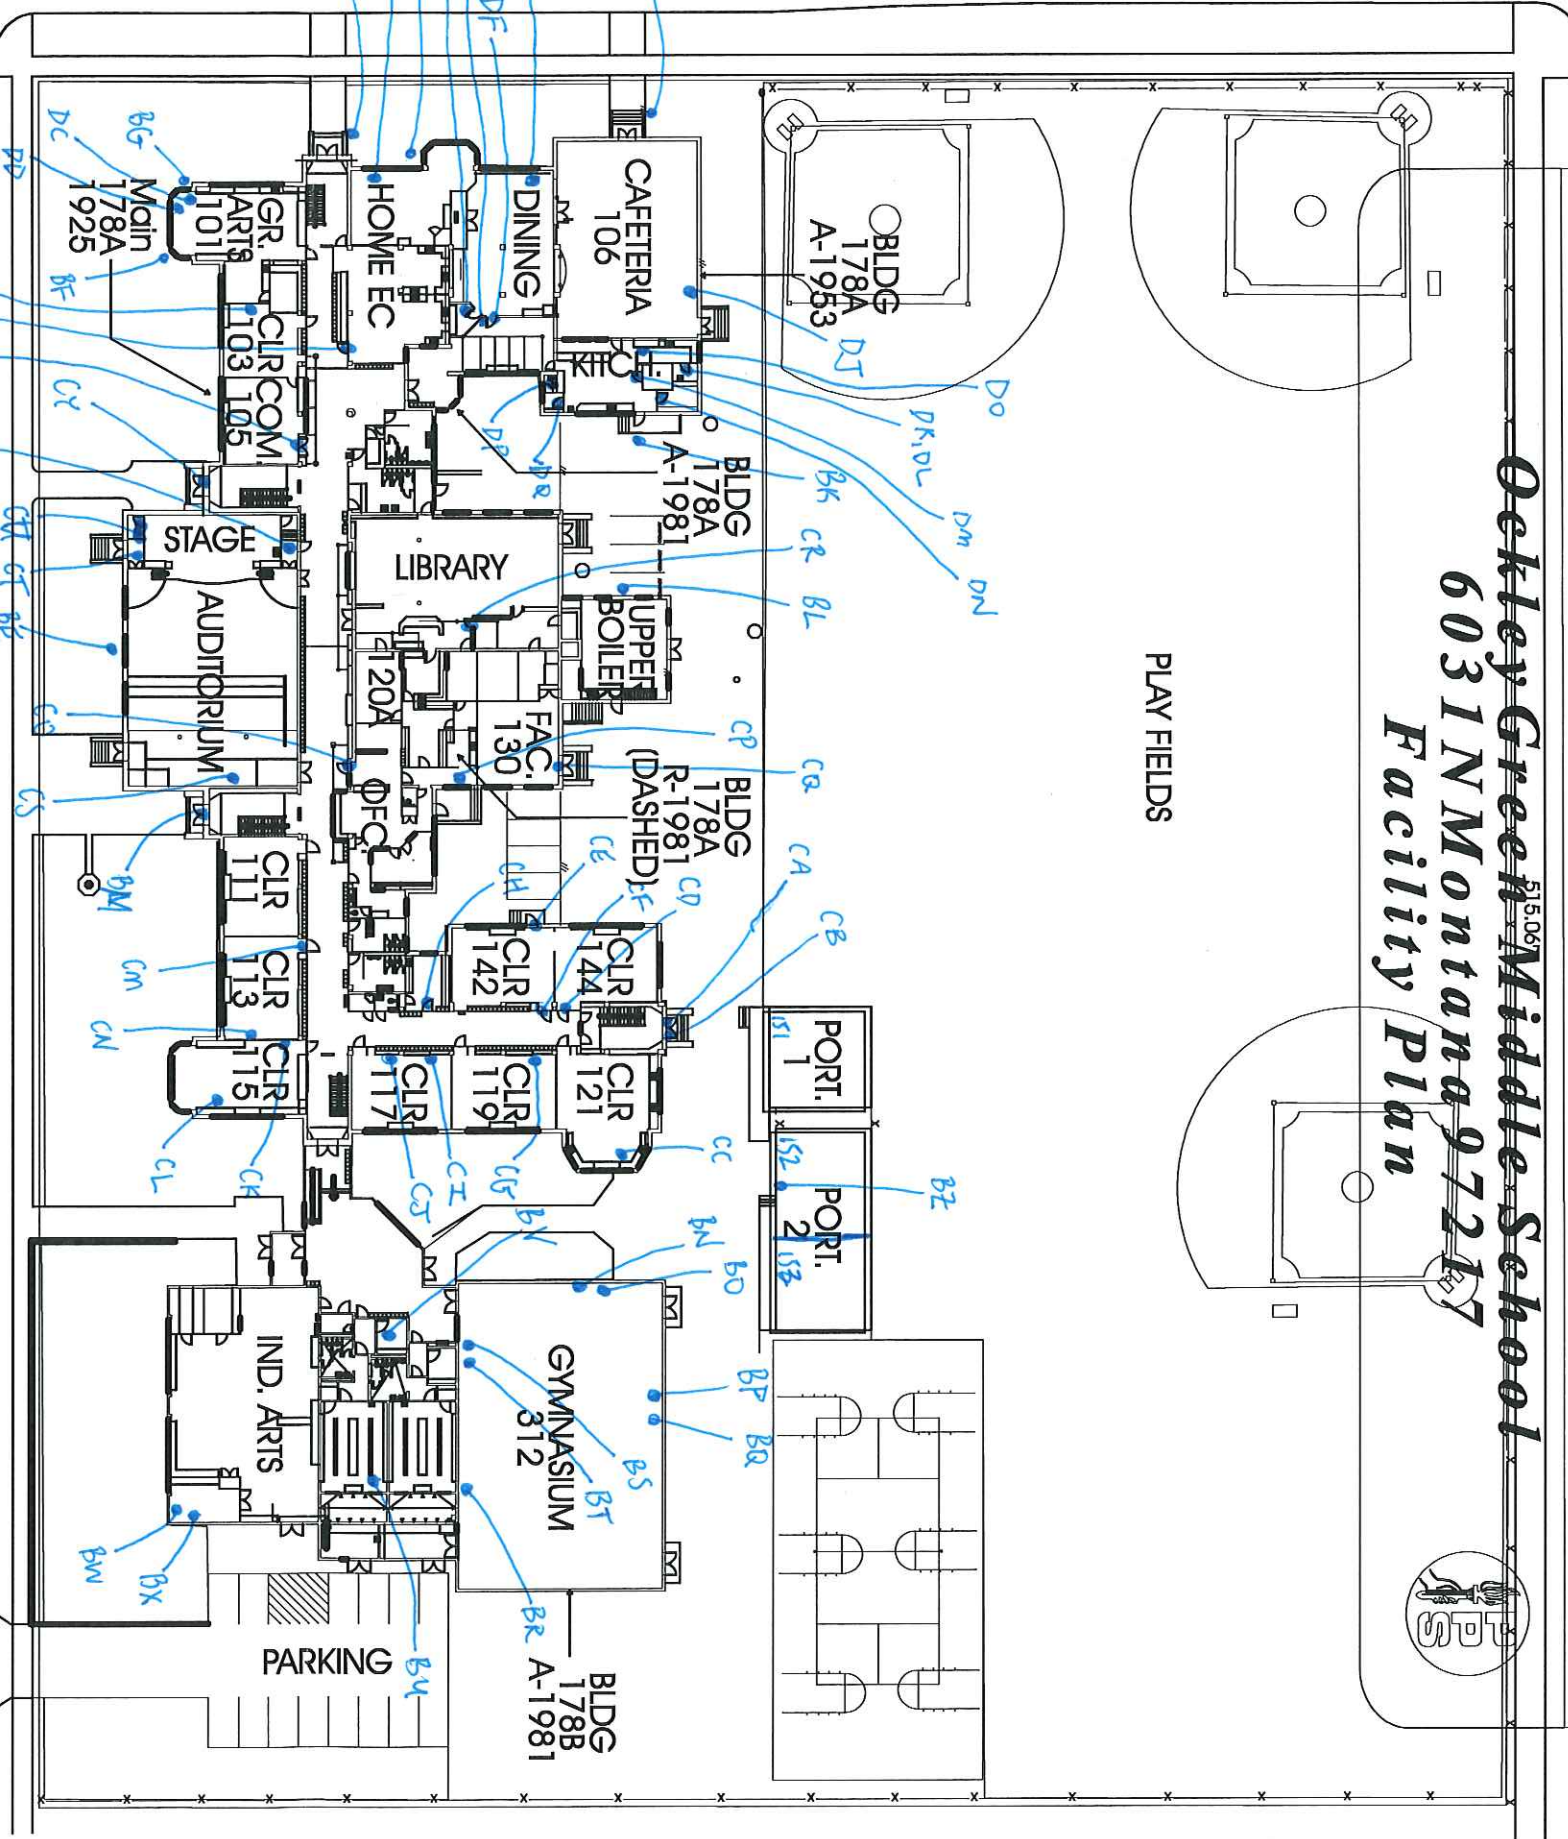
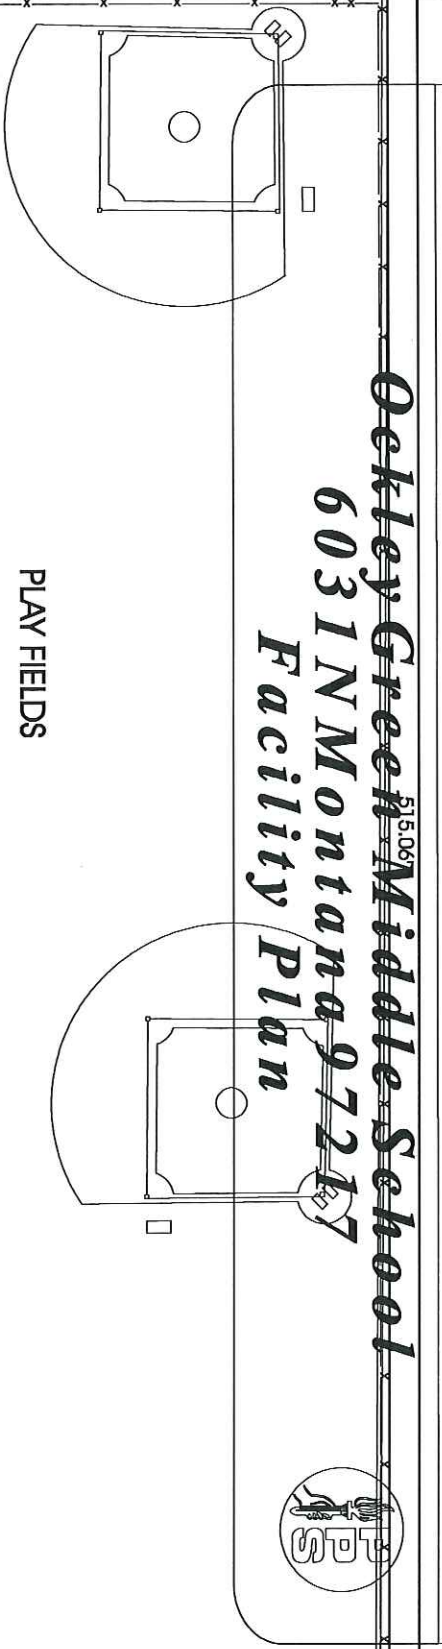
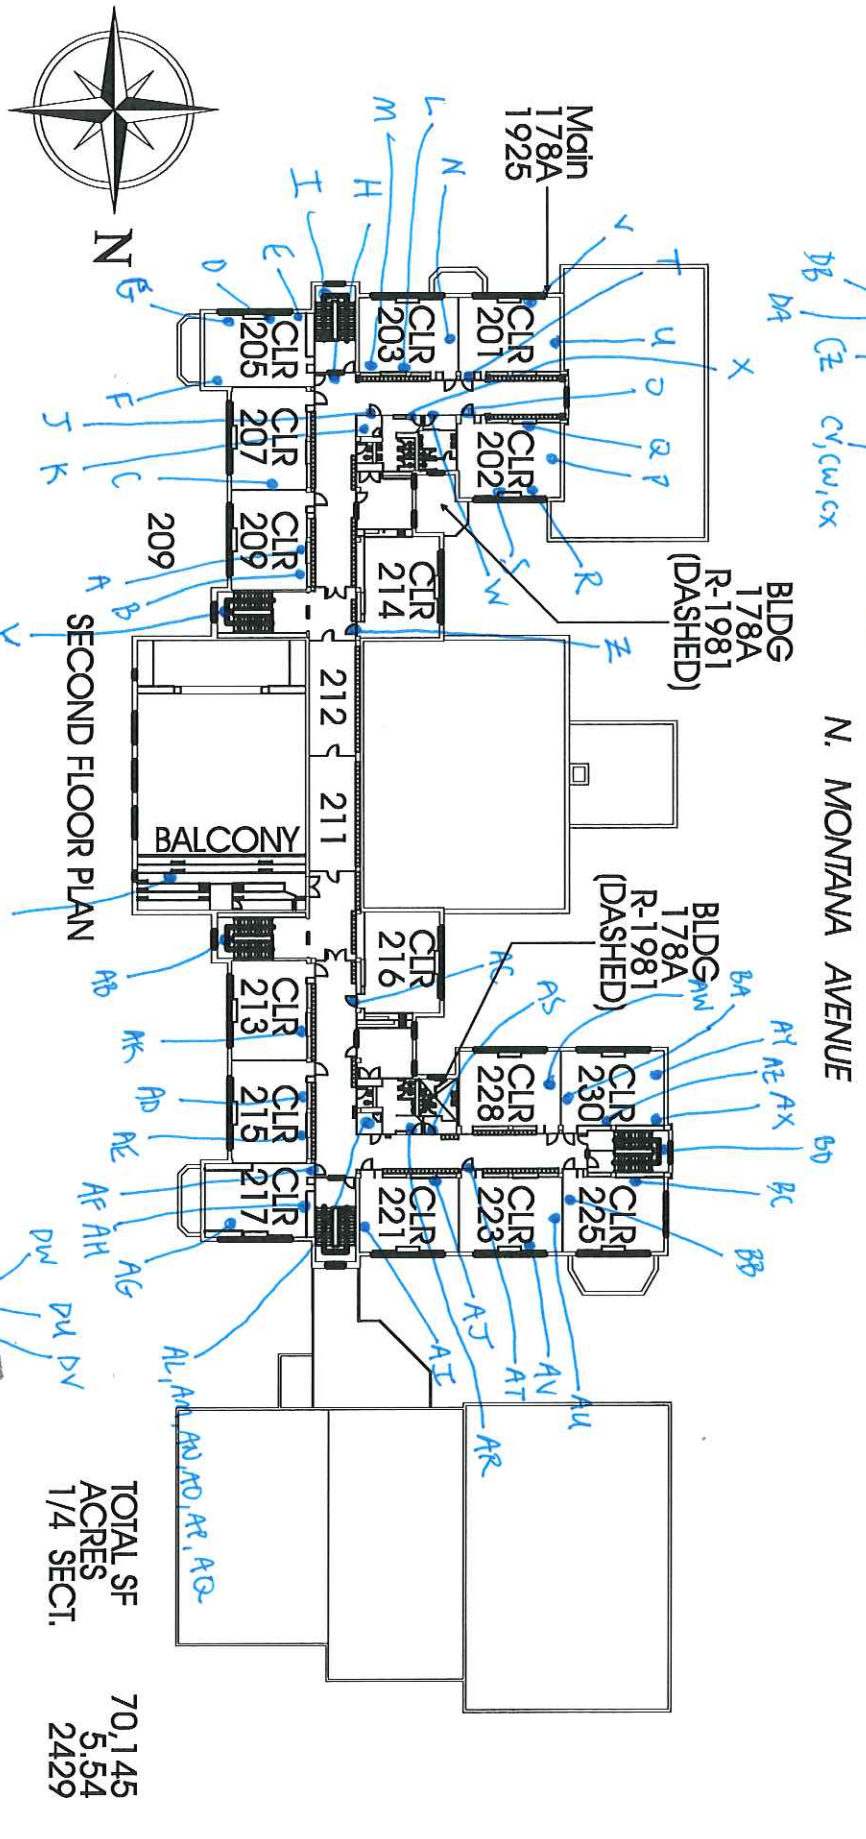
No paint chips were observed in garden spaces, or in window troughs of the school's metal sliding windows; however, paint chips were observed on the floor in custodial closet 222, in classroom 230, in the storage room of industrial arts room 304, in multiple locations in the gym, in the boiler room, and on the floor in general art room 101.

PBS recommends that all painted or varnished surfaces in deteriorated condition noted on the attached table be stabilized. All paint chips noted in this report should be removed.
