Regarding: Lead Paint Condition Assessment  
Hosford Middle School  
2303 SE 28th Place  
Portland, Oregon 97214  
PBS Project: 6500.721 Phase 0062

**Hosford Middle School**  
**Assessment of Paint/Varnish in Deteriorated Condition**

# Hosford Middle School 2303 SE 28th Place Facility Plan

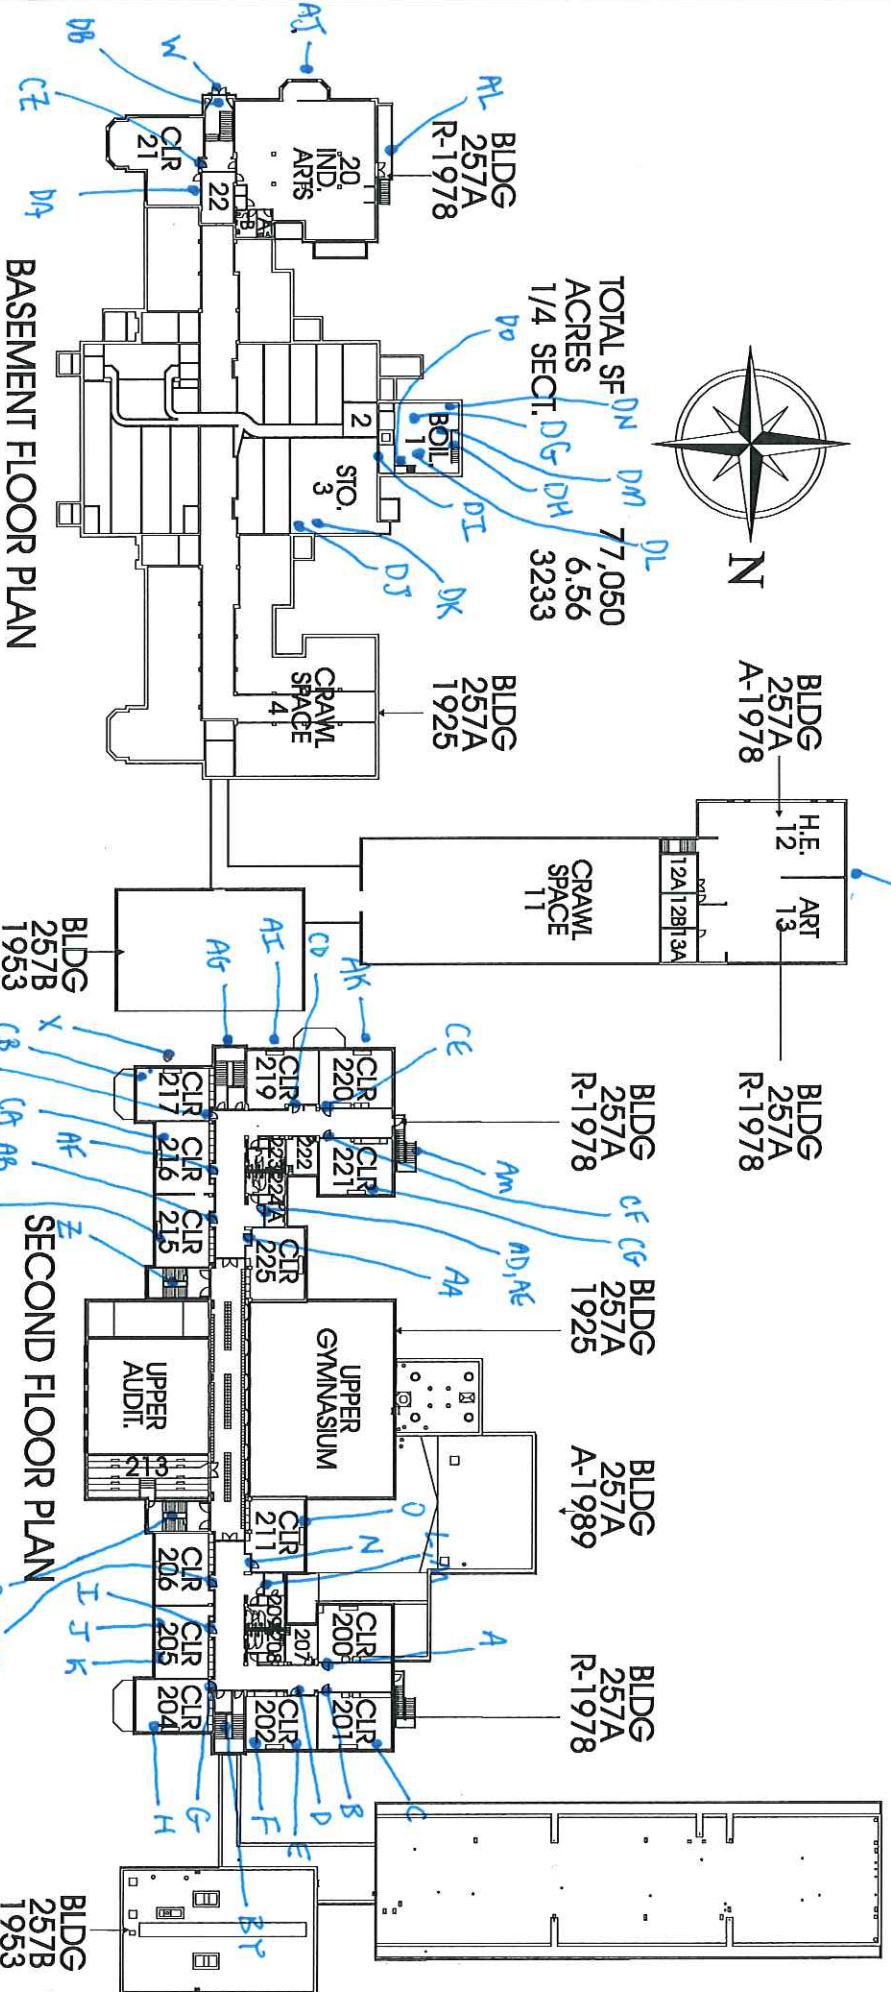
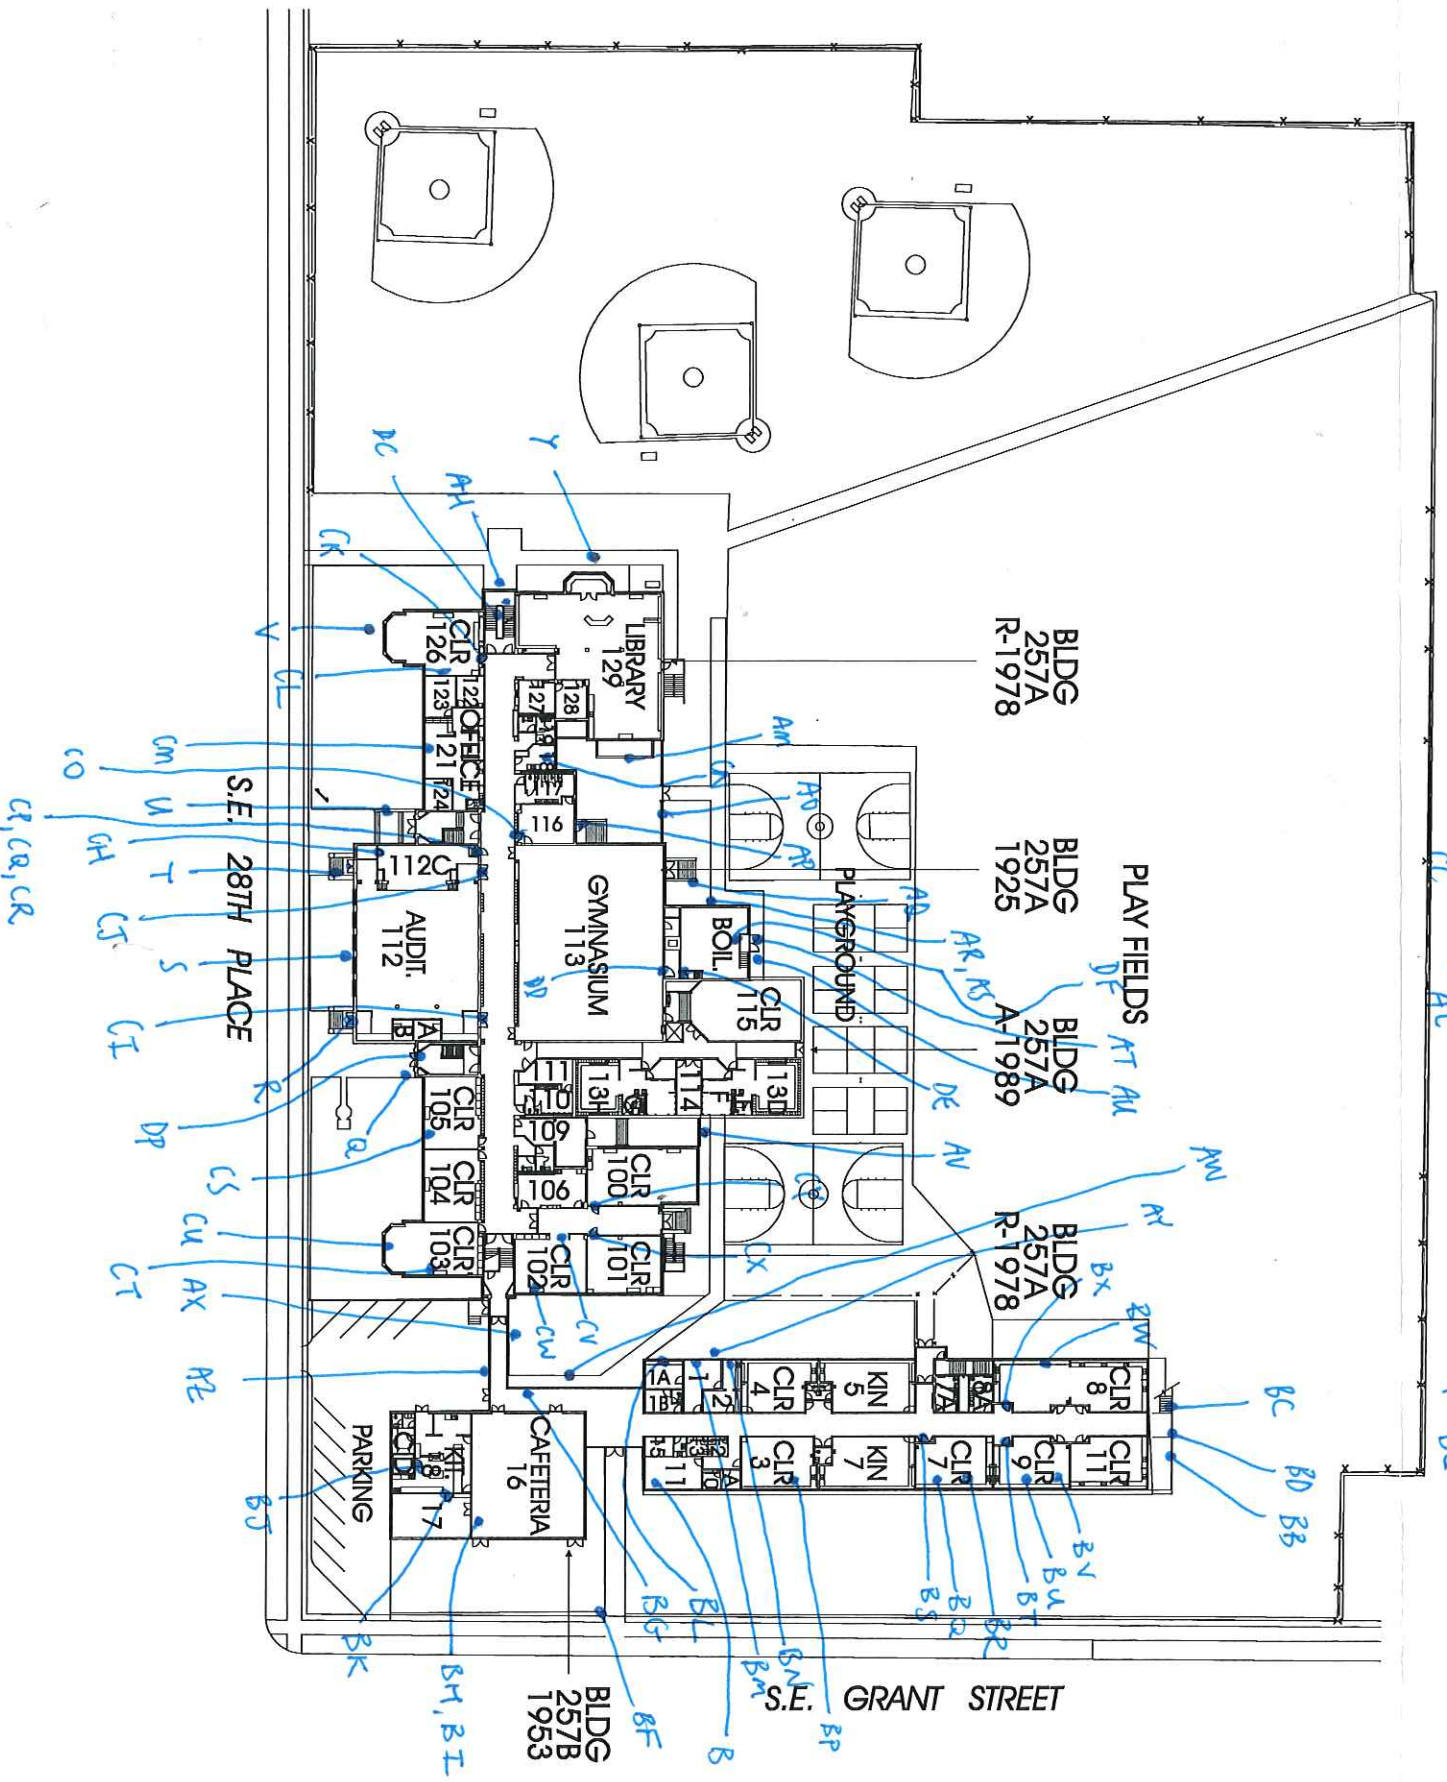
PBS did observe paint chips on asphalt and in soil on the west exterior of classrooms 8 and 11, a very small amount in the corner on the floor in the cafeteria, and in the custodial office across from classroom 216.

PBS recommends that all painted or varnished surfaces in deteriorated condition noted on the attached table be stabilized. All paint chips noted in this report should be removed.
