Regarding: Lead Paint Condition Assessment  
Beaumont Middle School  
4043 NE Fremont Street  
Portland, Oregon 97212  
PBS Project: 6500.721 Phase 0059

**Beaumont Middle School**  
**Assessment of Paint/Varnish in Deteriorated Condition**

# Baumont Middle School 4043 NE Fremont 97212 Facility Plan

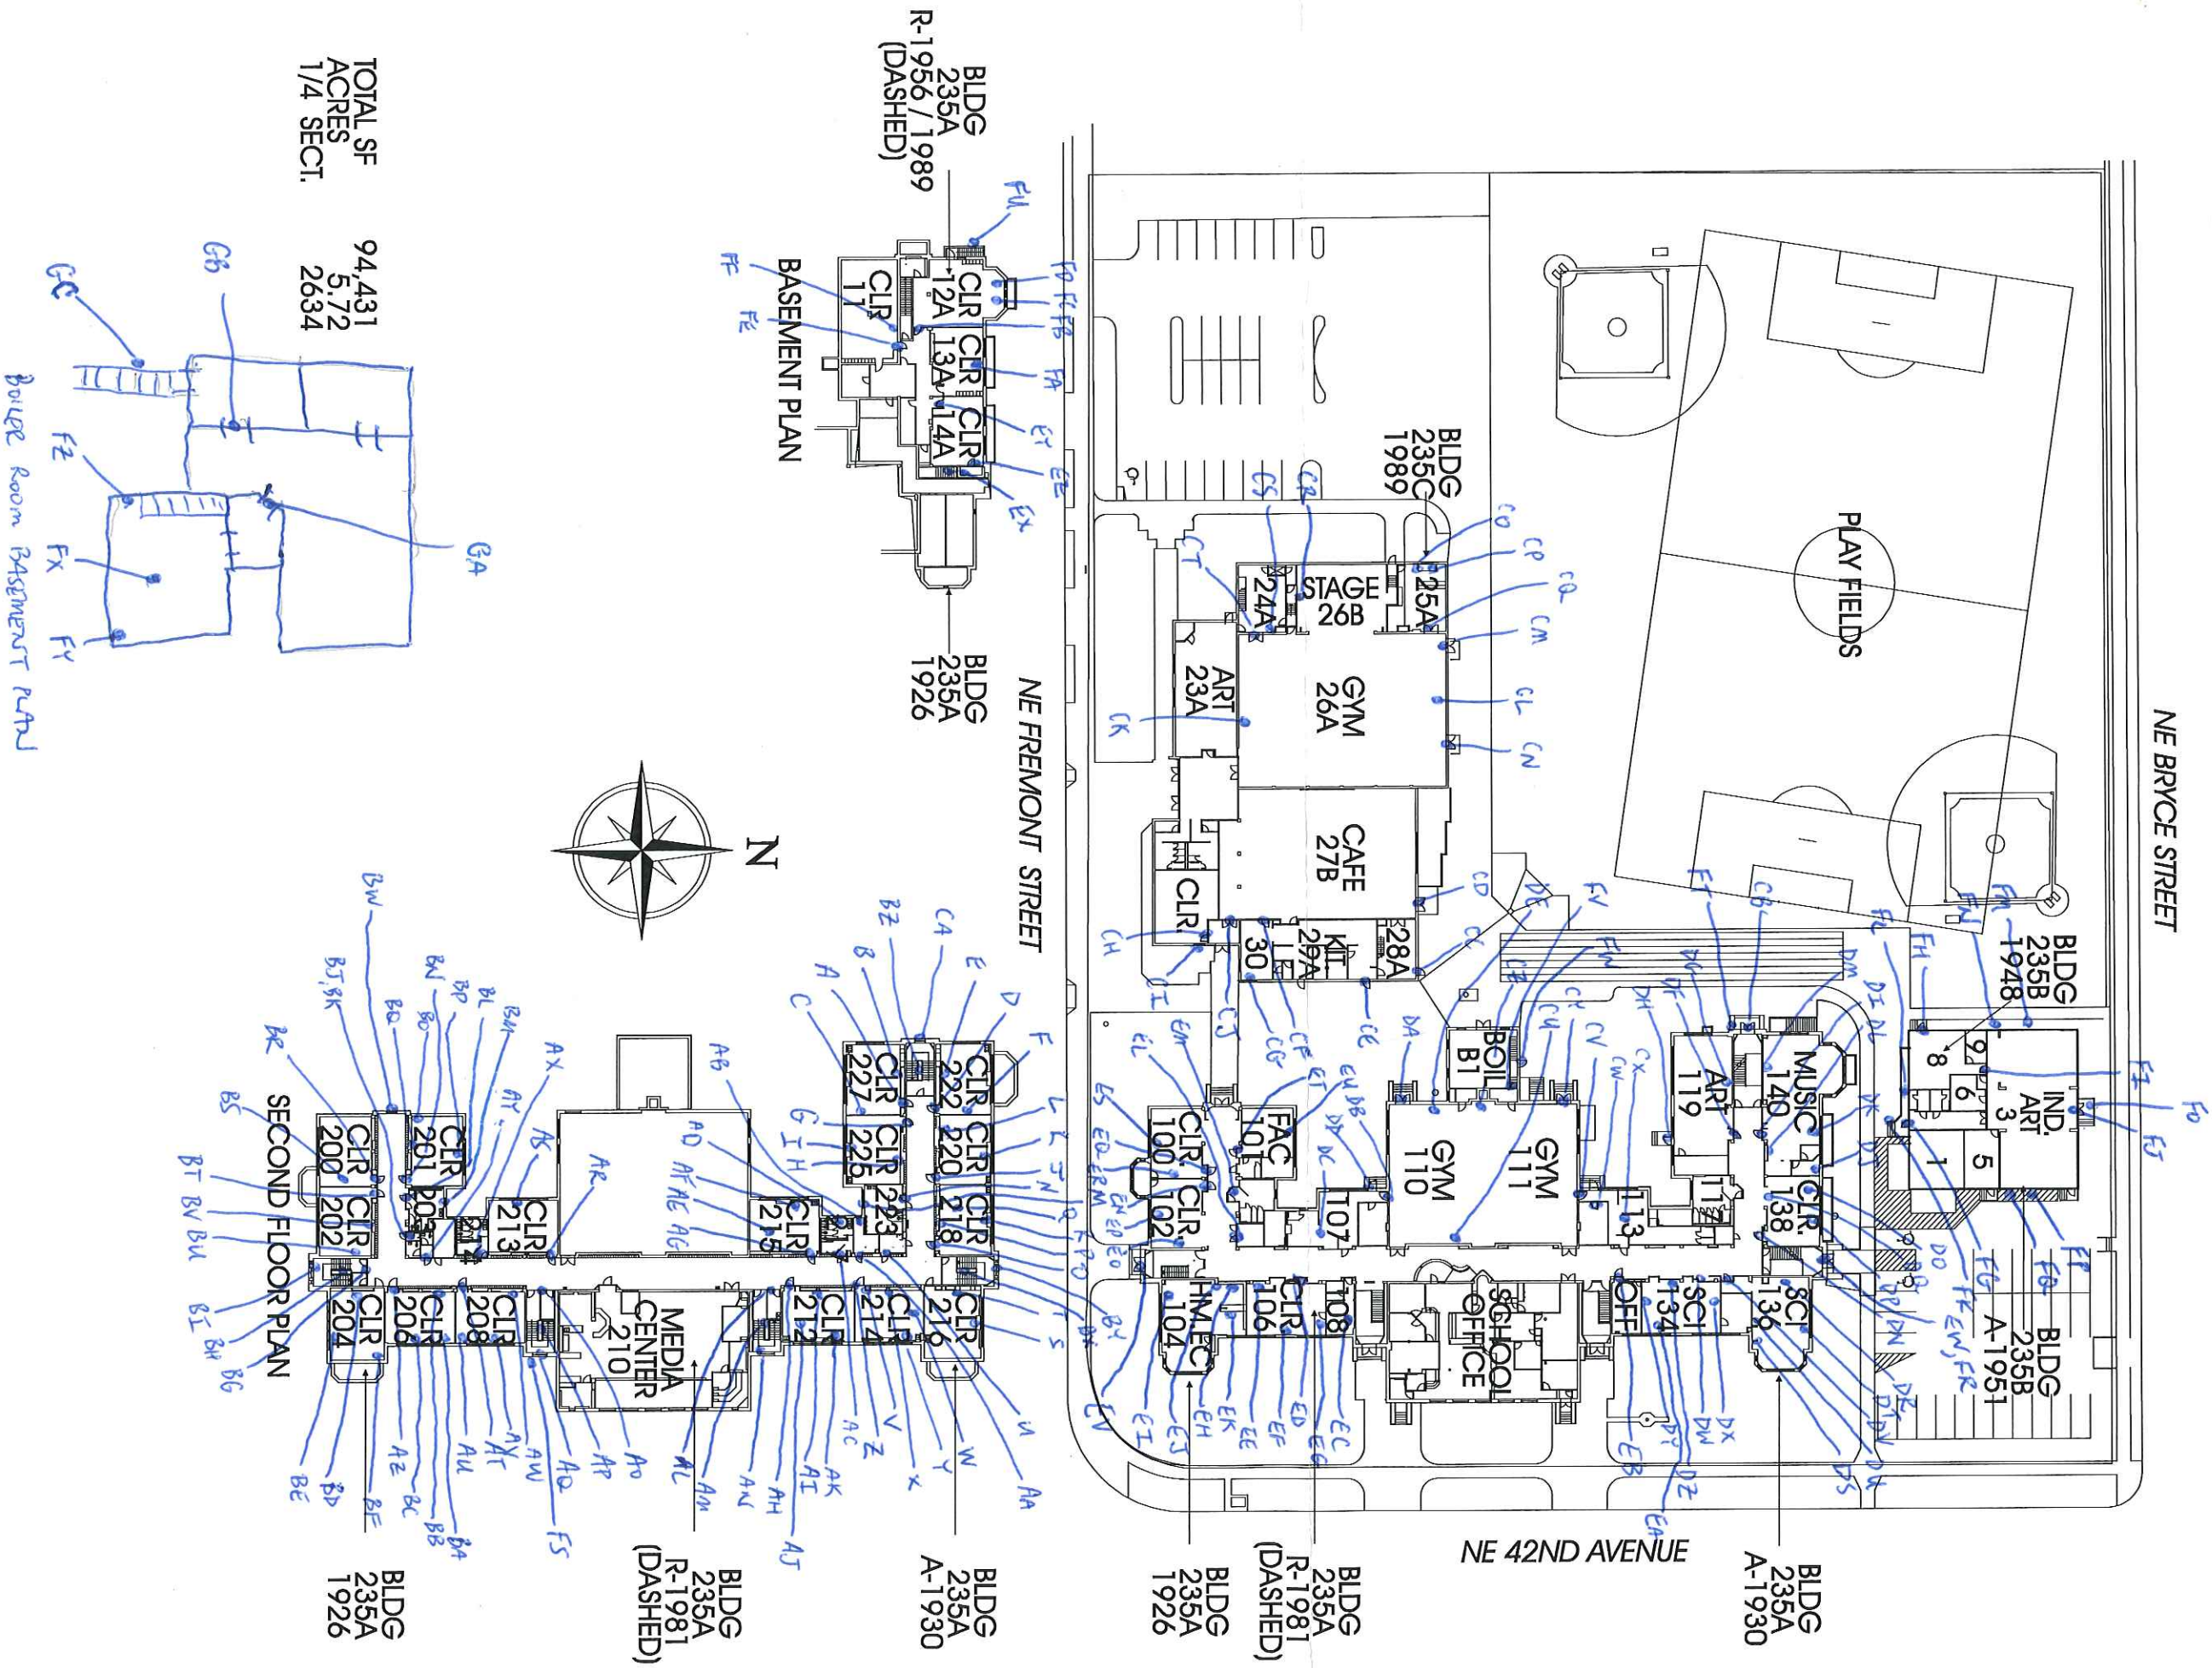
Overall, the building's painted and varnished surfaces were found to be in intact condition with areas of fair and deteriorated conditions. A table listing the locations and quantity of surfaces in deteriorated condition is attached to this report.

No paint chips were observed in the school's garden; however, paint chips were observed beneath the window in classroom 12A and on concrete in the gym's storage room 25A.

The school has metal sliding windows in a majority of the main building and the gym building; wood varnished windows in the basement and stairwells of the main building; and wood pull-in windows in the arts building. Abrasion was observed on wood varnished windows in the basement and stairwells and on wood pull-in windows in the arts building. Window troughs for these windows were observed to be dirty.

PBS recommends that all painted or varnished surfaces in deteriorated condition noted on the attached table be stabilized. All paint chips noted in this report should be removed. Dirty window troughs should be cleaned.
