Regarding: Lead Paint Condition Assessment
West Sylvan Middle School
8111 SW West Slope Drive
Portland, Oregon 97225
PBS Project: 6500.721 Phase 0069

On March 14, 2017, PBS Engineering and Environmental Inc. (PBS) conducted a visual inspection and assessment of painted and varnished surfaces on the interior and exterior of West Sylvan Middle School located at 8111 SW West Slope Drive in Portland, Oregon.

West Sylvan Middle School
Assessment of Paint/Varnish in Deteriorated Condition

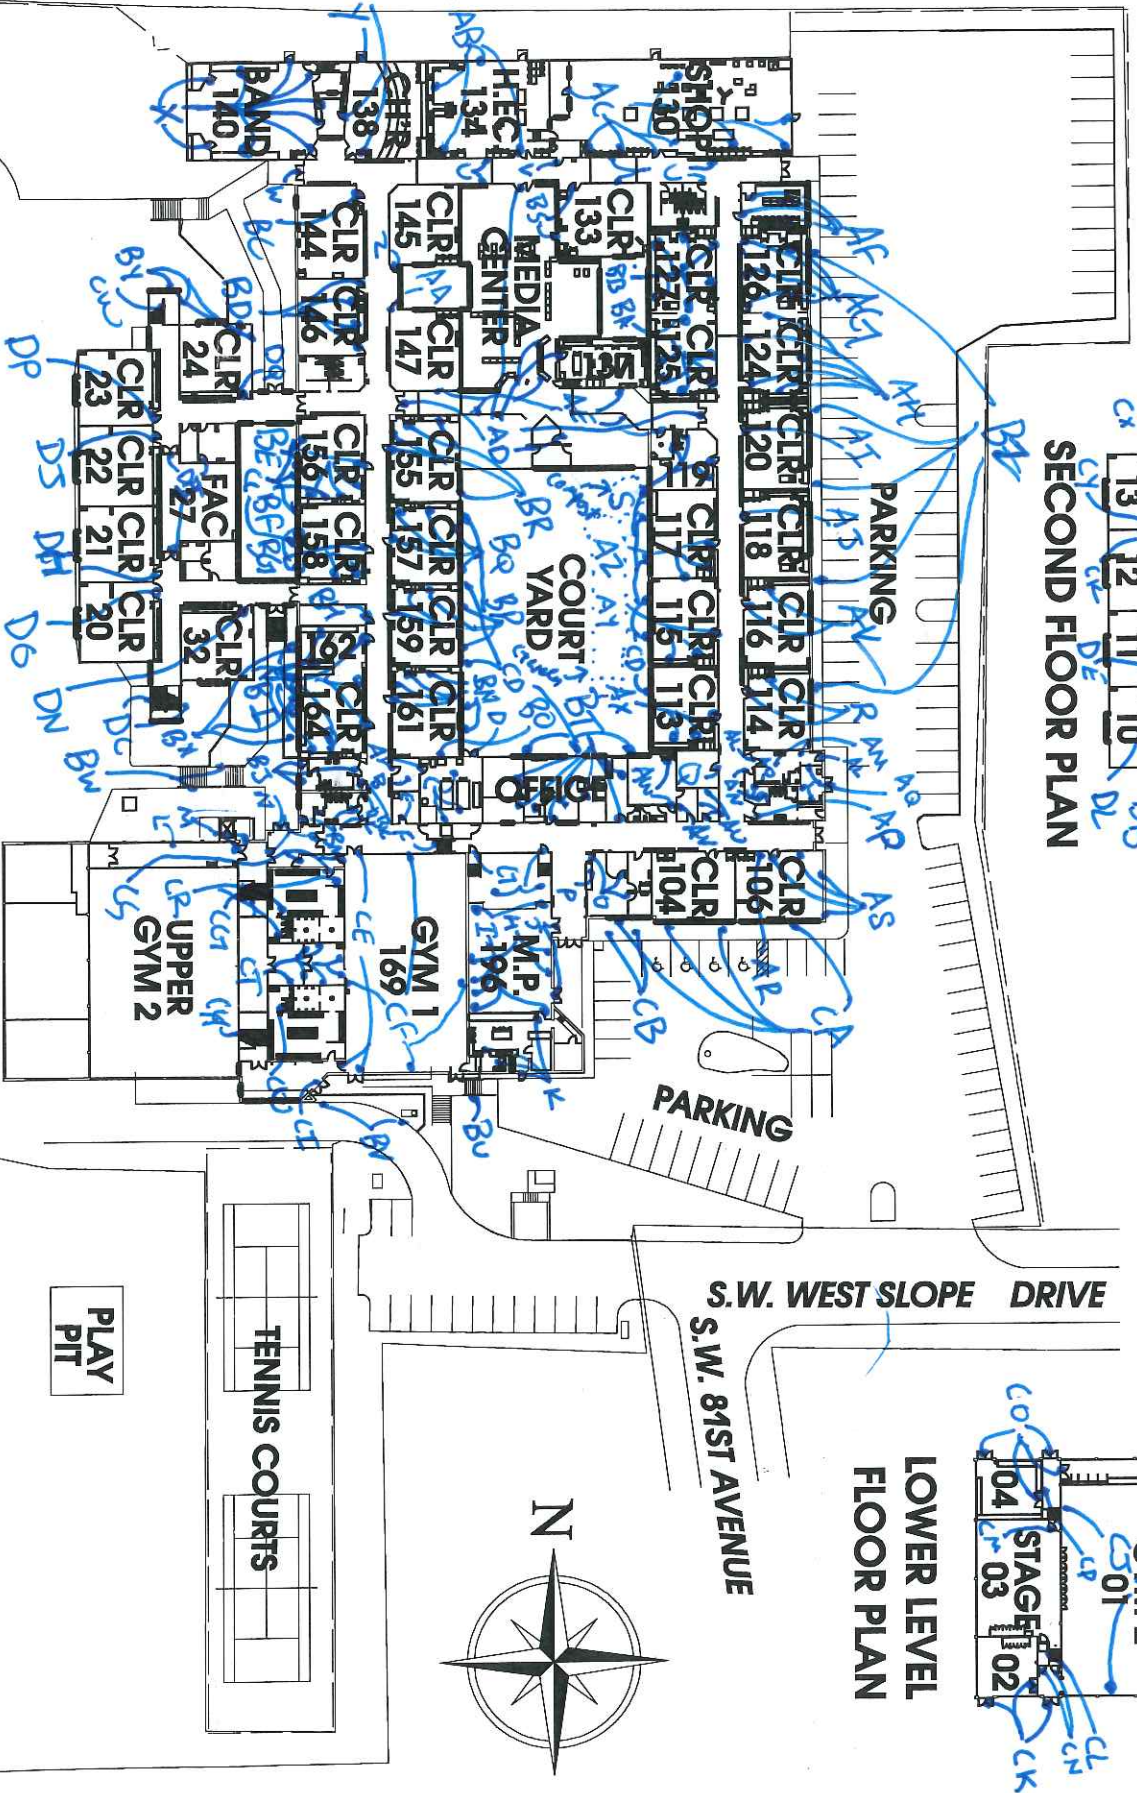
SITE / FIRST FLOOR PLAN

Overall, the building's painted and varnished surfaces were found to be in intact condition with areas of fair and deteriorated conditions. A table listing the locations and quantity of surfaces in deteriorated condition is attached to this report.

No paint chips were observed in garden boxes or the compost pile; however paint chips were observed in soil on the south and east sides of the building; the west side of the building outside classrooms 162 and 164; and in both courtyards.

The school has old metal framed windows with wood sills, and new metal framed windows. Paint chips were observed in old painted metal window troughs in the east hallway; south hallway; east, west, and south main courtyard; and in classrooms 156, 158, 162, and 164.

PBS recommends that all painted or varnished surfaces in deteriorated condition noted on the attached table be stabilized. All paint chips noted in this report should be removed. Window troughs in the east hallway; south hallway; east, west, and south main courtyard; and in classrooms 156, 158, 162, and 164 should be cleaned.
