Regarding: Lead Paint Condition Assessment
Benson Polytechnic High School
546 NE 12th Avenue
Portland, Oregon 97232
PBS Project: 6500.721 Phase 0072

On March 16, 2017, PBS Engineering and Environmental Inc. (PBS) conducted a visual inspection and assessment of painted and varnished surfaces on the interior and exterior of Benson Polytechnic High School located at 546 NE 12th Avenue in Portland, Oregon.

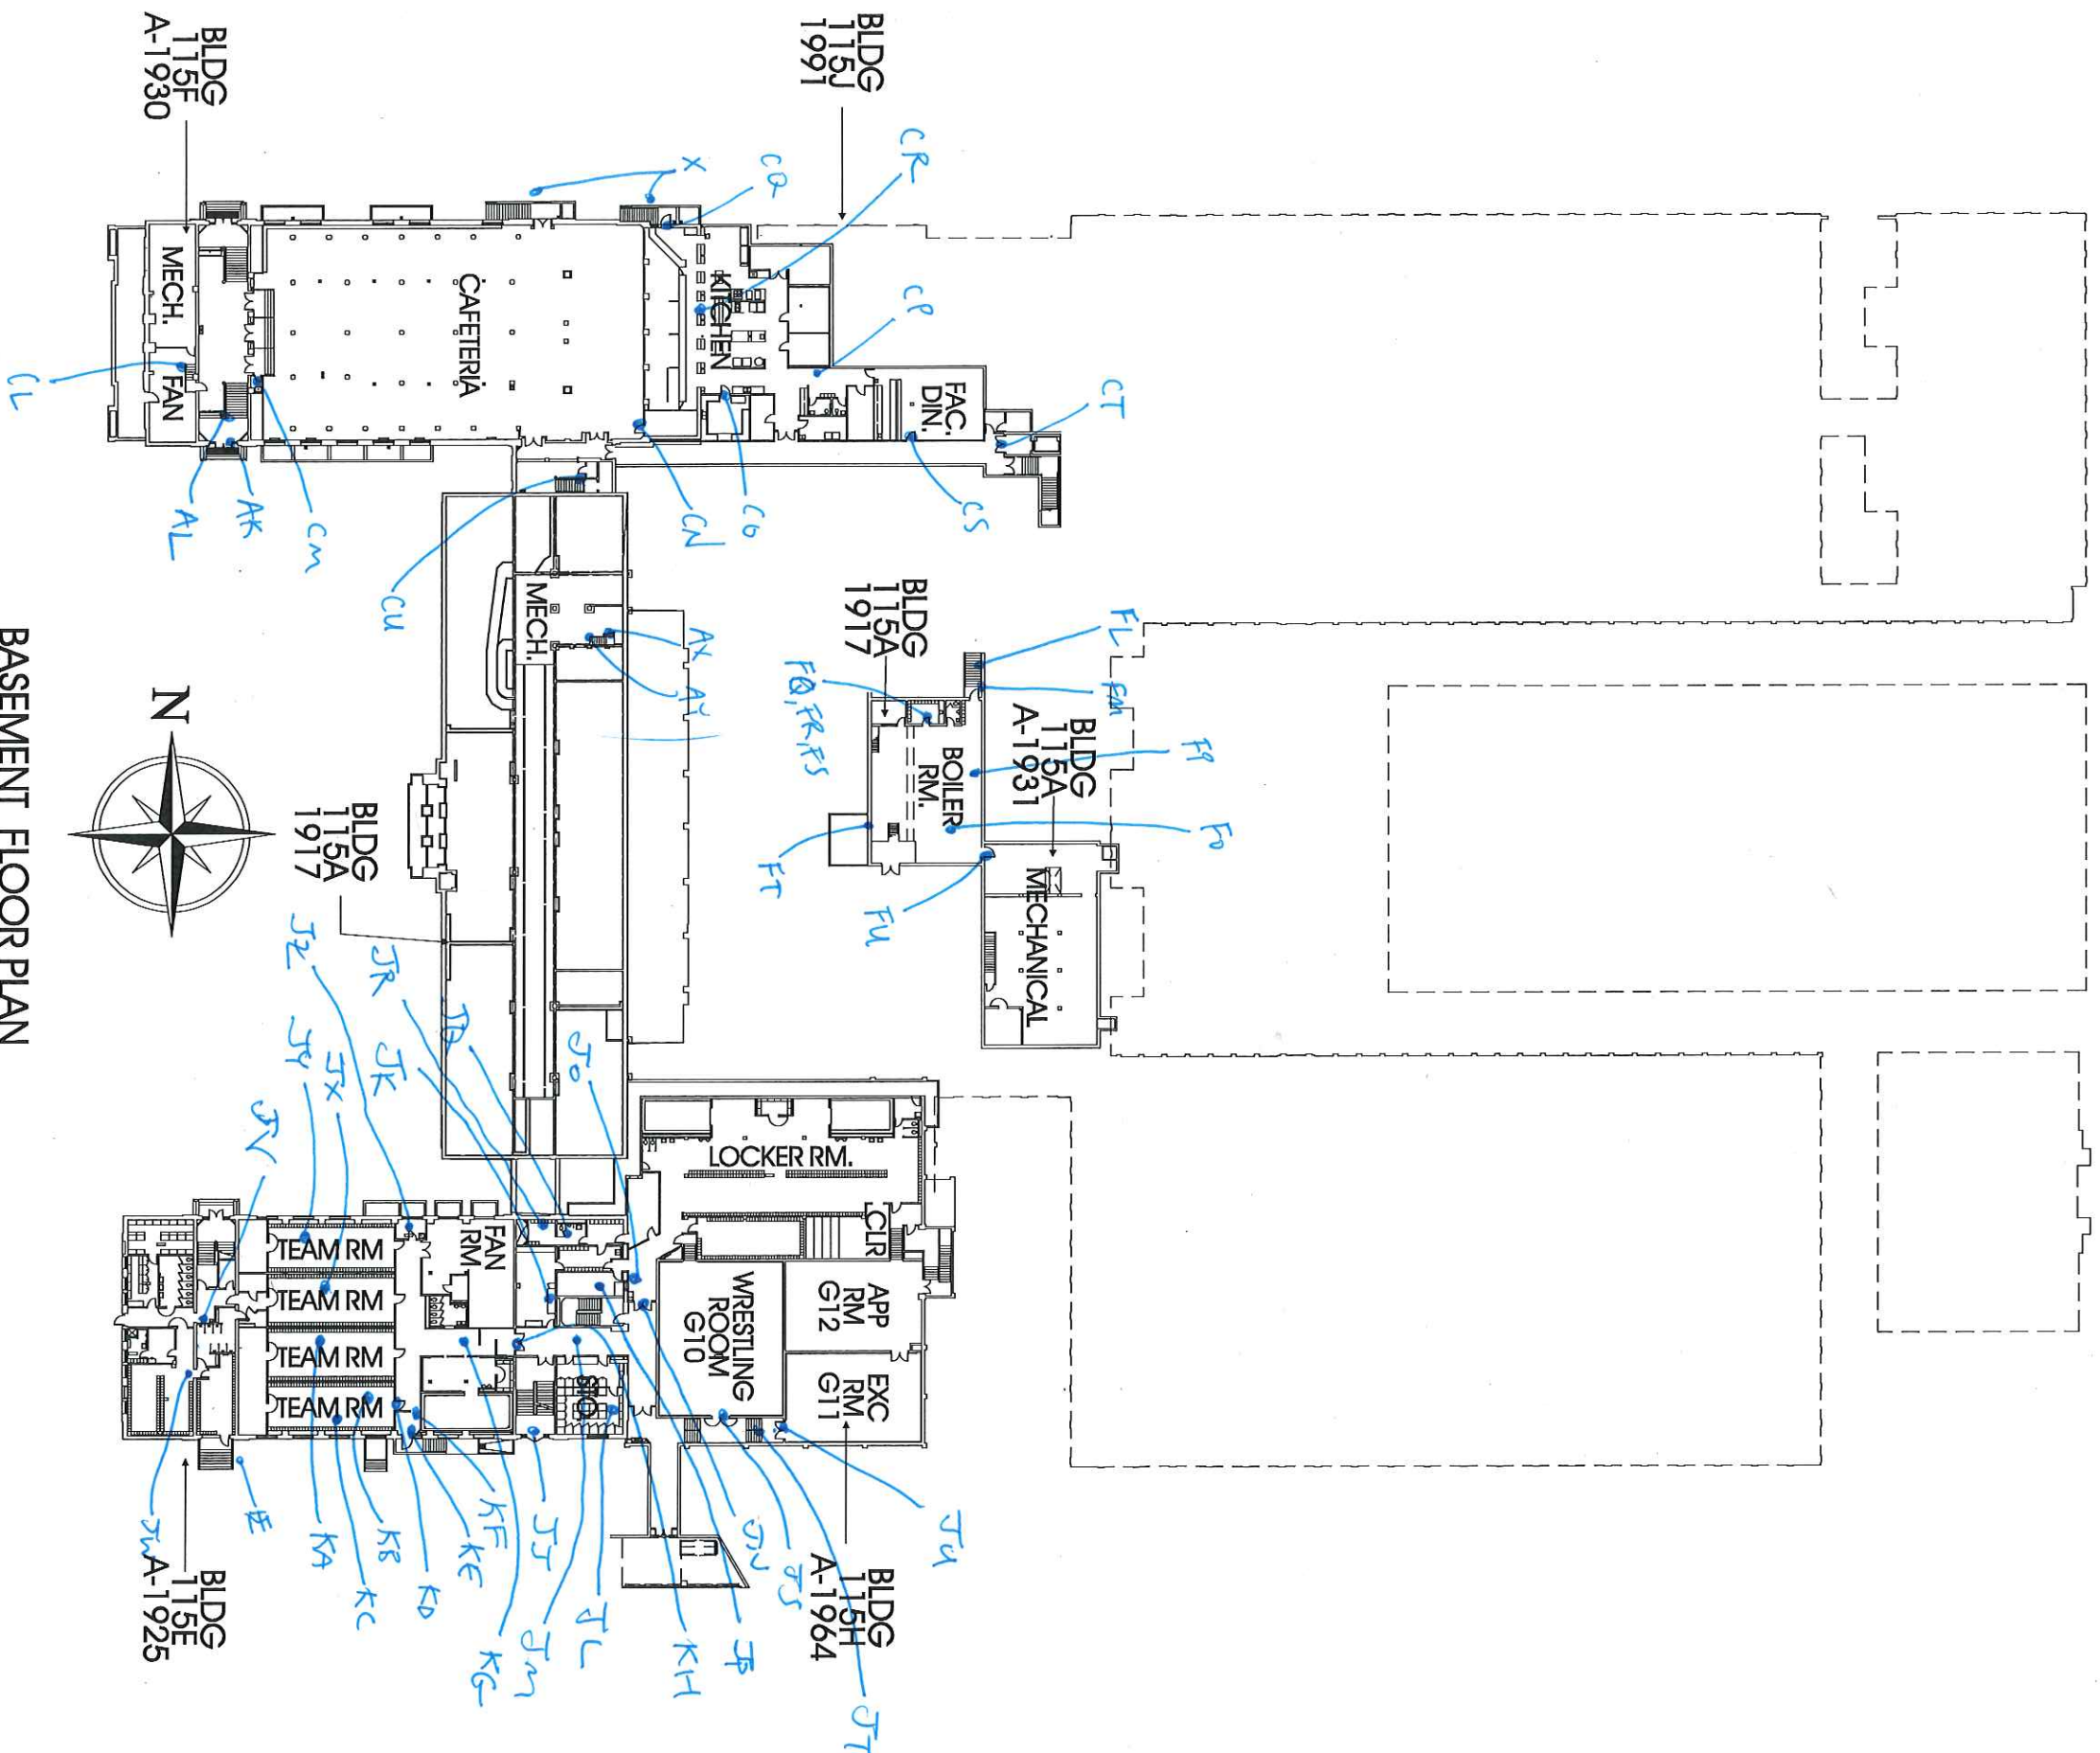
BASEMENT FLOOR PLAN

Overall, the building's painted and varnished surfaces were found to be in intact condition with areas of fair and deteriorated conditions. A table listing the locations and quantity of surfaces in deteriorated condition is attached to this report.

Paint chips were also observed in soil and on concrete on all sides of the building's exterior and in rooms C-117, C-141, C-145, F-116, D-115, and in the IT room between rooms 213 and 213B.

PBS recommends that all painted or varnished surfaces in deteriorated condition noted on the attached table be stabilized. All paint chips noted in this report should be removed. All window troughs should be cleaned and any paint chips removed.
