Regarding: Lead Paint Condition Assessment  
Capitol Hill Elementary School  
8401 SW 17th Avenue  
Portland, Oregon 97219  
PBS Project: 6500.721 Phase 0013

**Capitol Hill Elementary School  
Assessment of Paint/Varnish in Deteriorated Condition**

# Capitol Hill Elementary School 8401 SW 17th Street 97219 Facility Plan

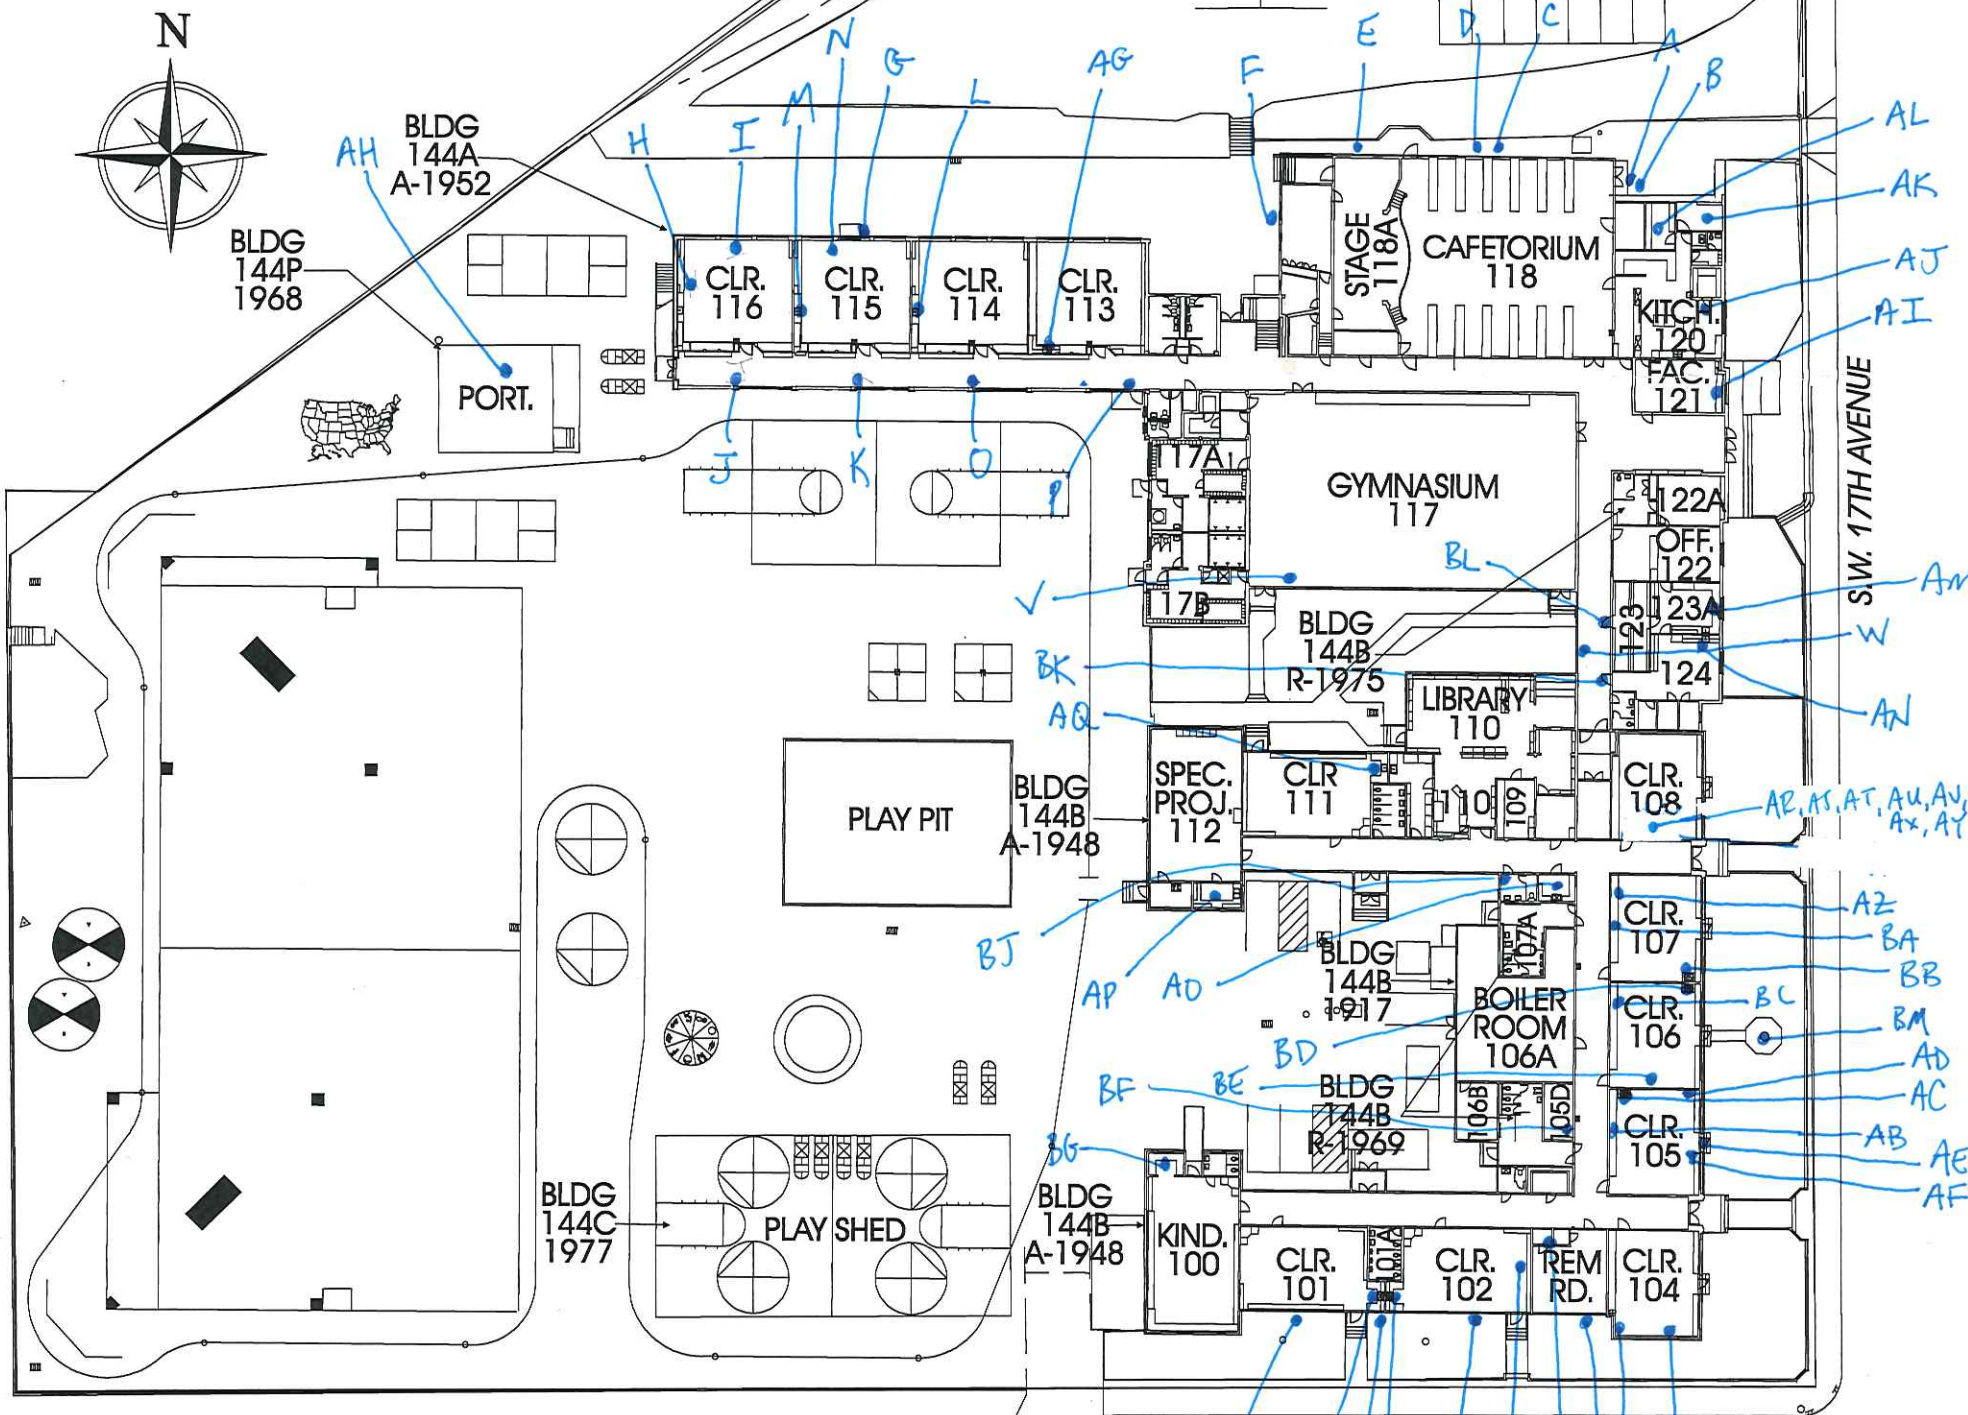
SITE / FIRST FLOOR PLAN

One area of high concern noted during PBS' site visit was classroom 108, which is a K-2 room. Paint chips were observed on the carpet in room 108.

\* TEACHER IN 105 SAYS KIDS TALK ABOUT  
108 SEE A ...

PBS recommends that all painted or varnished surfaces in deteriorated condition noted on the attached table be stabilized. Paint chips on the carpet in classroom 108 should be removed.
