Regarding: Lead Paint Condition Assessment
Creston Elementary School
4701 SE Bush Street
Portland, Oregon 97206
PBS Project: 6500.721 Phase 0079

Creston Elementary School
Assessment of Paint/Varnish in Deteriorated Condition

Creston Elementary School 4701 SE Bush Street 97206 Facility Plan

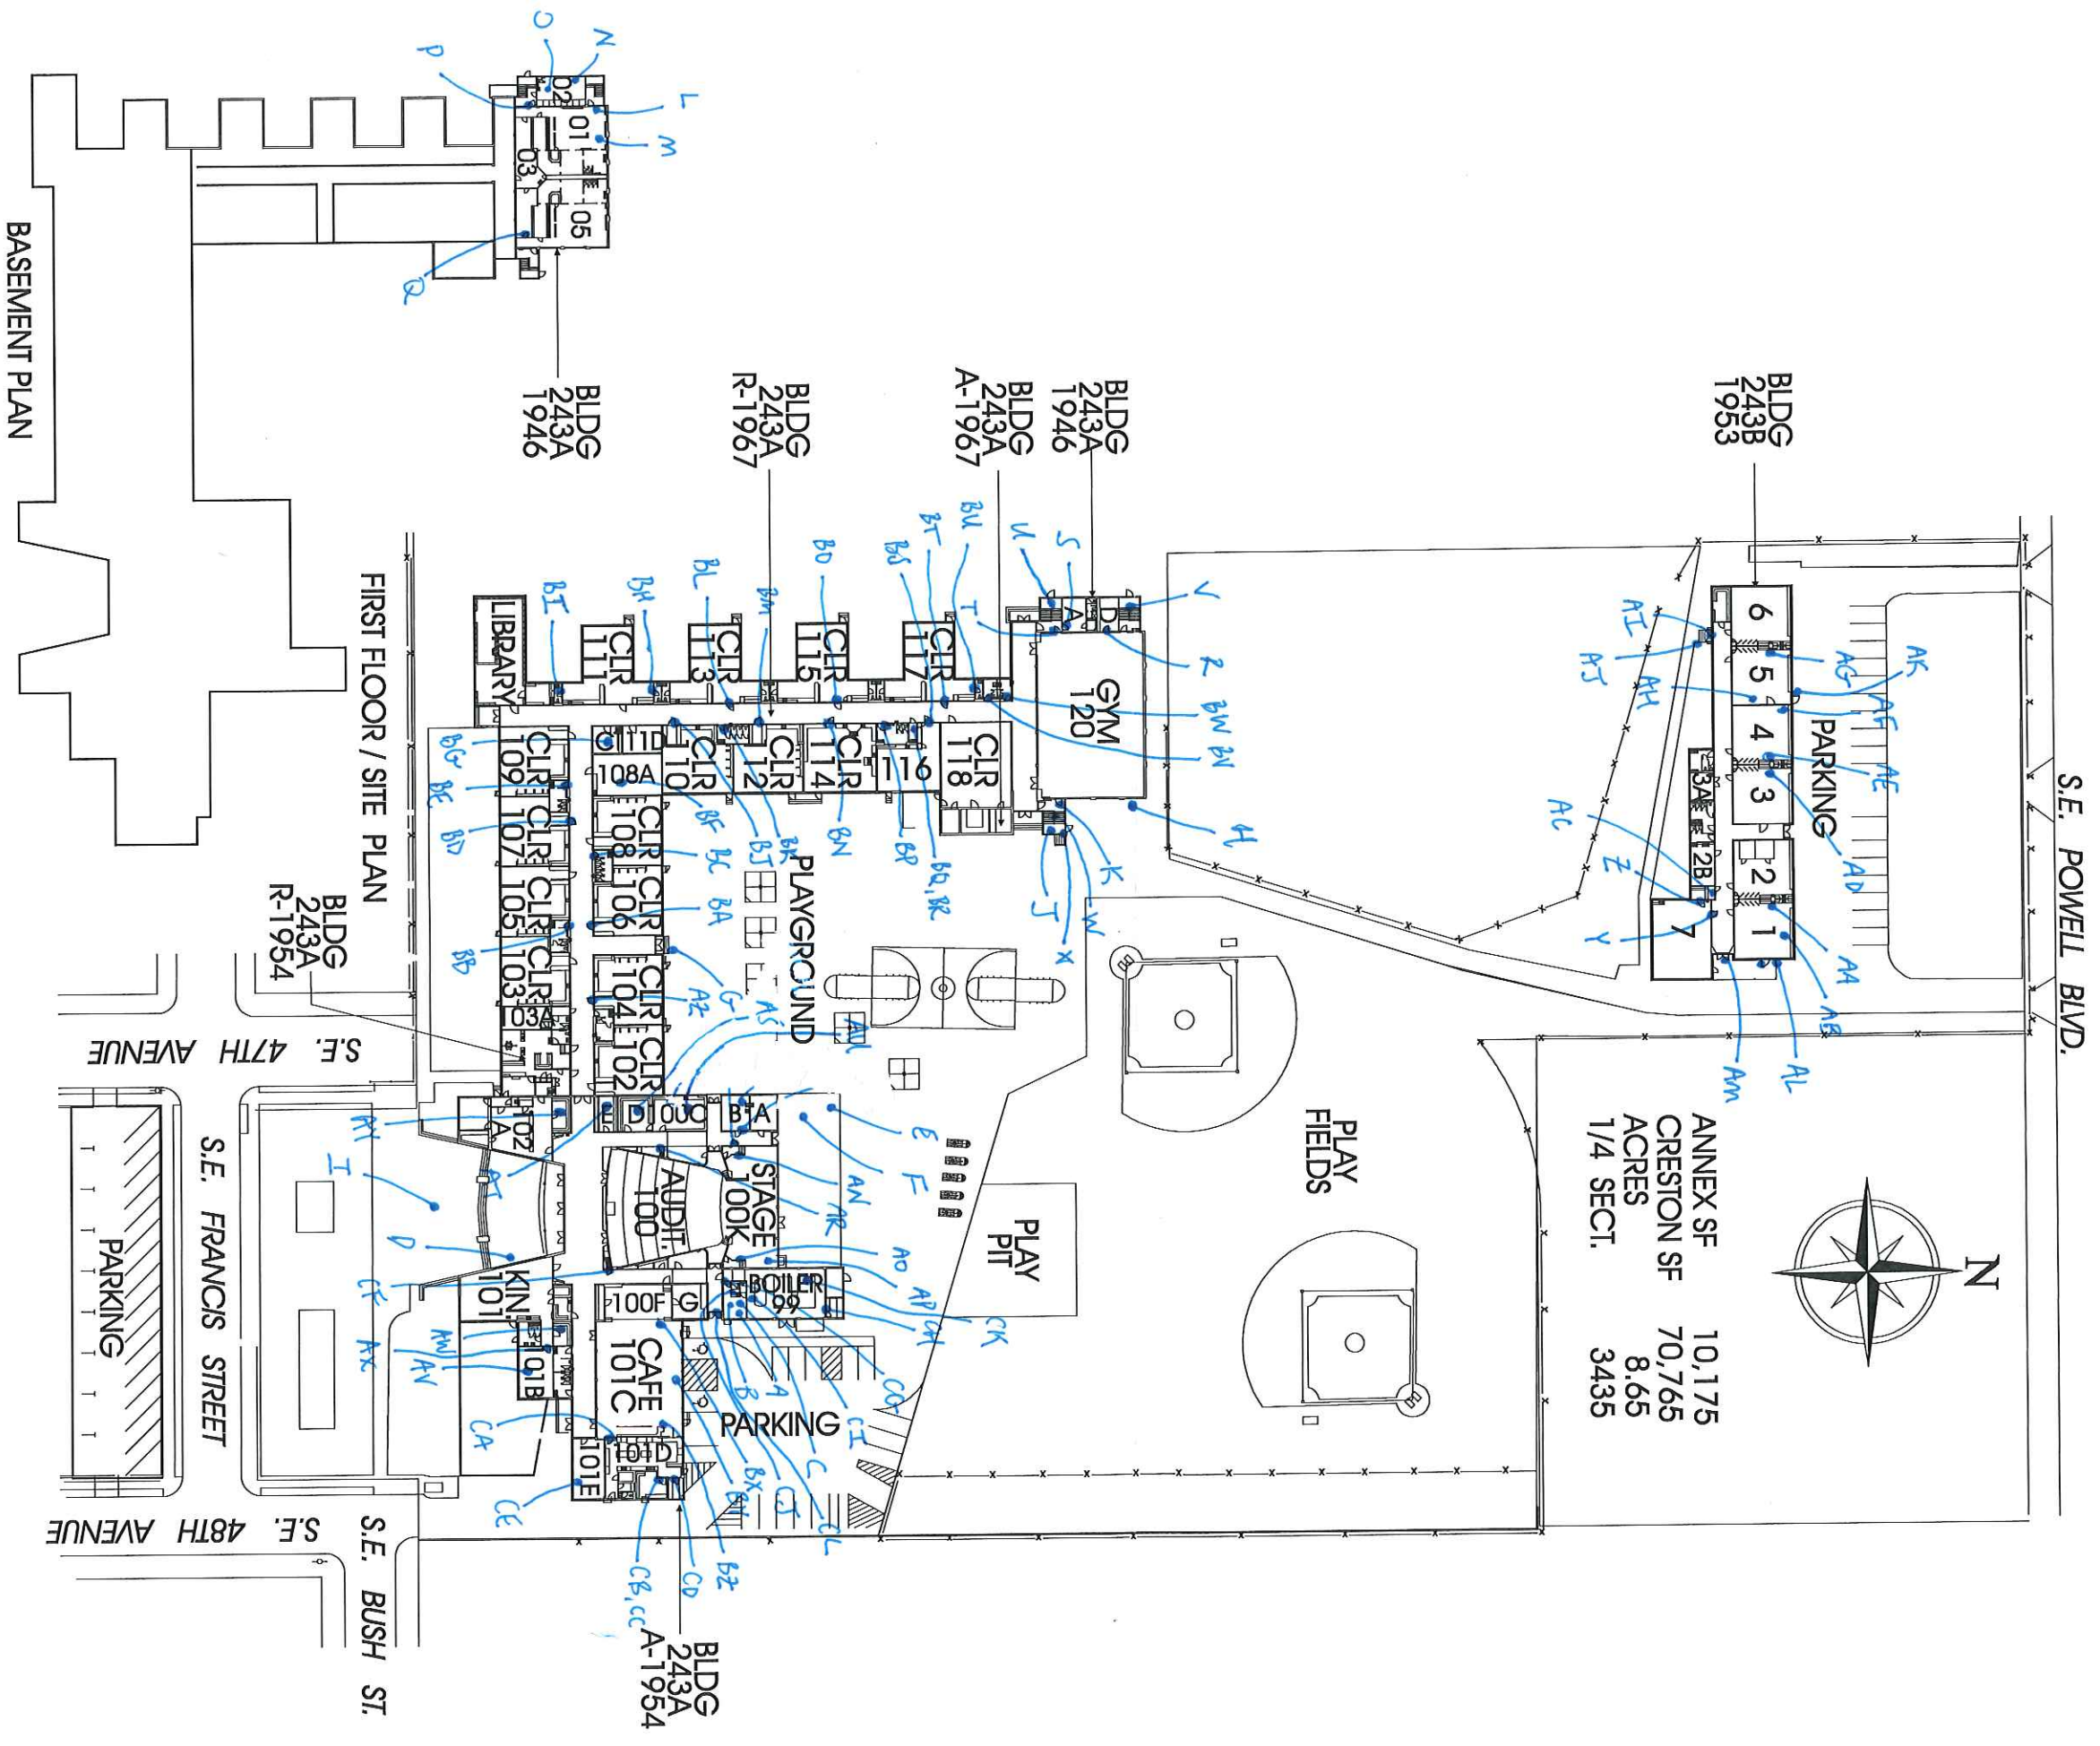
Overall, the building's painted and varnished surfaces were found to be in intact condition with areas of fair and deteriorated conditions. A table listing the locations and quantity of surfaces in deteriorated condition is attached to this report.

PBS recommends that all painted or varnished surfaces in deteriorated condition noted on the attached table be stabilized. Paint chips on the floor of the boiler room office should be removed.
