Regarding: Lead Paint Condition Assessment
Peninsula Elementary School
8125 N Emerald Avenue
Portland, Oregon 97217
PBS Project: 6500.721 Phase 0039

**Peninsula Elementary School
Assessment of Paint/Varnish in Deteriorated Condition**

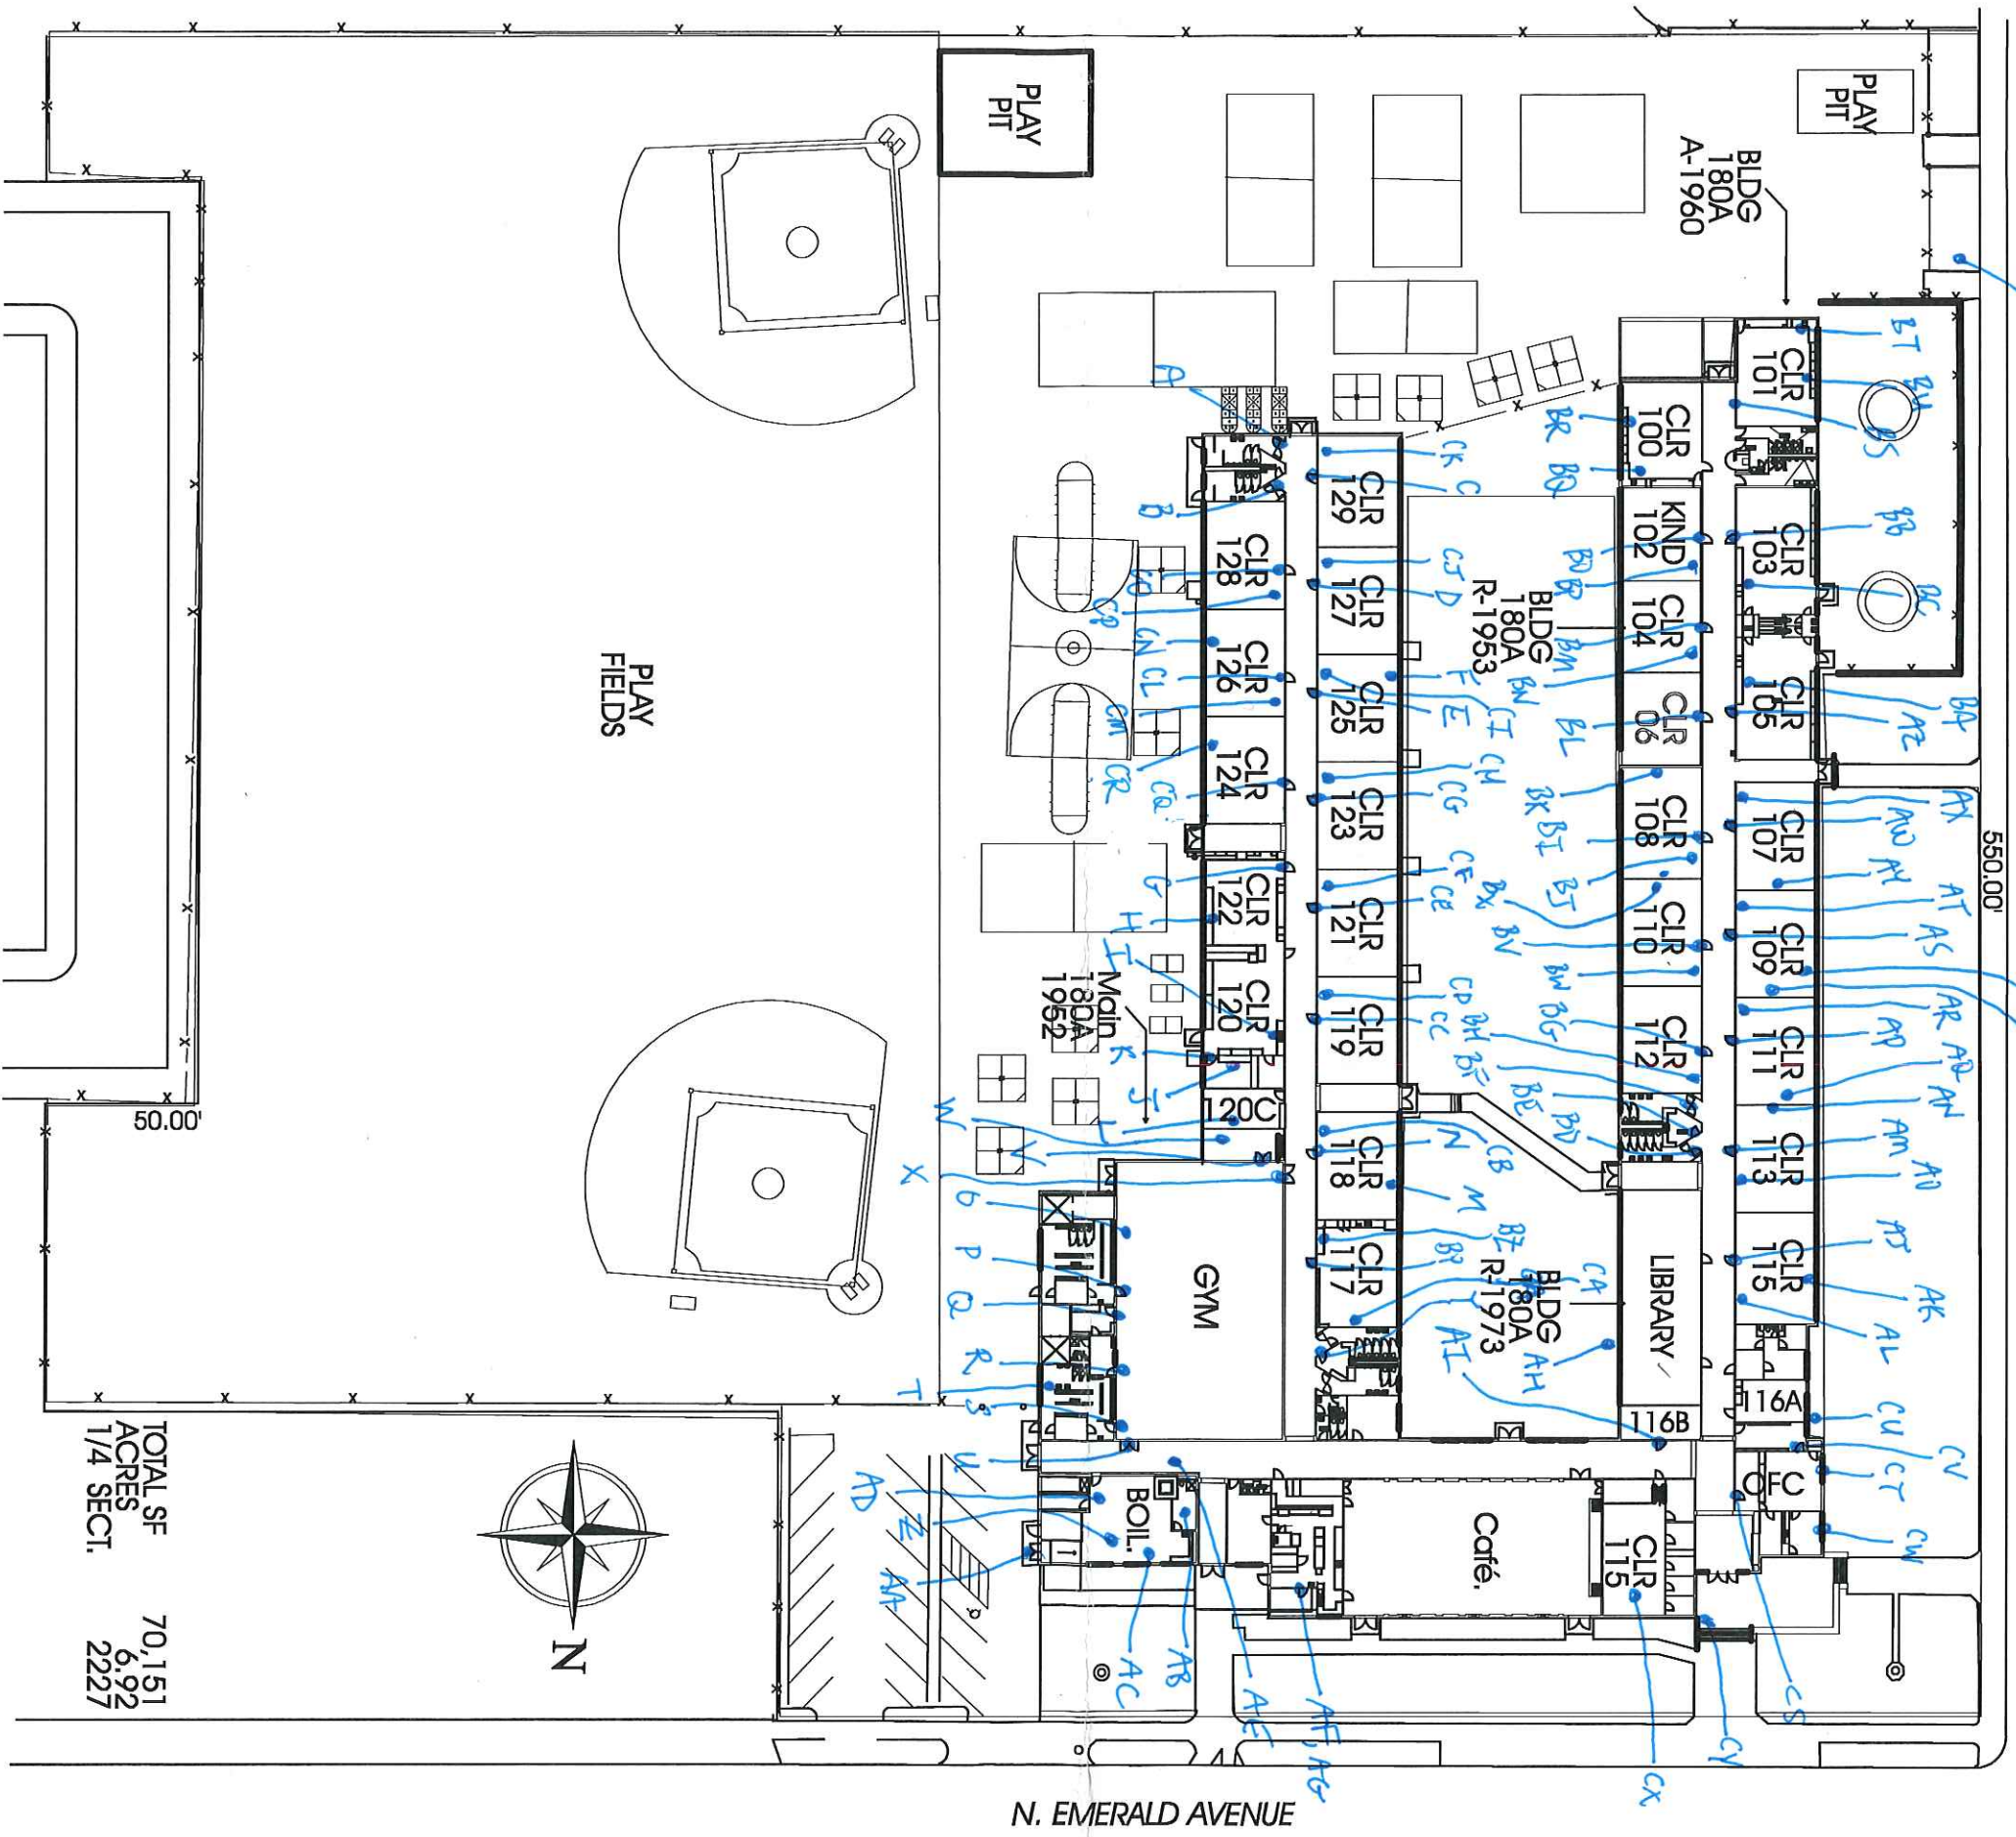
Peninsula Elementary School 8125 N Emerald 97217 Facility Plan

Overall, the building's painted and varnished surfaces were found to be in intact condition with areas of fair and deteriorated conditions. A table listing the locations and quantity of surfaces in deteriorated condition is attached to this report.

PBS recommends that all painted or varnished surfaces in deteriorated condition noted on the attached table be stabilized. All paint chips noted in this report should be removed. Window troughs should be cleaned.
