Regarding: Lead Paint Condition Assessment
King Elementary School
4906 NE 6th Avenue
Portland, Oregon 97211
PBS Project: 6500.721 Phase 0028

King Elementary School
Assessment of Paint/Varnish in Deteriorated Condition

King Elementary School 4906 NE 6th 97211 Facility Plan

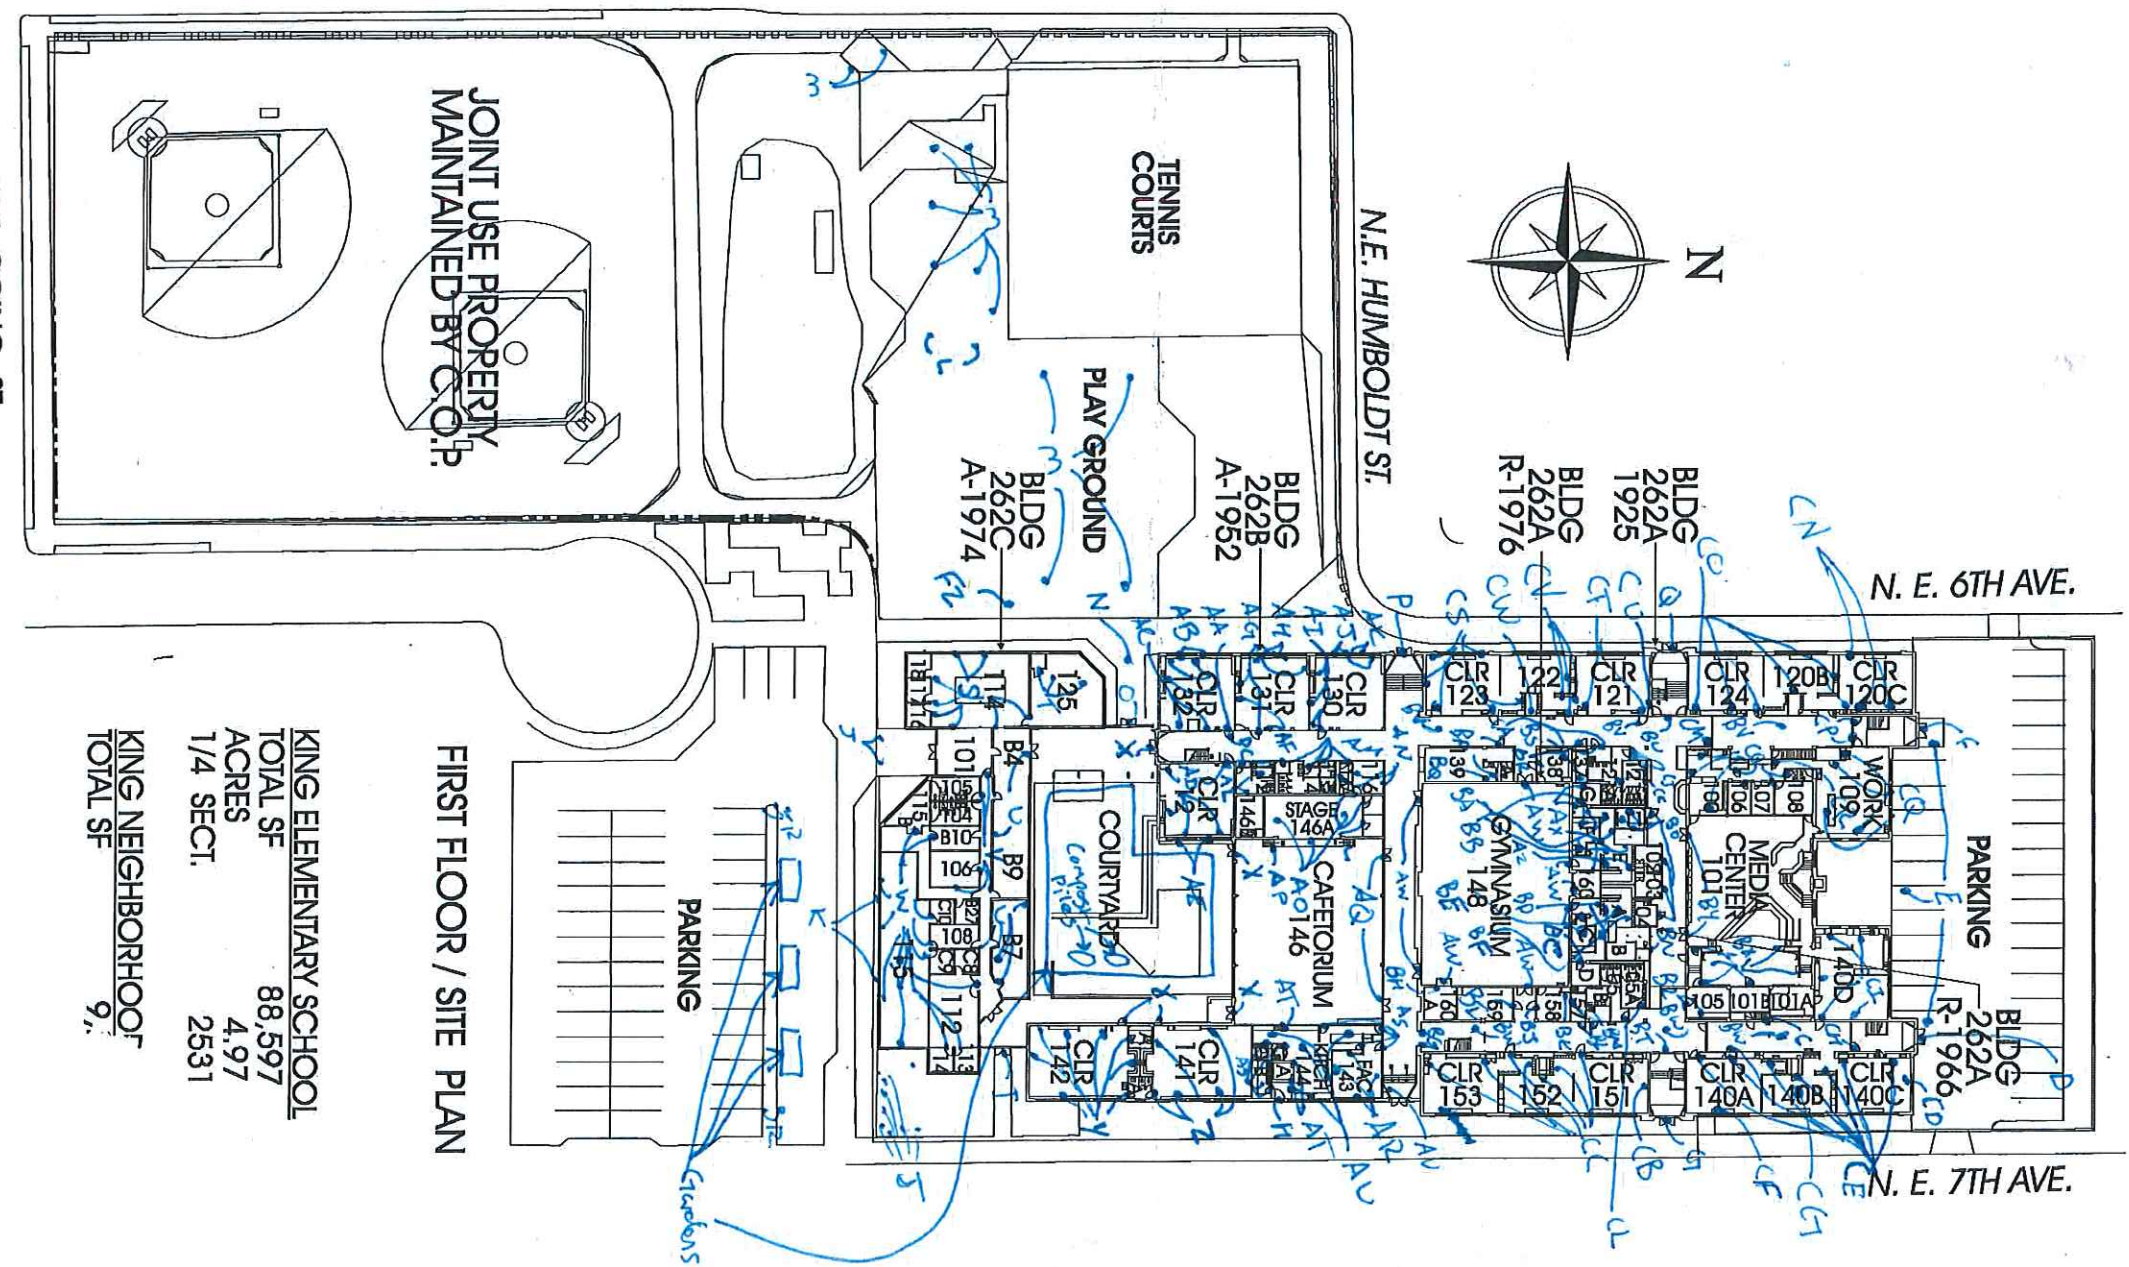
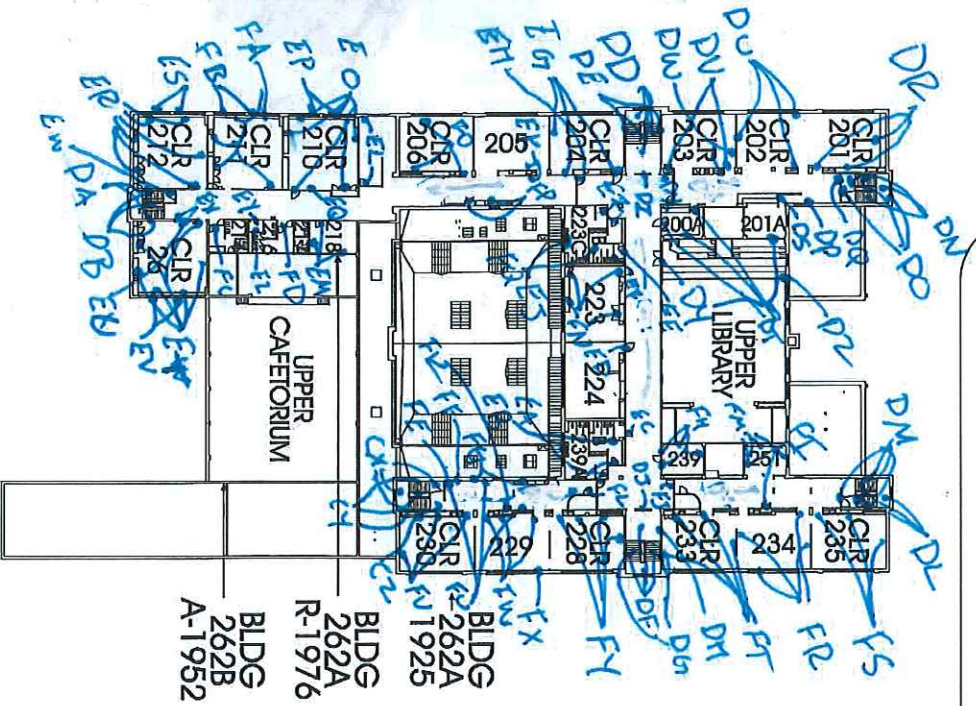
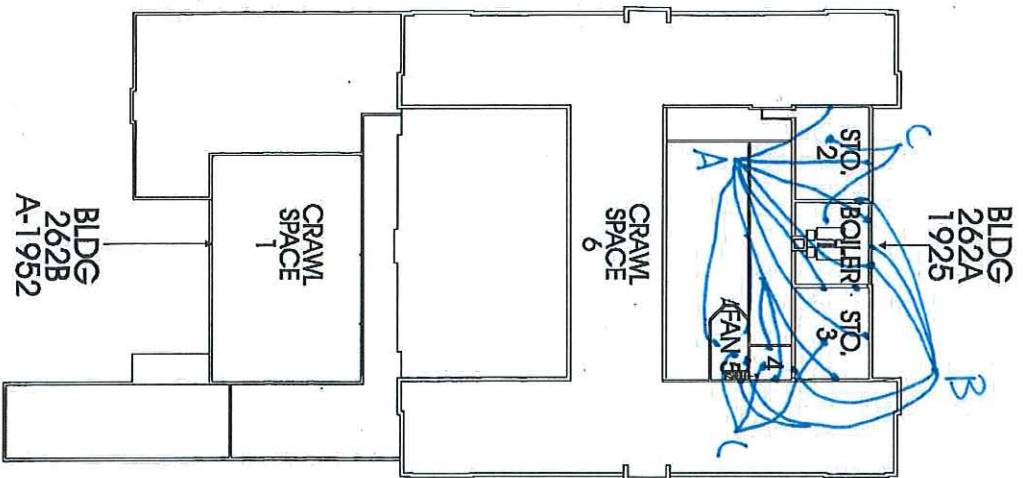
Overall, the building's painted and varnished surfaces were found to be in intact condition with areas of fair and deteriorated conditions. A table listing the locations and quantity of surfaces in deteriorated condition is attached to this report.

PBS recommends that all painted or varnished surfaces in deteriorated condition noted on the attached table be stabilized. All paint chips previously noted in this report should be removed.
