Regarding: Lead Paint Condition Assessment  
Metropolitan Learning Center  
2033 NW Glisan Street  
Portland, Oregon 97209  
PBS Project: 6500.721 Phase 0037

**Metropolitan  
Assessment of Paint/Varnish in Deteriorated Condition**

# Metropolitan Learning Center 2033 N W Glisan Street 97209 Facility Plan

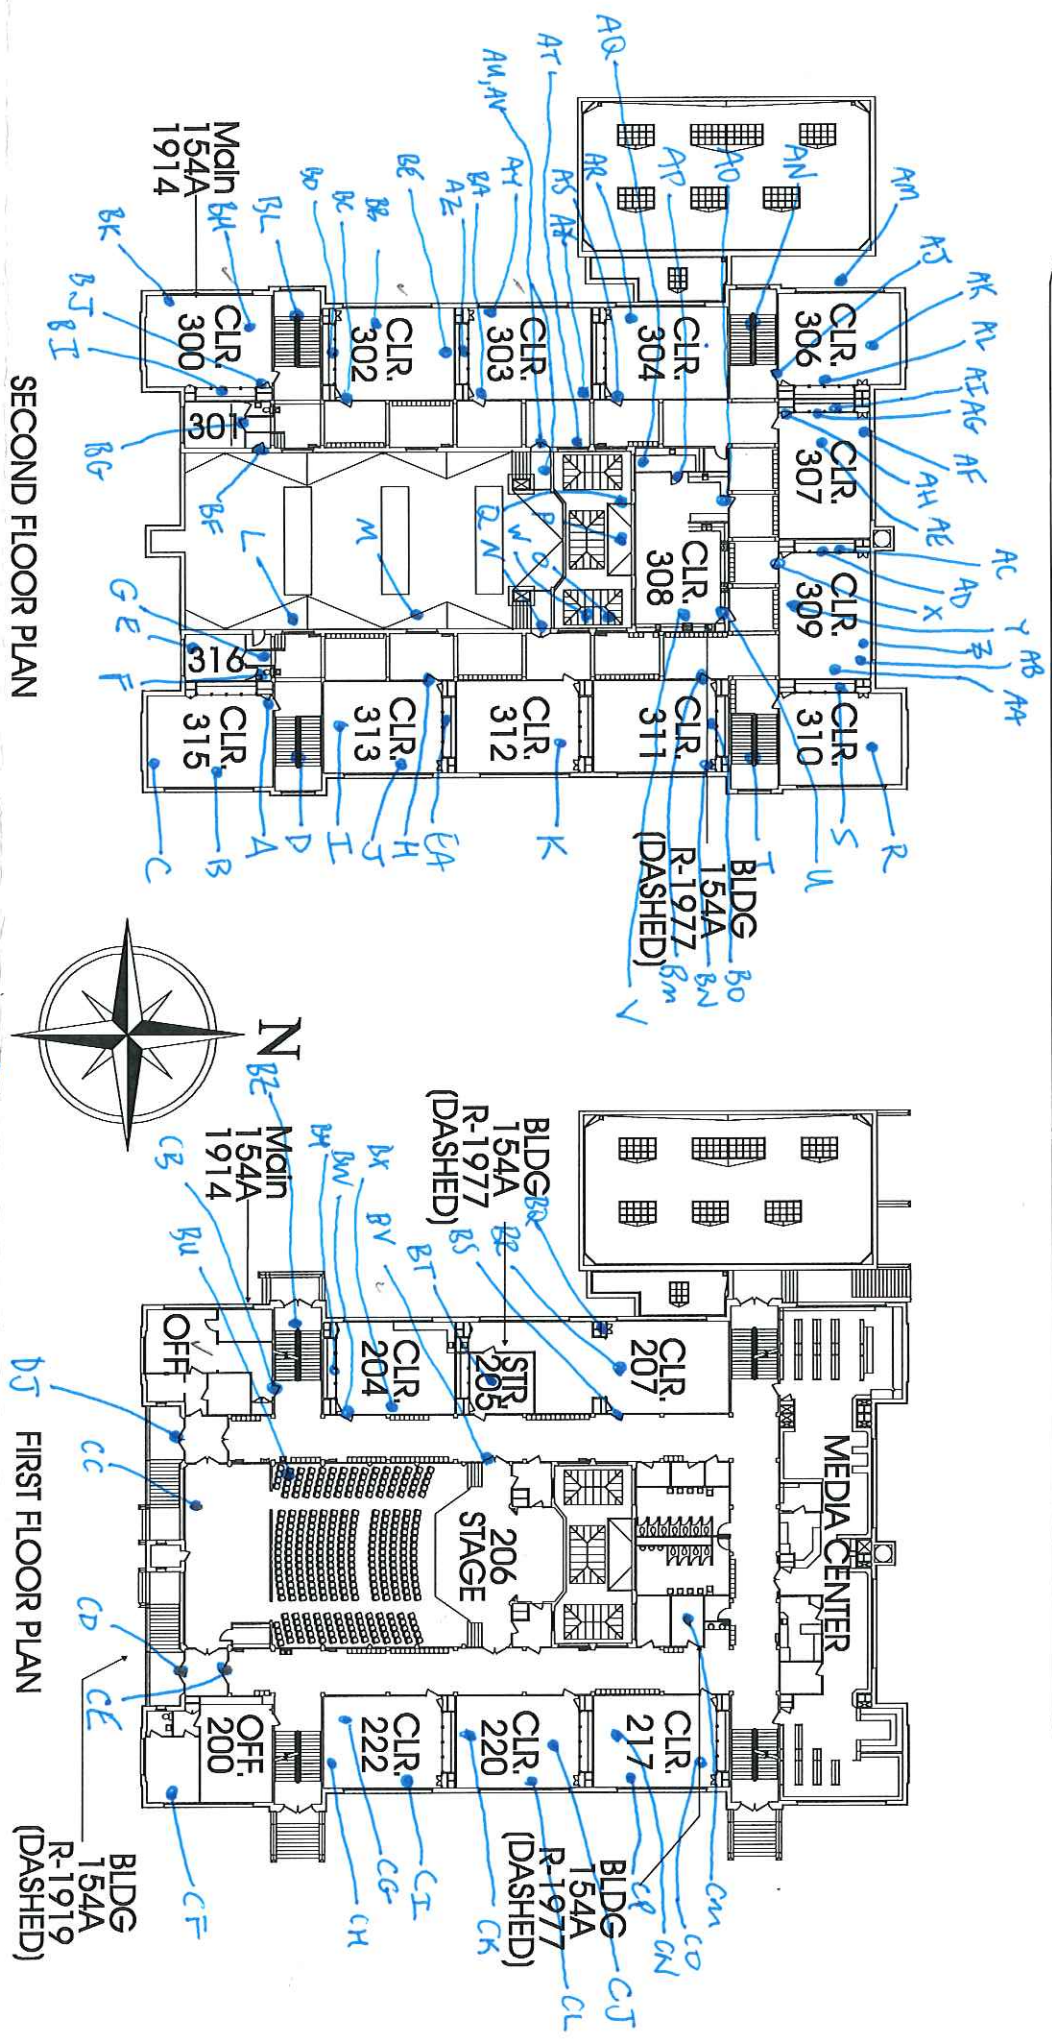
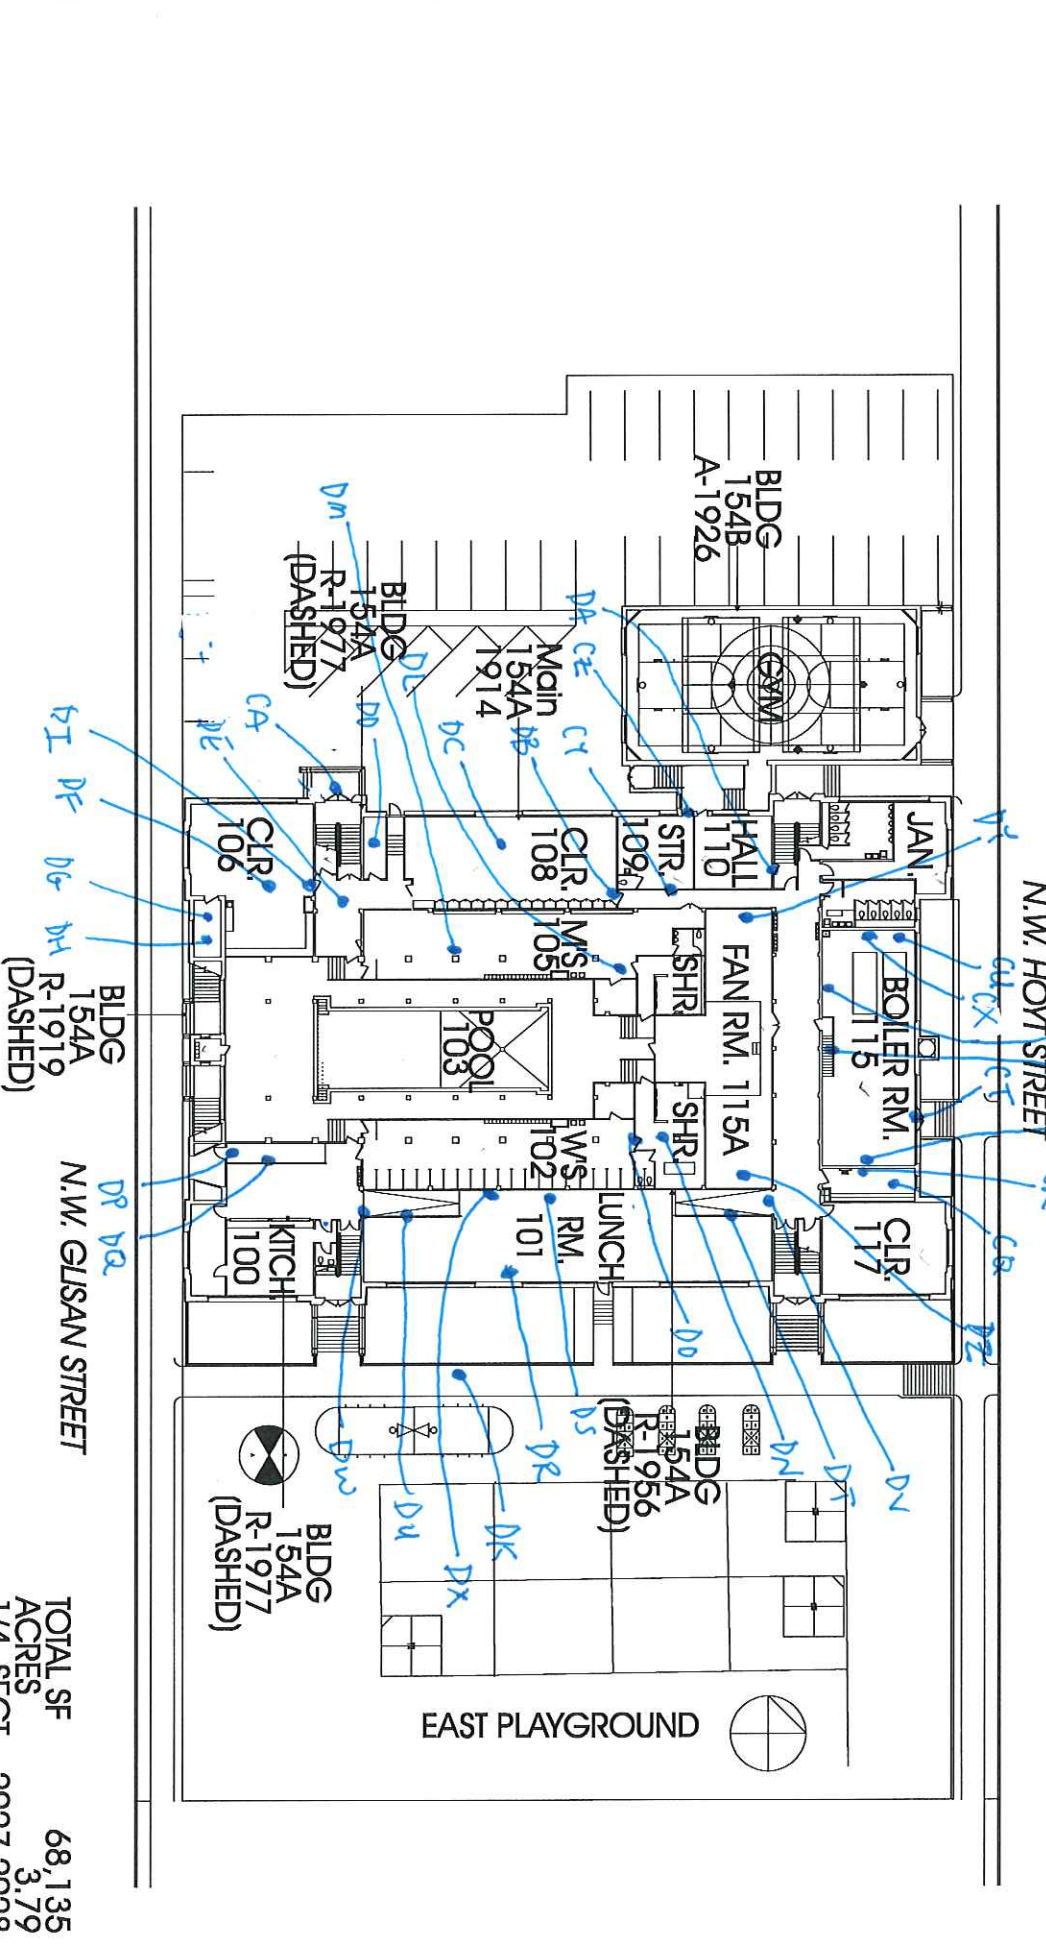
Overall, the building's painted and varnished surfaces were found to be in intact condition with areas of fair and deteriorated conditions. A table listing the locations and quantity of surfaces in deteriorated condition is attached to this report.

PBS recommends that all painted or varnished surfaces in deteriorated condition noted on the attached table be stabilized.
