Regarding: Lead Paint Condition Assessment  
Odyssey at East Sylvan Elementary School  
1849 SW 58th Avenue  
Portland, Oregon 97221  
PBS Project: 6500.721 Phase 0038

**Odyssey at East Sylvan Elementary School  
Assessment of Paint/Varnish in Deteriorated Condition**

East Sylvan Elementary School - 1849 SW 58th Ave - 97221  
**FACILITY PLAN**

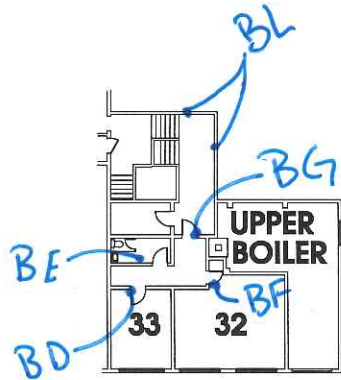
**SITE PLAN**

Paint chips were also observed in soil on the east and west sides of the school and next to the baseball field bleachers.

PBS recommends that all painted or varnished surfaces in deteriorated condition noted on the attached table be stabilized. All paint chips noted in this report should be removed. Window troughs should be cleaned.
