Regarding: Lead Paint Condition Assessment
Glencoe Elementary School
825 SE 51st Avenue
Portland, Oregon 97215
PBS Project: 6500.721, Phase 0022

Glencoe Elementary School 825 SE 51st Street Facility Plan

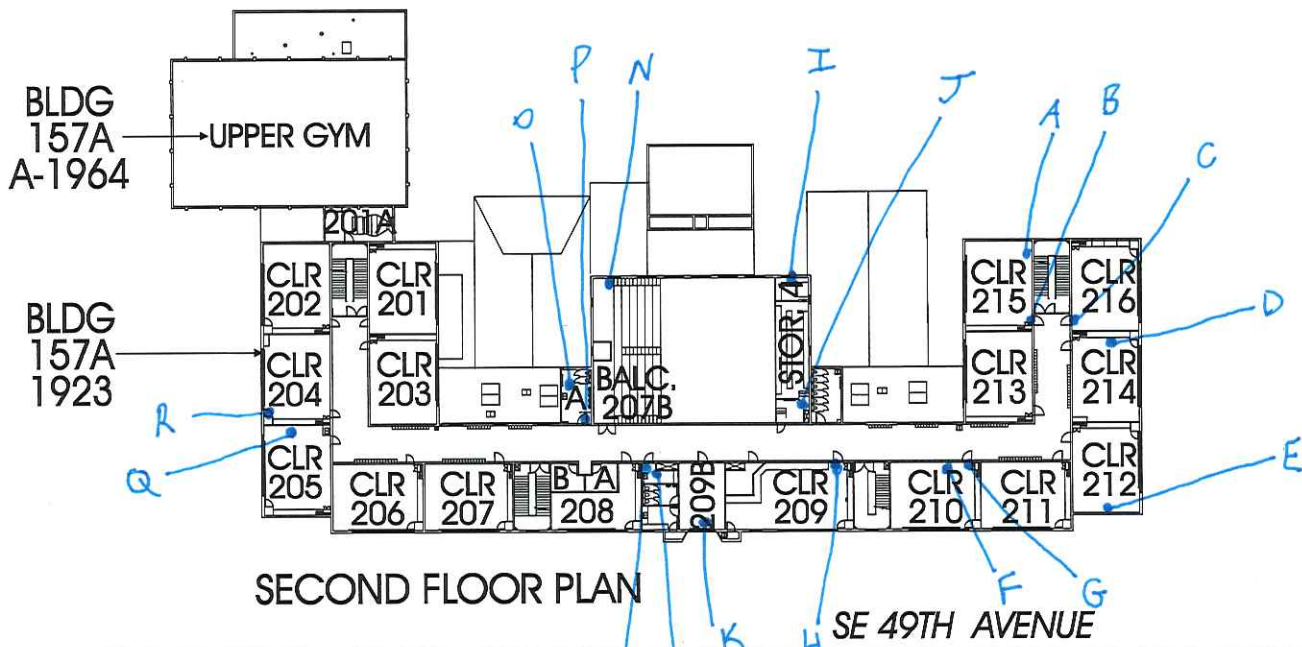
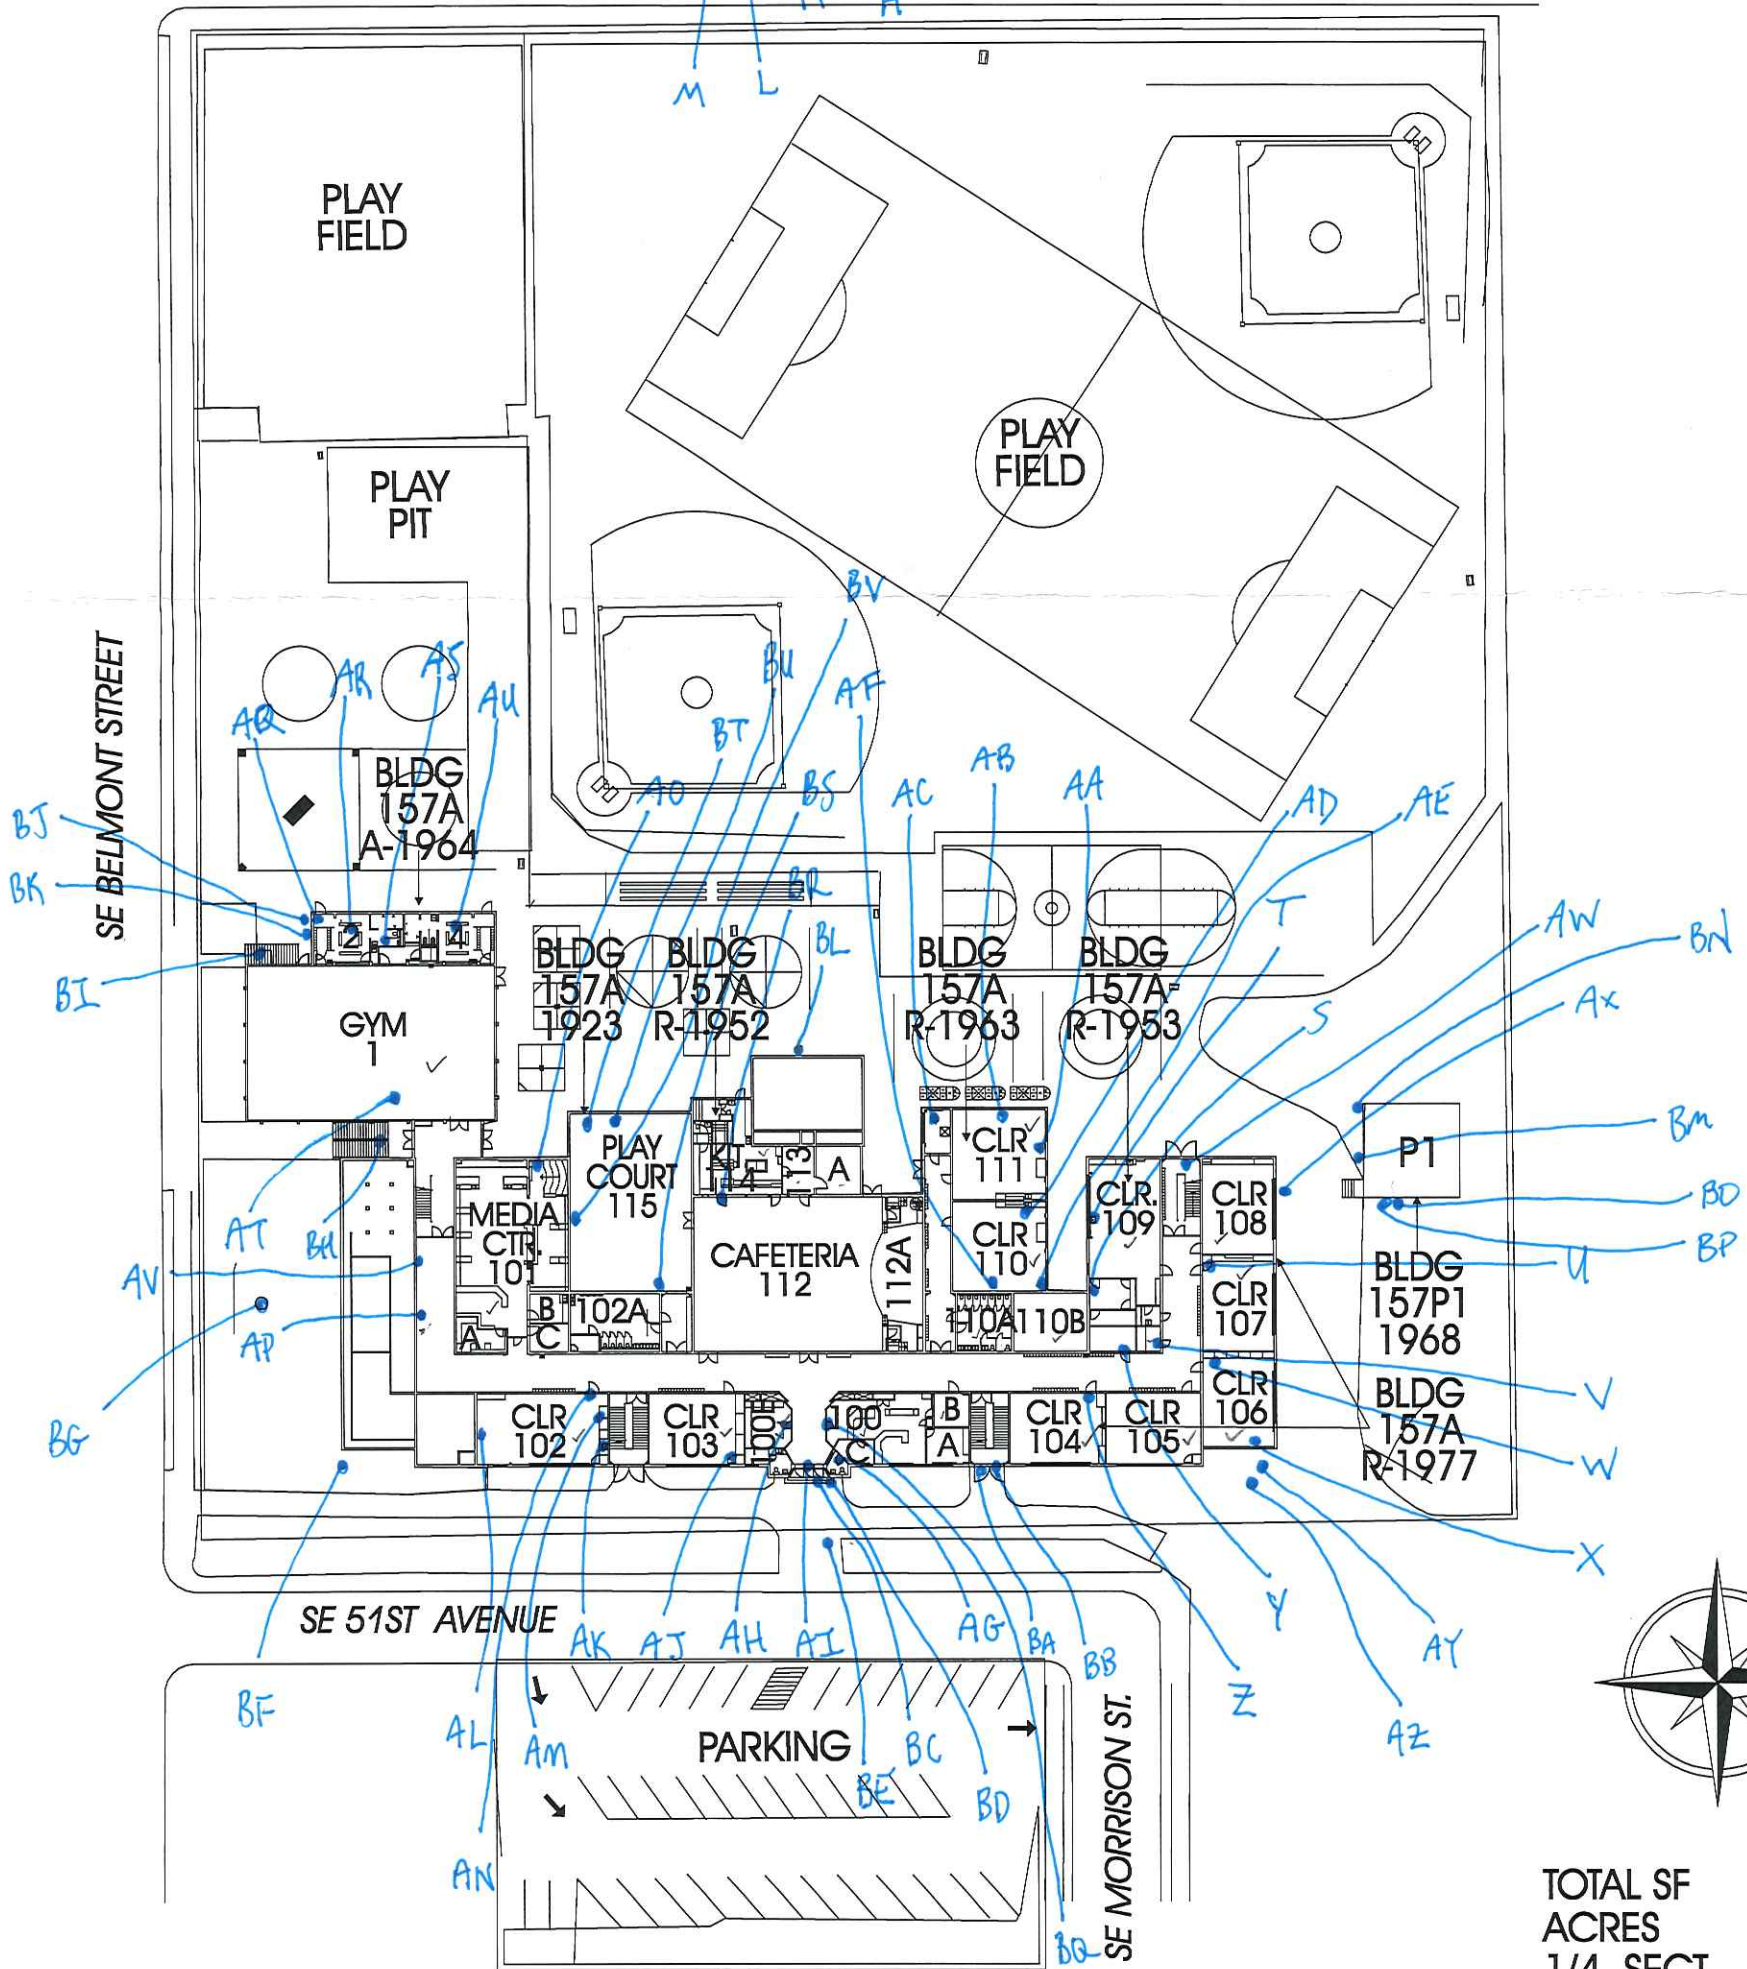
Overall, the building's painted and varnished surfaces were found to be in intact condition with areas of fair and deteriorated conditions. A table listing the locations and quantity of surfaces in deteriorated condition is attached to this report.

Paint chips were observed on soil on the exterior of the portable, near deteriorated [paint] conditions.

PBS recommends that all painted or varnished surfaces in deteriorated condition noted on the attached table be stabilized. Paint chips on the soil on the exterior of the portable should be removed.
