Regarding: Lead Paint Condition Assessment
Chapman Elementary School
1445 NW 26th Avenue
Portland, Oregon 97201
PBS Project: 6500.721 Phase 0016

**Chapman Elementary School
Assessment of Paint/Varnish in Deteriorated Condition**

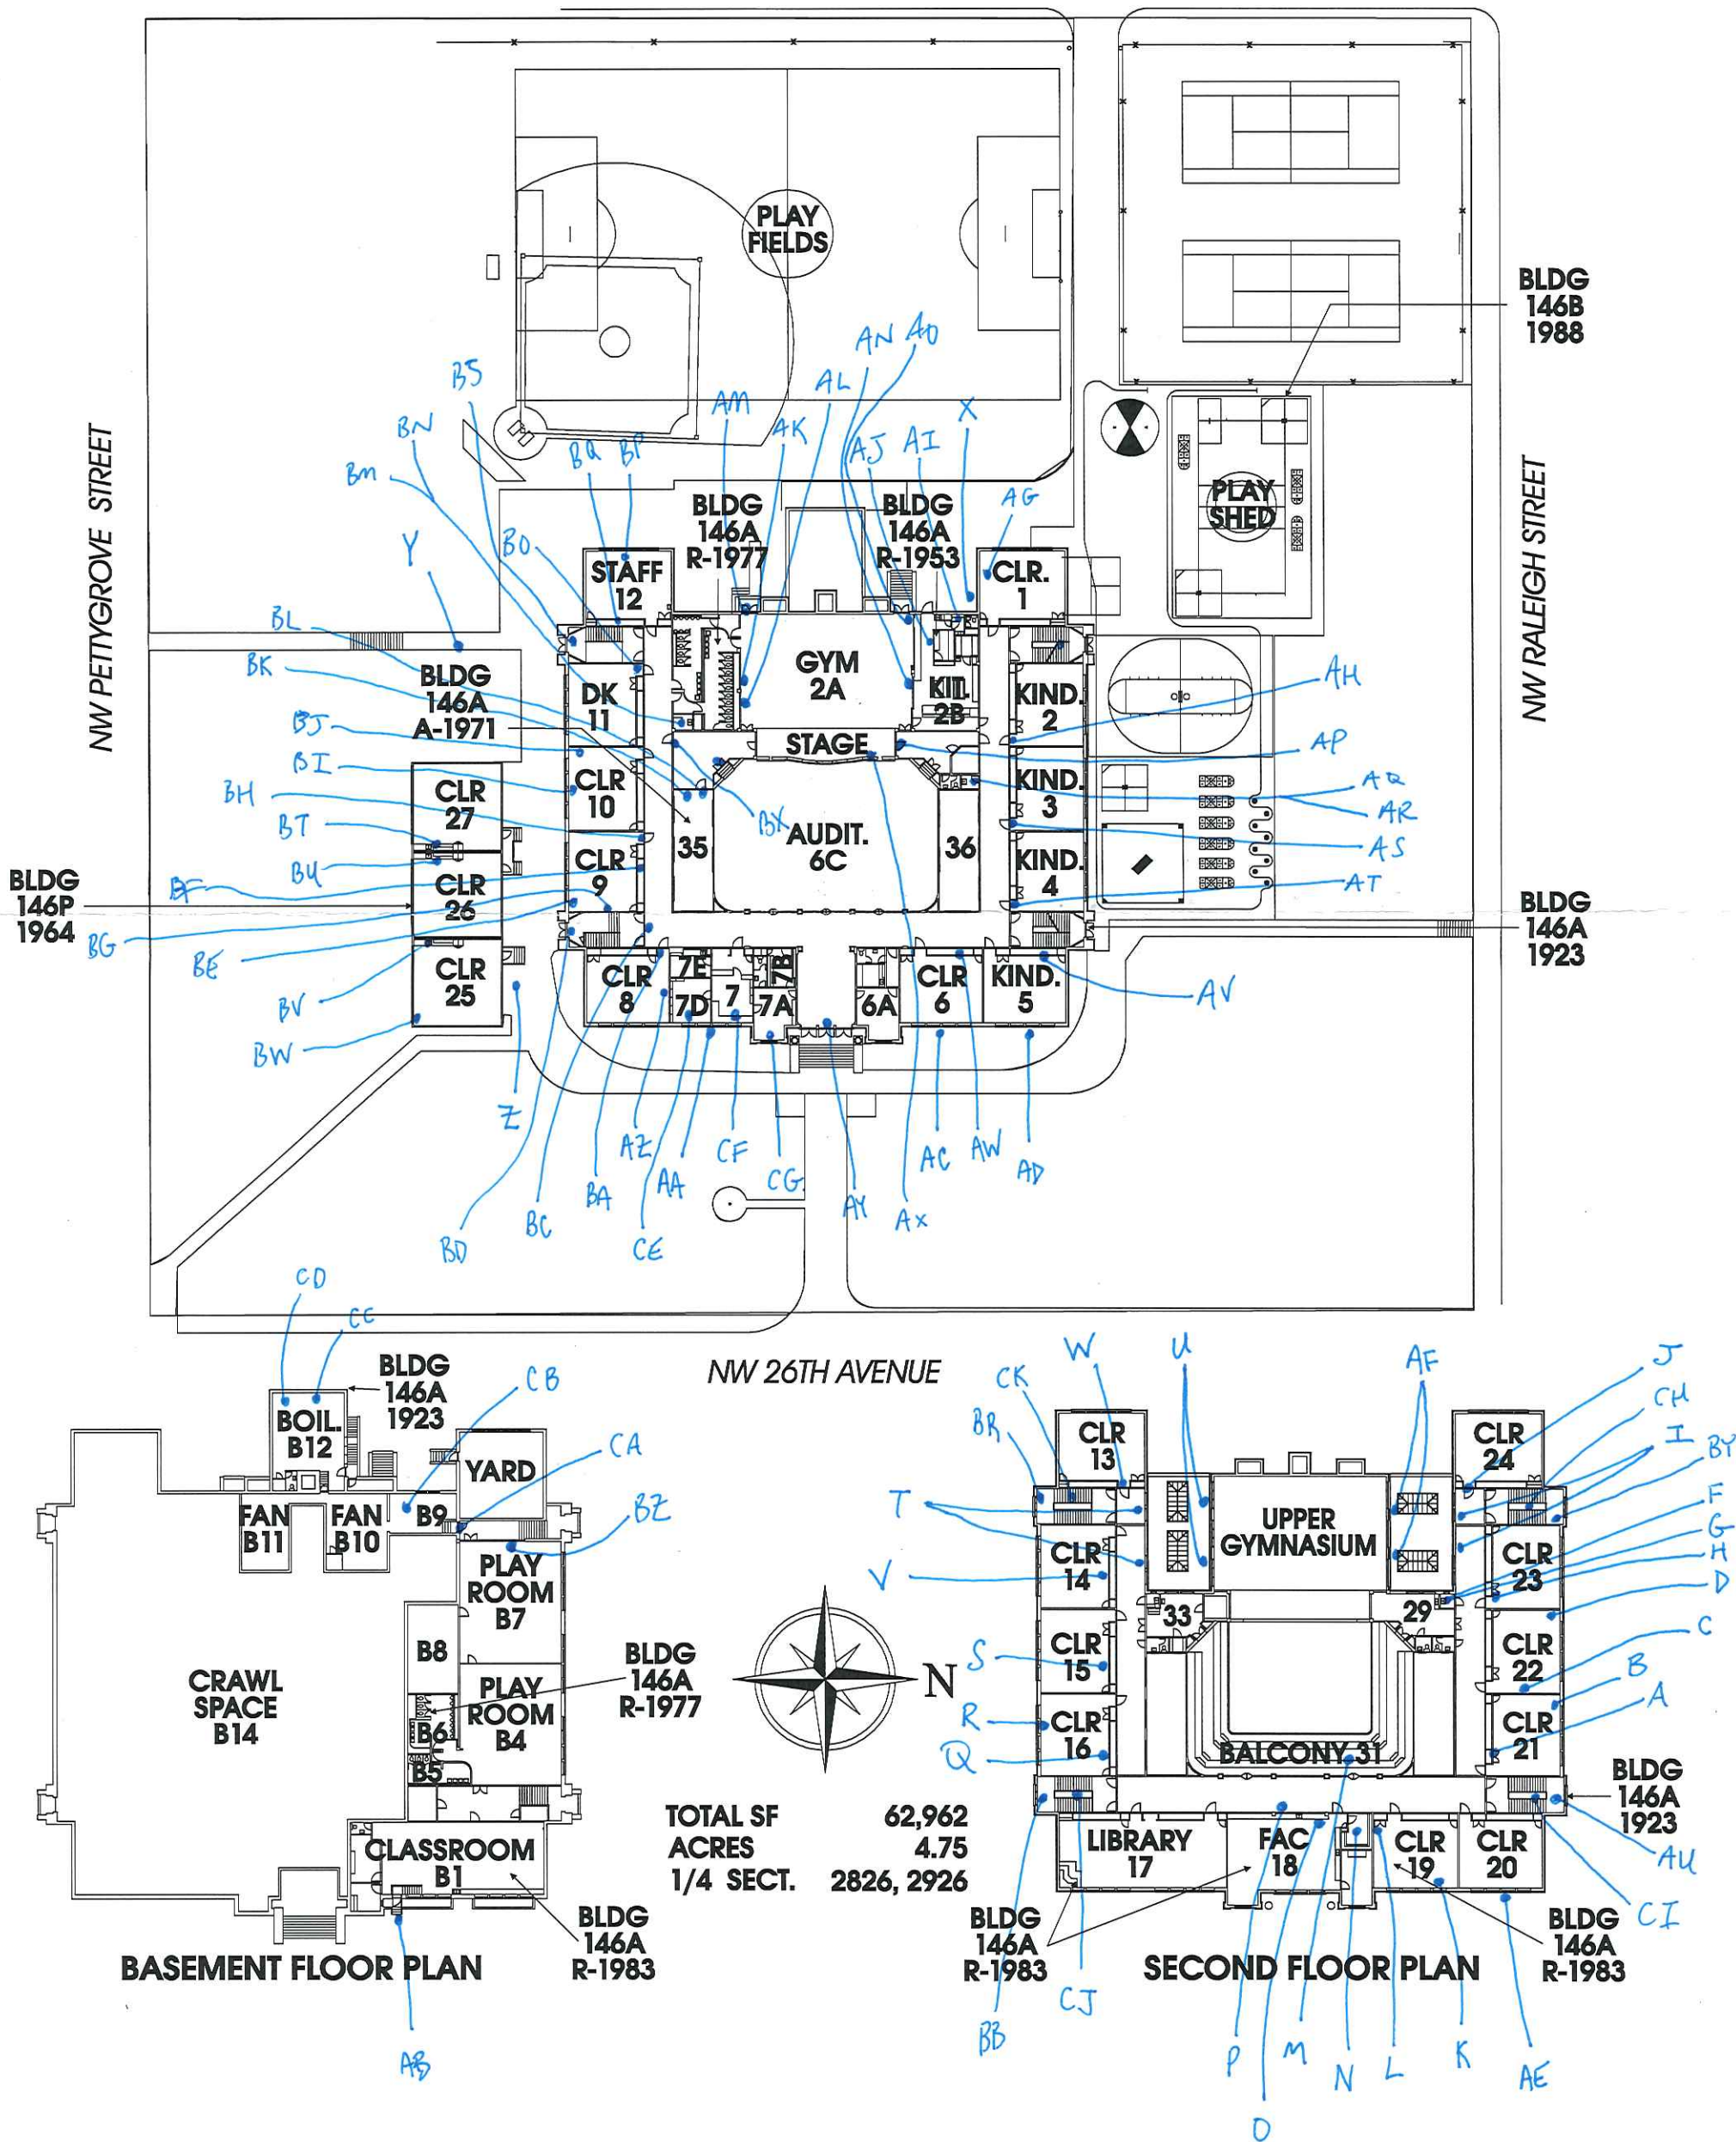
Chapman Elementary School 1445 NW 26th Street 97210 Facility Plan

ID	Interior / Exterior	Location	Structure	Above / Below five feet	K-2nd Grade	Substrate	Quantity
A	Interior	Classroom 21	Built-in shelves at entrance	Below	No	Wood	20
B	Interior	Classroom 21	Built-in shelves at windows	Below	No	Wood	40
C	Interior	Classroom 22	East wall	Below	No	Plaster	75
D	Interior	Classroom 22	Built-in cabinets and trim under sink	Below	No	Wood	20
E	Interior	Classroom 23B	Radiator	Below	No	Metal	10
F	Interior	Janitor closet across from Classroom 23	Doorframe	Above and below	No	Wood	15
G	Interior	Janitor closet across from Classroom 23	Floor	Below	No	Concrete	30
H	Interior	Classroom 23	Built-in shelves at entrance	Above and below	No	Wood	30
I	Interior	Hallway	Windowsills between Classroom 23 and 24	Below	No	Wood	25
J	Interior	Classroom 24	Door frame	Above and below	No	Wood	15
K	Interior	Classroom 19	Built-in shelves at windows	Below	No	Wood	40
L	Interior	Southwest corner of Classroom 19	Wall	Above and below	No	Plaster	15

M	Interior	Balcony 31	Floor	Below	No	Concrete	2000
N	Interior	Room 18A	Built-in cabinets	Above and below	No	Wood	200
O	Interior	Facility 18	Wall near entrance	Below	No	Plaster	20
P	Interior	Hallway outside of room 18	Lockers on east side of hallway	Above and below	No	Metal	120
Q	Interior	Classroom 16	Built-in cabinets and trim under sink	Above and below	No	Wood	20
R	Interior	Classroom 16	Built-in cabinets at window	Above and below	No	Wood	40
S	Interior	Classroom 15	Built-in cabinets and trim under sink	Above and below	No	Wood	20
T	Interior	Hallway between Classroom 15 and Classroom 14	Windowsills	Above and below	No	Wood	25
U	Exterior	Outside upper gymnasium on south wall	Window frames	Above and below	No	Wood	180
V	Interior	Classroom 14	Trim above dry erase	Above	No	Wood	20
W	Interior	Classroom 13	Door and frame	Above and below	No	Wood	60

ID	Interior / Exterior	Location	Structure	Above / Below five feet	K-2nd Grade	Substrate	Quantity
X	Exterior	Outside south exterior wall of Classroom 1	Wall	Above and below	No	Metal	200
Y	Exterior	Handrails by garden	Handrails	Below	No	Metal	80
Z	Exterior	Classroom 25	Nike racks	Below	No	Metal	30
AA	Exterior	Classroom 7	Window frames	Above	No	Wood	160
AB	Exterior	Steps down to Classroom B1	Handrails	Below	No	Metal	20
AC	Exterior	Classroom 6	Window frames	Above	No	Wood	160
AD	Exterior	Kindergarten 5	Window frames	Above	No	Wood	160
AE	Exterior	Classroom 20	Window frames	Above	No	Wood	160
AF	Exterior	Upper gymnasium on north wall	Window frames	Above and below	No	Wood	180
AG	Interior	Classroom 1	Trim above built-in board, south wall	Above	No	Wood	2
AH	Interior	Kindergarten 2	Doorframe	Above and below	Yes	Wood	15
AI	Interior	Kitchen	Wall behind lockers	Below	No	Plaster	15
AJ	Interior	Kitchen	Wall next to dry storage	Above and below	No	Plaster	30

AK	Interior	Gym	Walls next to restroom entrances	Above and below	No	Plaster	25
AL	Interior	Gym	South wall under windows	Above	No	Concrete	20
AM	Interior	Gym	Door, exit in southwest corner	Above and below	No	Wood	40
AN	Interior	Gym	North wall	Below	No	Plaster	20
AO	Interior	Gym	Wall, northwest corner	Above	No	Concrete	100
AP	Interior	North entry to stage	Door and frame	Above and below	No	Wood	60
AQ	Interior	Janitor closet across from Classroom 3	Floor	Below	No	Concrete	35
AR	Interior	Janitor closet across from Classroom 3	Wall	Above and below	No	Plaster	120
AS	Interior	Kindergarten 3	Doorframe	Above and below	Yes	Wood	15
AT	Interior	Kindergarten 4	Doorframe	Above and below	Yes	Wood	15
AU	Interior	Stairwell landing, northeast	Window frames	Above and below	No	Wood	80

ID	Interior / Exterior	Location	Structure	Above / Below five feet	K-2nd Grade	Substrate	Quantity
AV	Interior	Kindergarten 5	Built-in cabinets and trim under sink	Below	Yes	Wood	15
AW	Interior	Classroom 6	Built-in cabinets and trim under sink	Below	No	Wood	15
AX	Interior	Auditorium stage	Trim at edge of stage	Below	No	Wood	60
AY	Interior	Main entryway	Middle door	Above and below	No	Wood	45
AZ	Interior	Classroom 8	Trim on doorways leading to stairs	Above	No	Wood	20
BA	Interior	Classroom 8	Door and trim	Above and below	No	Wood	60
BB	Interior	Stairwell landing, southeast	Window frames	Above and below	No	Wood	80
BC	Interior	Hallway outside of Classroom 8	Trim on doorways leading to stairs	Above and below	No	Wood	30
BD	Interior	Hallway, southeast entrance to building	Door	Above and below	No	Wood	45
BE	Interior	Classroom 9	South wall, trim along ceiling	Above	Yes	Wood	20
BF	Interior	Classroom 9	Built-in cabinets under sink	Below	Yes	Wood	20

BG	Interior	Classroom 9	East wall under built-in boards	Below	Yes	Plaster	30
BH	Interior	Classroom 9	Doorframe	Above and below	Yes	Wood	15
BI	Interior	Classroom 10	Wall behind radiator	Below	Yes	Plaster	40
BJ	Interior	Classroom 10	Built-in cabinets and trim under sink	Below	Yes	Wood	20
BK	Interior	Room 35	West wall under window	Below	No	Concrete	15
BL	Interior	Room 35	Door and frame	Above and below	No	Wood	70
BM	Interior	Janitor closet across from Classroom 11	Floor	Below	No	Concrete	35
BN	Interior	Janitor closet across from Classroom 11	Wall	Above and below	No	Plaster	120
BO	Interior	Classroom 11	Wall northwest corner	Above and below	Yes	Plaster	30
BP	Interior	Classroom 12	Wall behind radiator	Below	Yes	Plaster	N/A
BQ	Interior	Classroom 12	Built-in cabinets and trim under sink	Below	Yes	Wood	20
BR	Interior	Stairwell landing southwest	Window frames	Above	No	Wood	N/A
BS	Interior	Southwest building entrance	Doors	Above and below	No	Wood	90

ID	Interior / Exterior	Location	Structure	Above / Below five feet	K-2nd Grade	Substrate	Quantity
BT	Interior	Classroom 27	Built-in cabinets and trim under sink	Below	No	Wood	40
BU	Interior	Classroom 26	Built-in cabinets and trim under sink	Below	No	Wood	40
BV	Interior	Classroom 25	South wall above windows	Above	No	Plaster	40
BW	Interior	Classroom 25	Built-in cabinets and trim under sink	Below	No	Wood	40
BX	Interior	Entrance to gym	Doorframe	Above and below	No	Wood	15
BY	Interior	Stairwell landing northwest	Window frames	Above and below	No	Wood	80
BZ	Interior	Playroom B7	West wall	Above	No	Plaster	10
CA	Interior	Room B9	Doorframe	Above and below	No	Wood	15
CB	Interior	Room B9	Floor	Below	No	Concrete	300
CC	Interior	Boiler room	Ceiling	Above	No	Wood	400
CD	Interior	Boiler room	Floor	Below	No	Concrete	400
CE	Interior	7D, nurse	Trim under sink cabinets	Below	No	Wood	10
CF	Interior	7, office	Windowsills	Below	No	Wood	15

CG	Interior	7A, principal	Windowsills	Below	No	Wood	15
CH	Interior	Northwest stairwell	Handrails	Below	No	Wood	100
CI	Interior	Northeast stairwell	Handrails	Below	No	Wood	100
CJ	Interior	Southeast stairwell	Handrails	Below	No	Wood	100
CK	Interior	Southwest stairwell	Handrails	Below	No	Wood	100

PBS recommends that all painted or varnished surfaces in deteriorated condition noted on the attached table be stabilized.
