Regarding: Lead Paint Condition Assessment  
Grout Elementary School  
3119 SE Holgate Boulevard  
Portland, Oregon 97202  
PBS Project: 6500.721 Phase 0023

**Grout Elementary School**  
**Assessment of Paint/Varnish in Deteriorated Condition**

# Grout Elementary School 3119 SE Holgate Blvd. 97202 Facility Plan

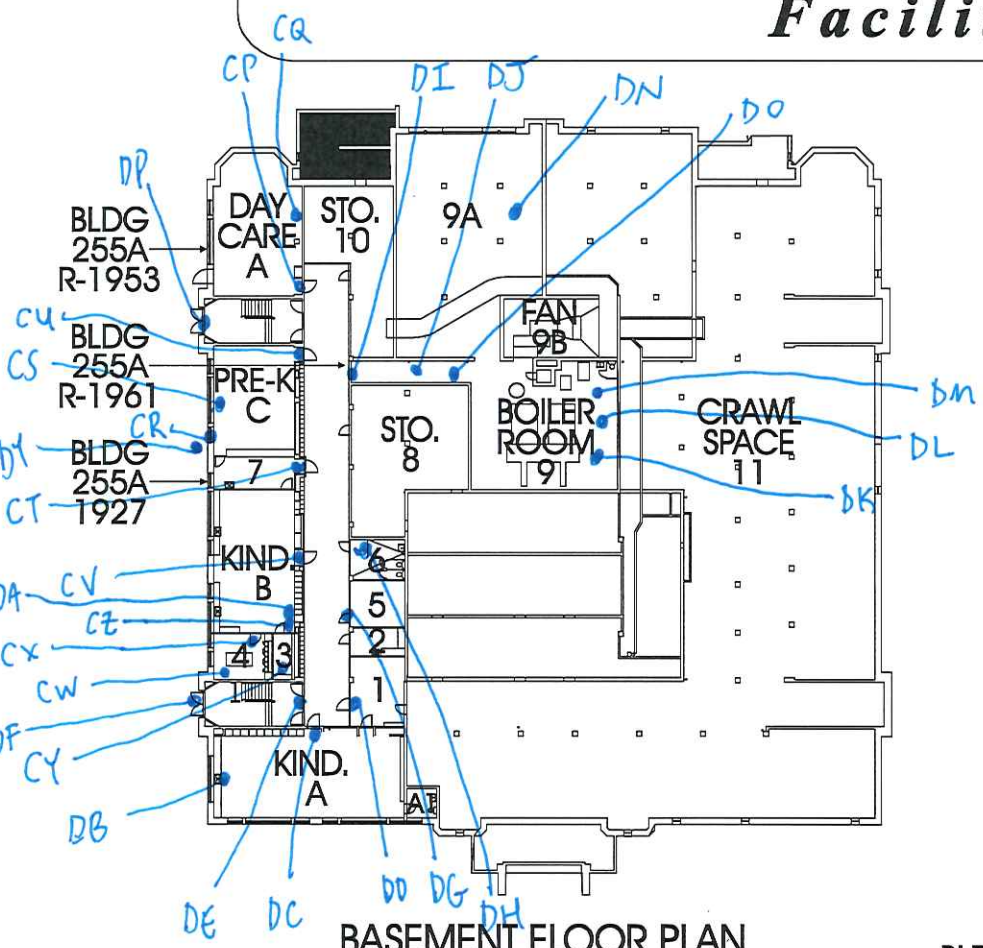
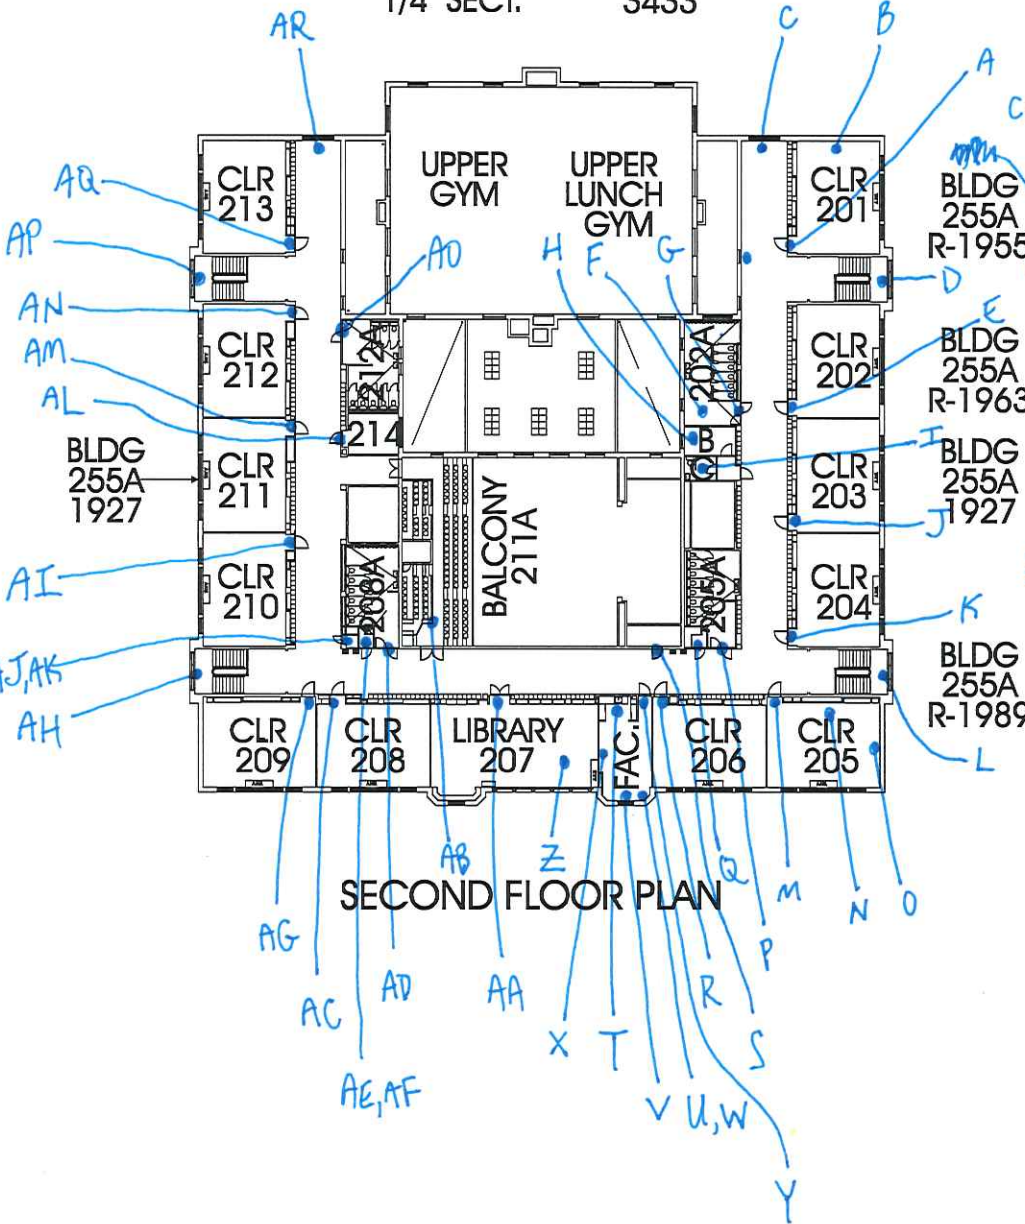
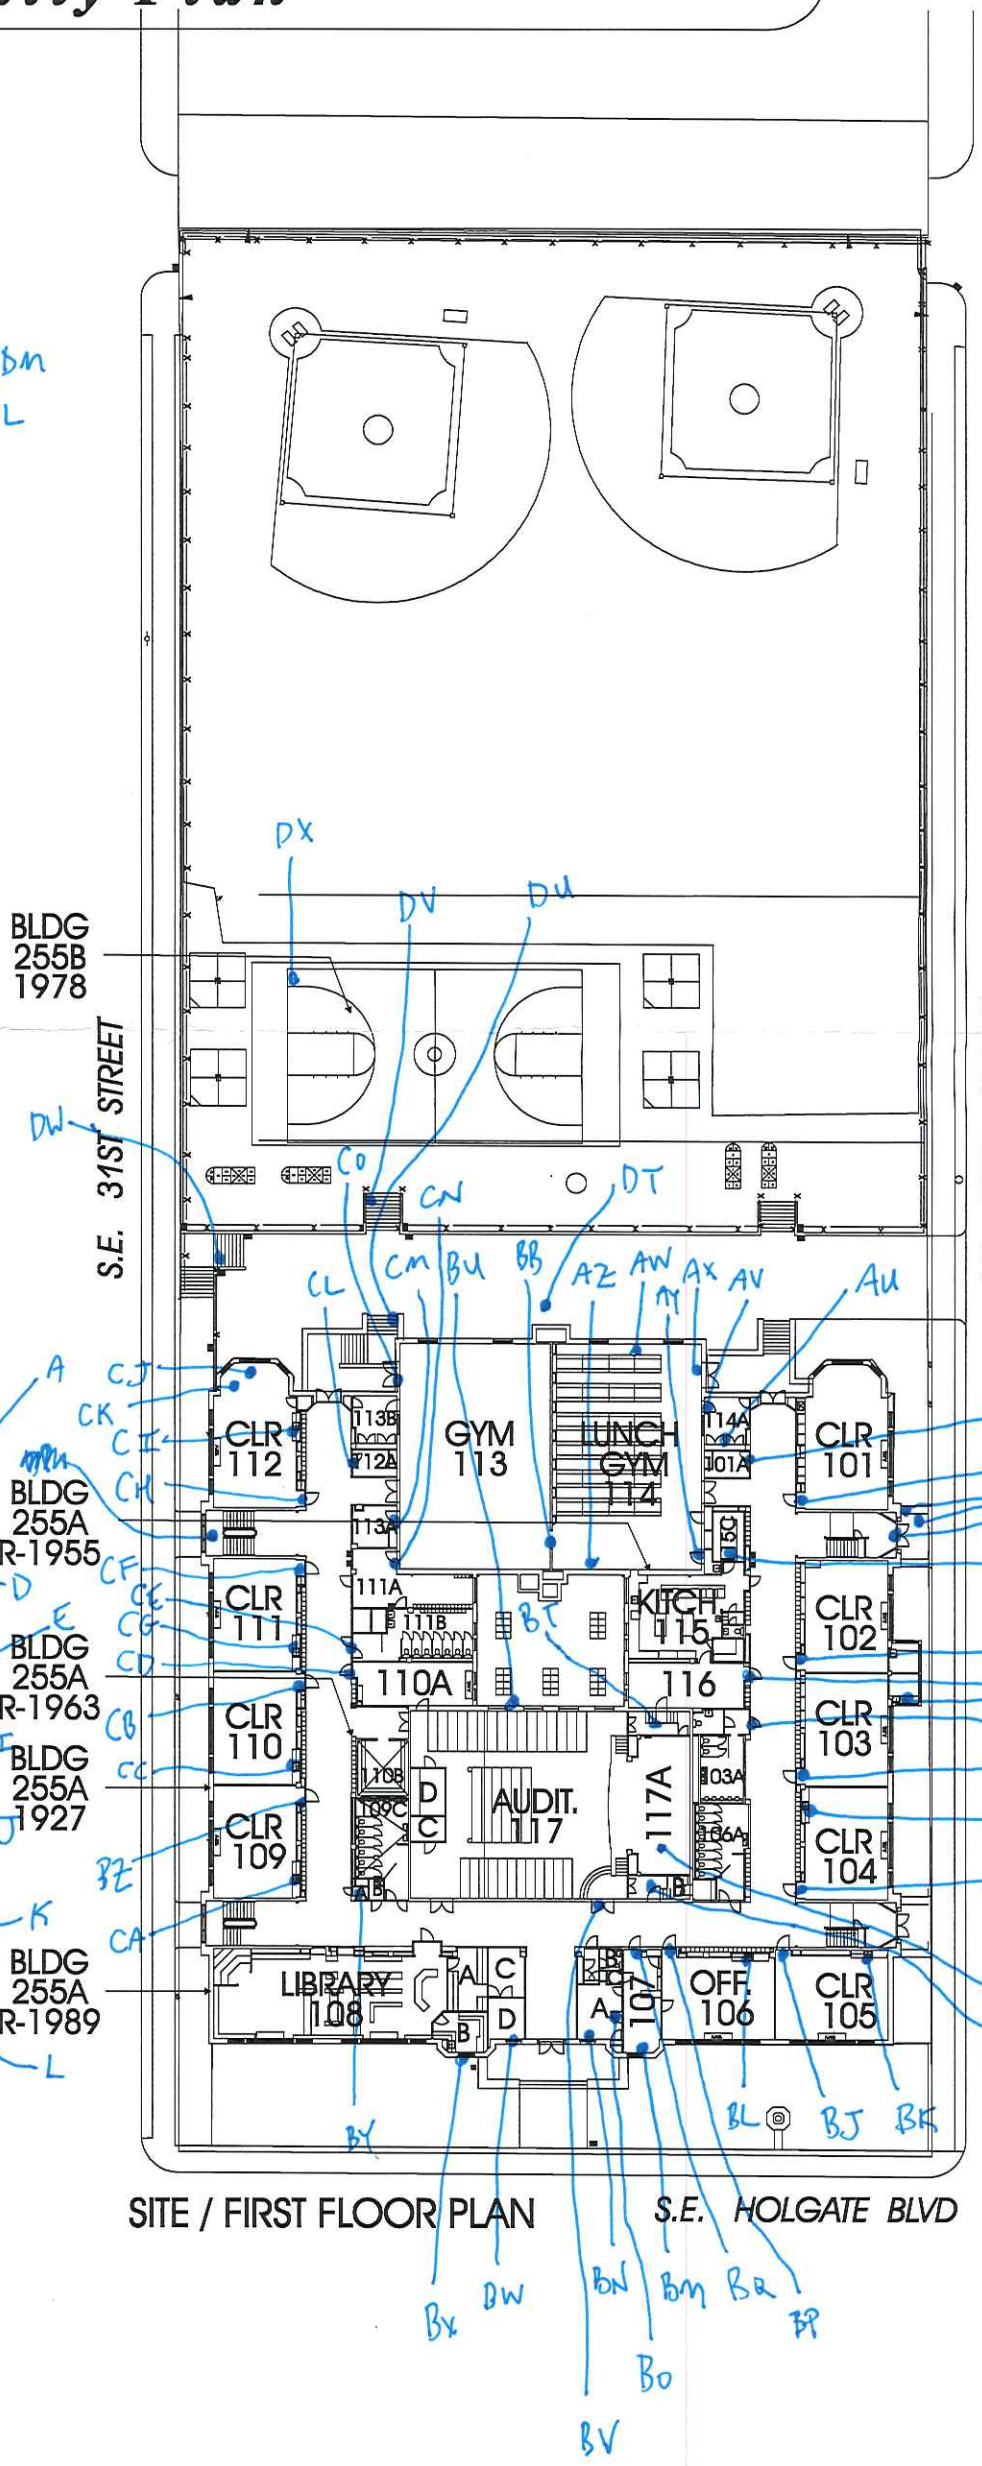
Overall, the building's painted and varnished surfaces were found to be in intact condition with areas of fair and deteriorated conditions. A table listing the locations and quantity of surfaces in deteriorated condition is attached to this report.

Areas of high concern noted during PBS' site visit were paint chips observed near deteriorated conditions in the counselor's office, next to Library 207, and in Classroom 112.

PBS recommends that all painted or varnished surfaces in deteriorated condition noted on the attached table be stabilized. Paint chips in the counselor's office, next to Library 207, and in Classroom 112 should be removed. Wooden window troughs should be cleaned.
