Regarding: Lead Paint Condition Assessment
Sellwood Middle School
8300 SE 15th Avenue
Portland, Oregon 97202
PBS Project: 6500.721 Phase 0068

Sellwood Middle School 8300 SE 15th Avenue 97202 Facility Plan

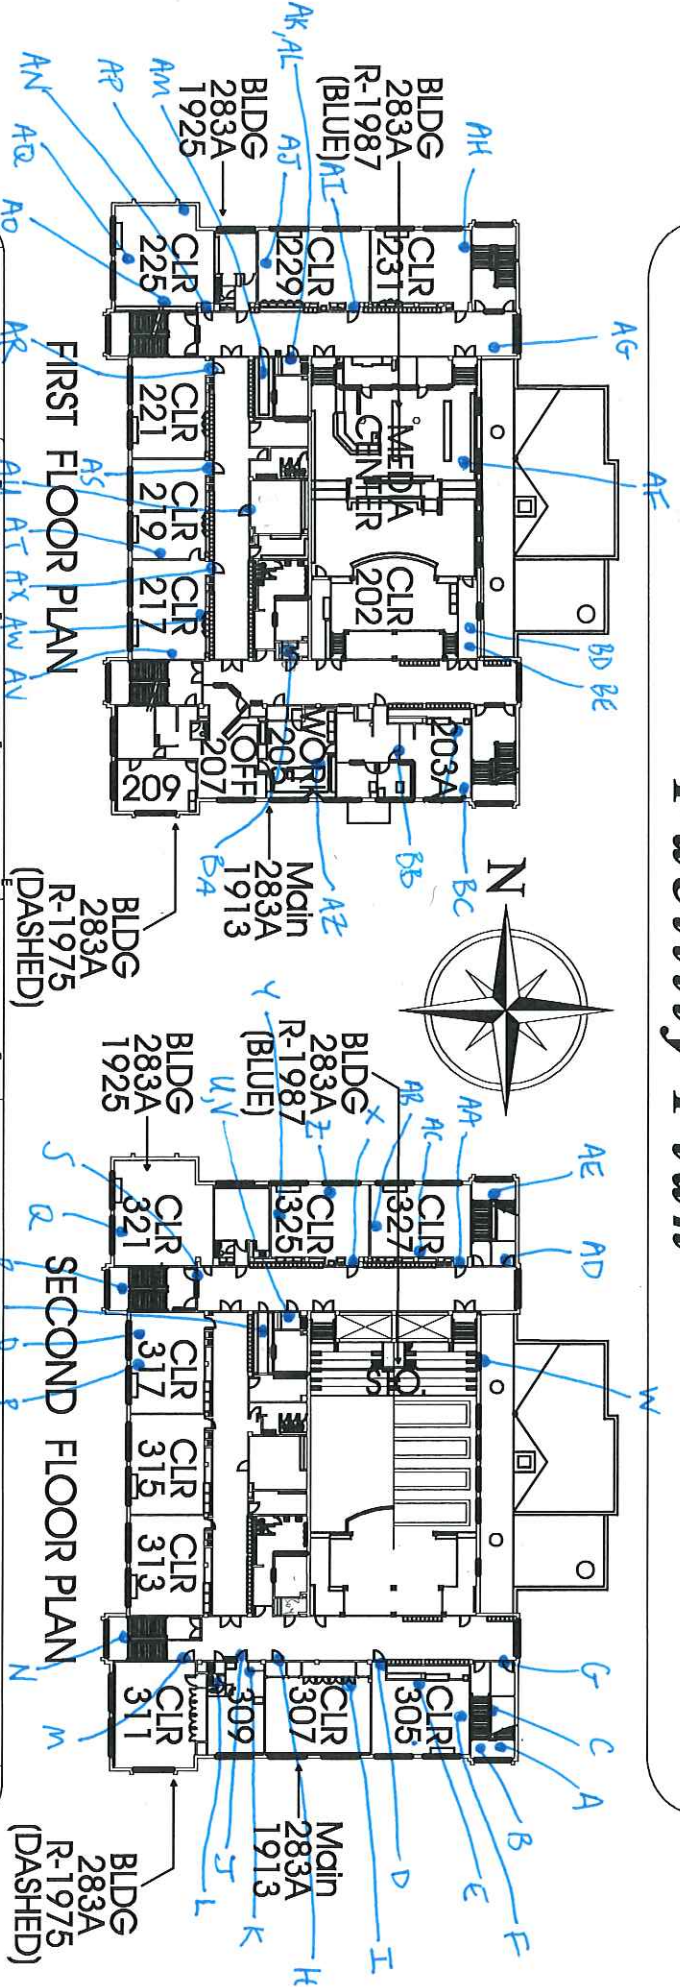
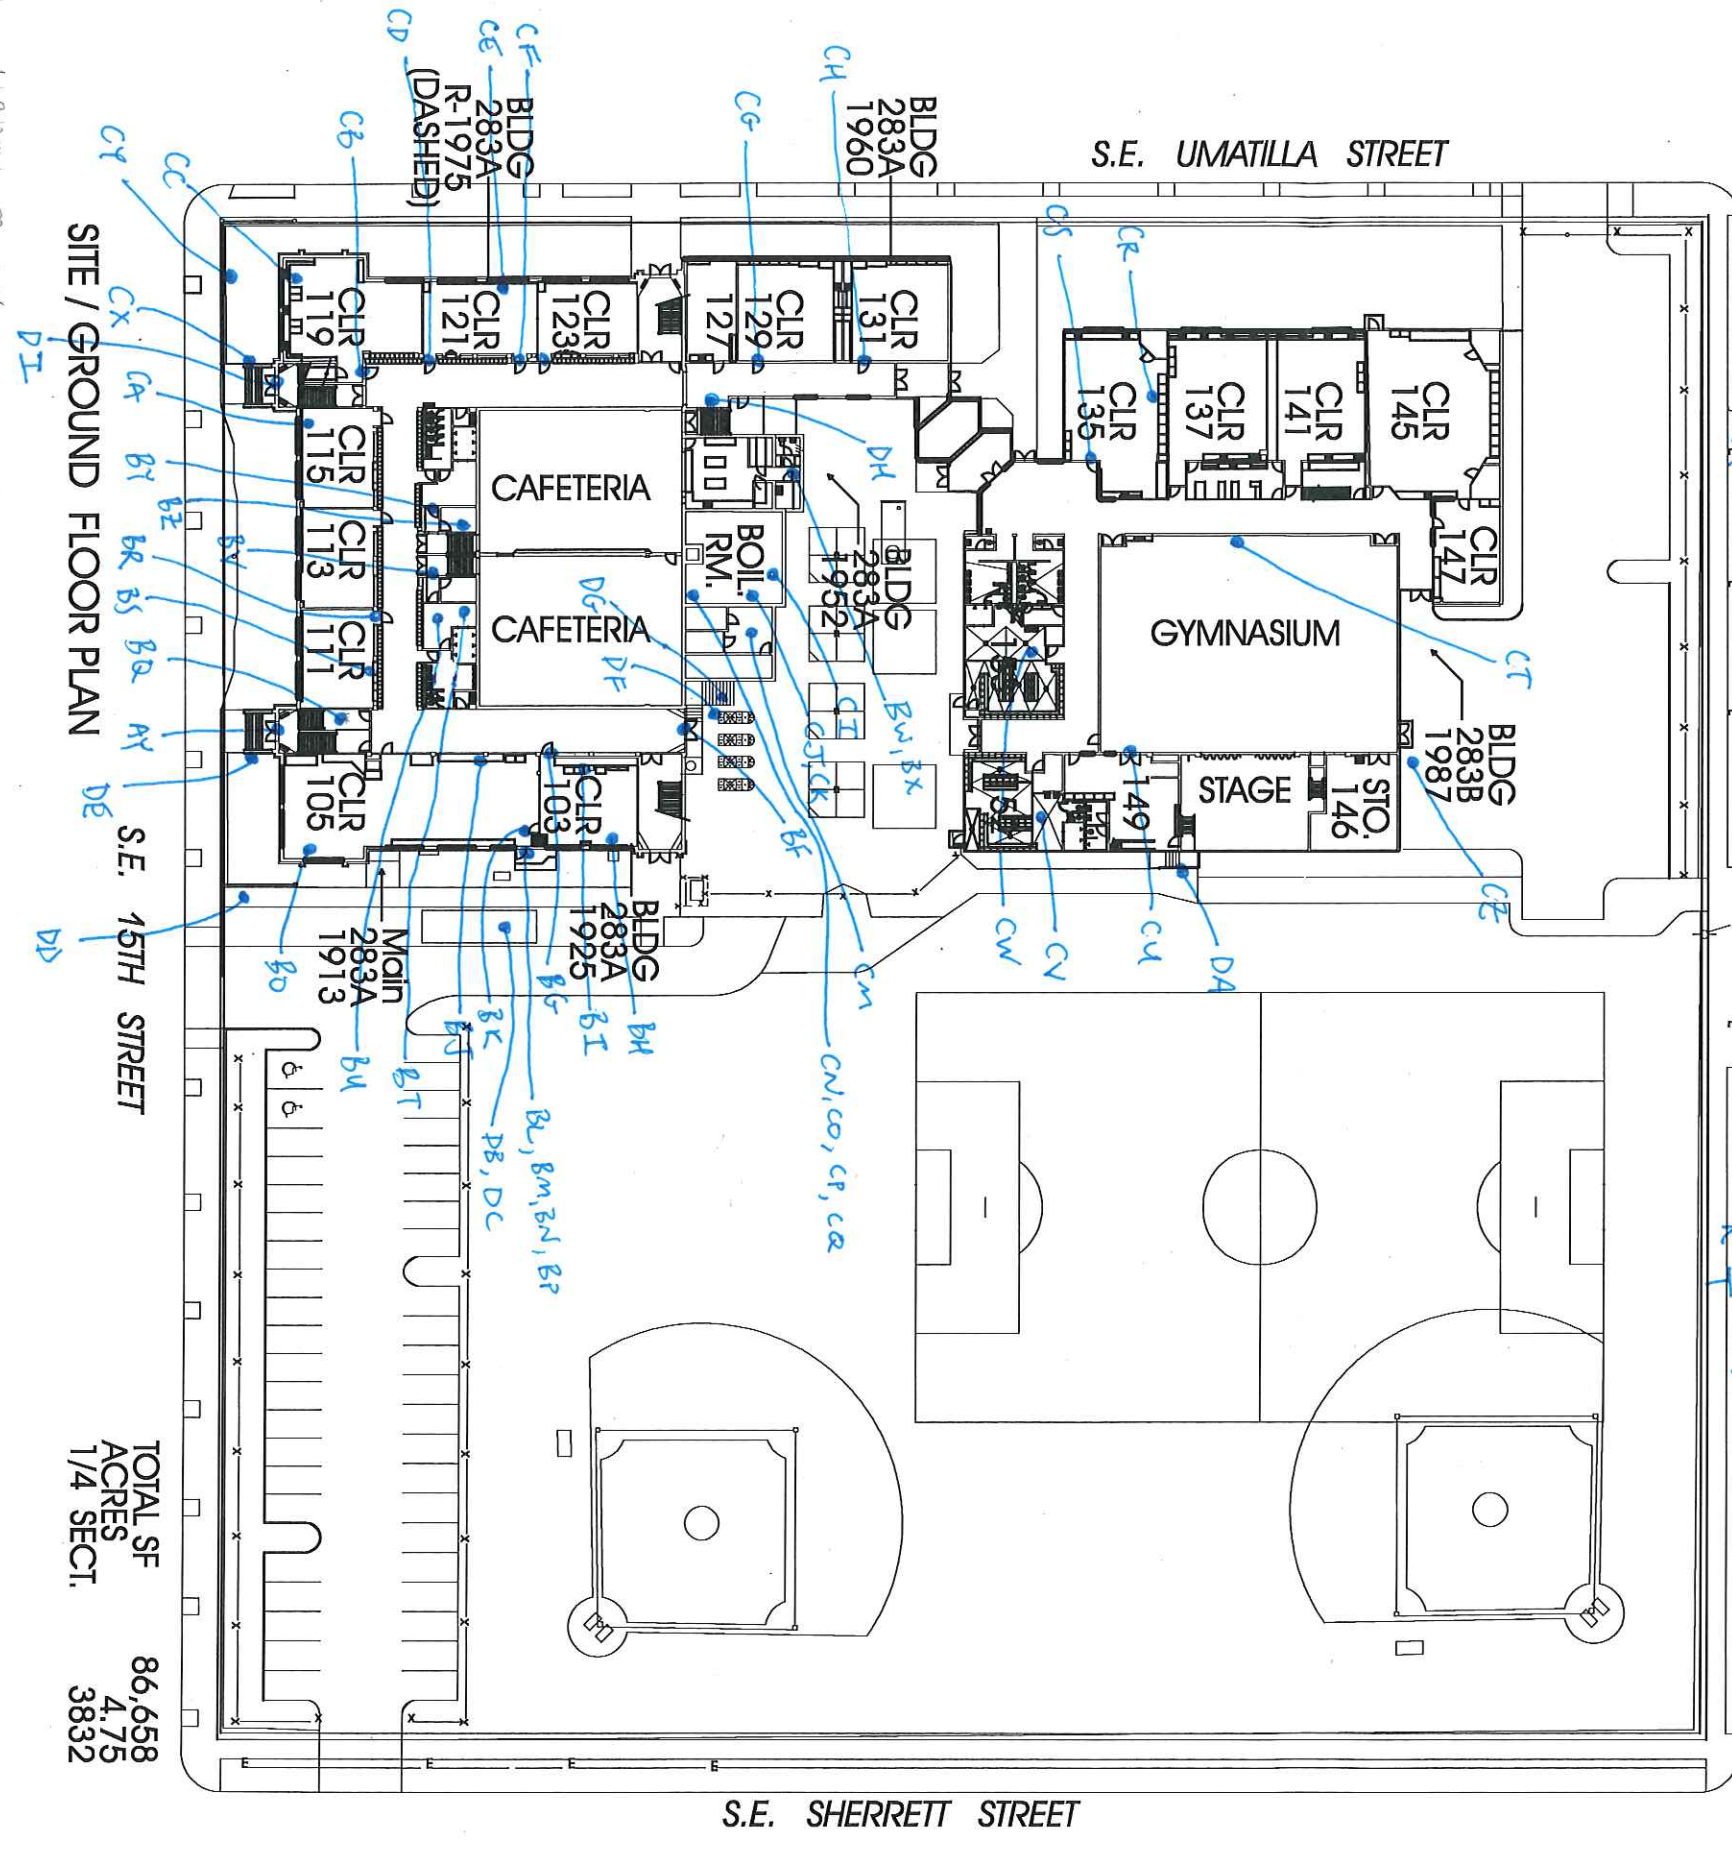
Overall, the building's painted and varnished surfaces were found to be in intact condition with areas of fair and deteriorated conditions. A table listing the locations and quantity of surfaces in deteriorated condition is attached to this report.

Paint chips were also observed in the boiler room, the southeast stairwell, storage 110A, and room 200.

PBS recommends that all painted or varnished surfaces in deteriorated condition noted on the attached table be stabilized. All paint chips noted in this report should be removed, including those in the media center's window troughs.
