Regarding: Lead Paint Condition Assessment
Jackson Middle School
10625 SW 35th Avenue
Portland, Oregon 97219
PBS Project: 6500.721 Phase 0063

Jackson Middle School
Assessment of Paint/Varnish in Deteriorated Condition

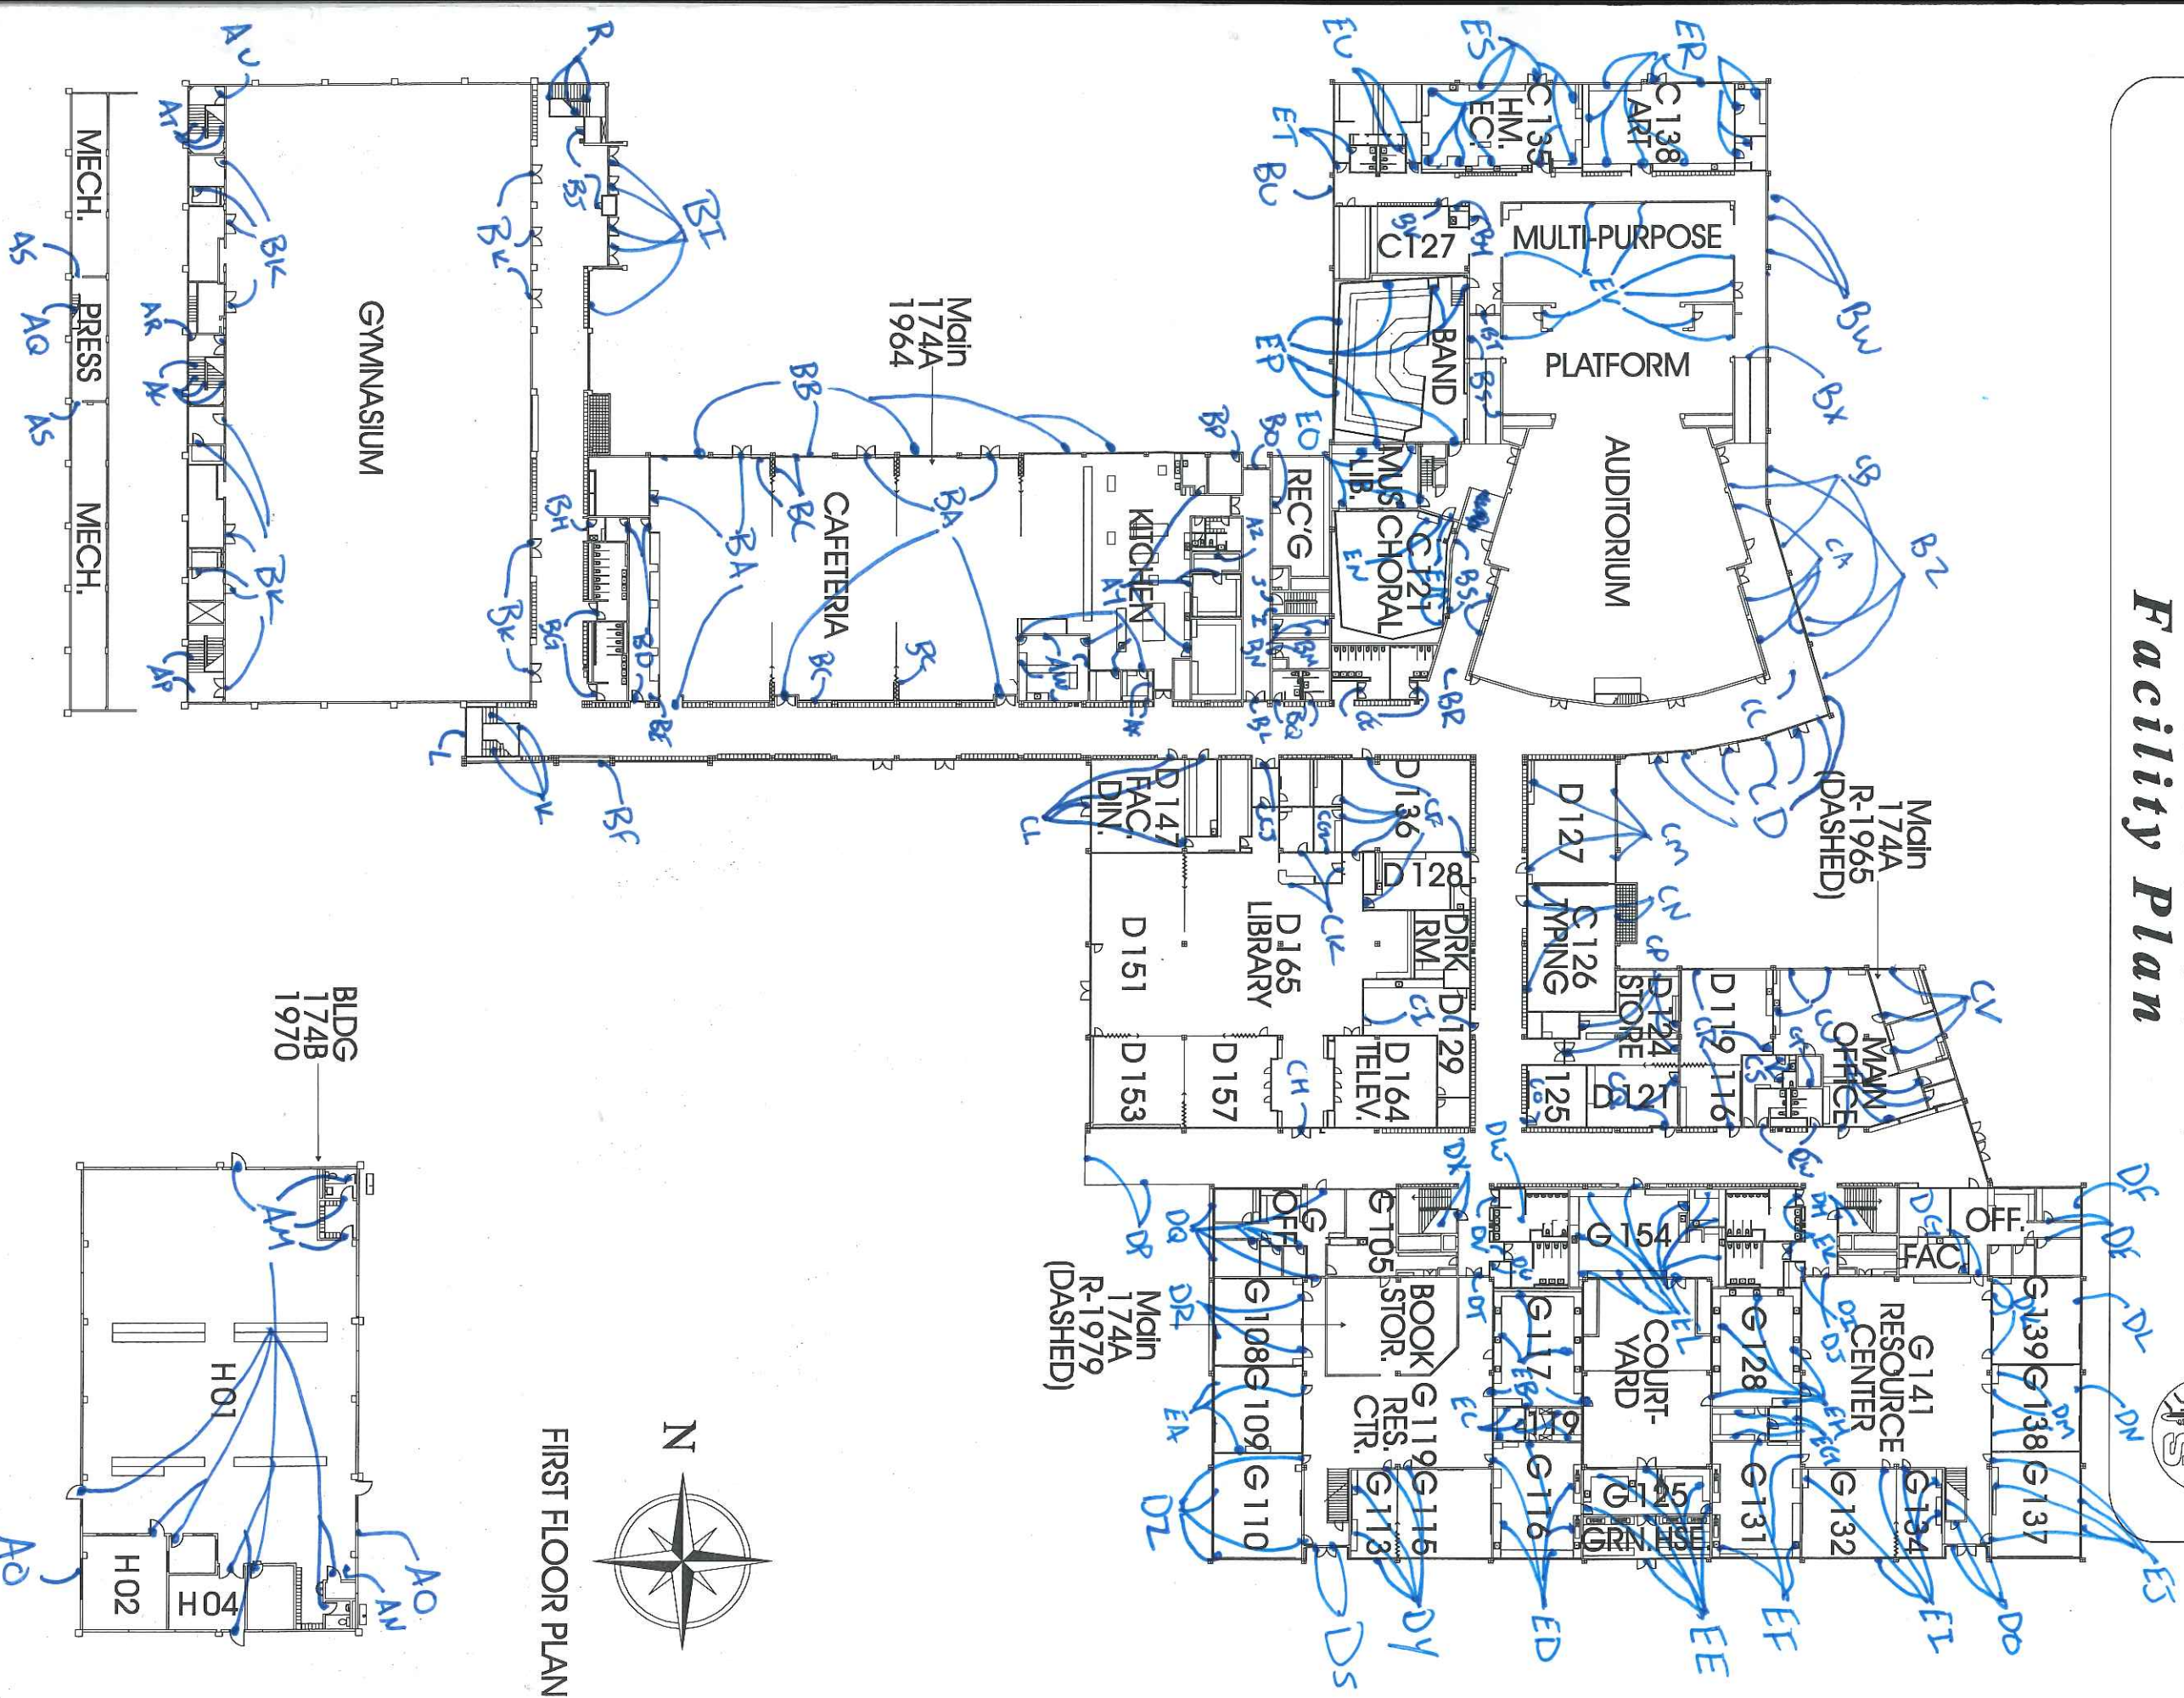
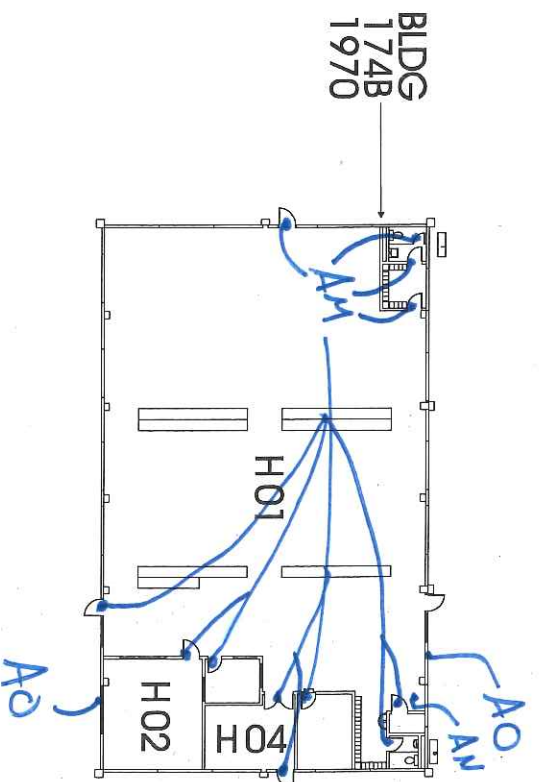
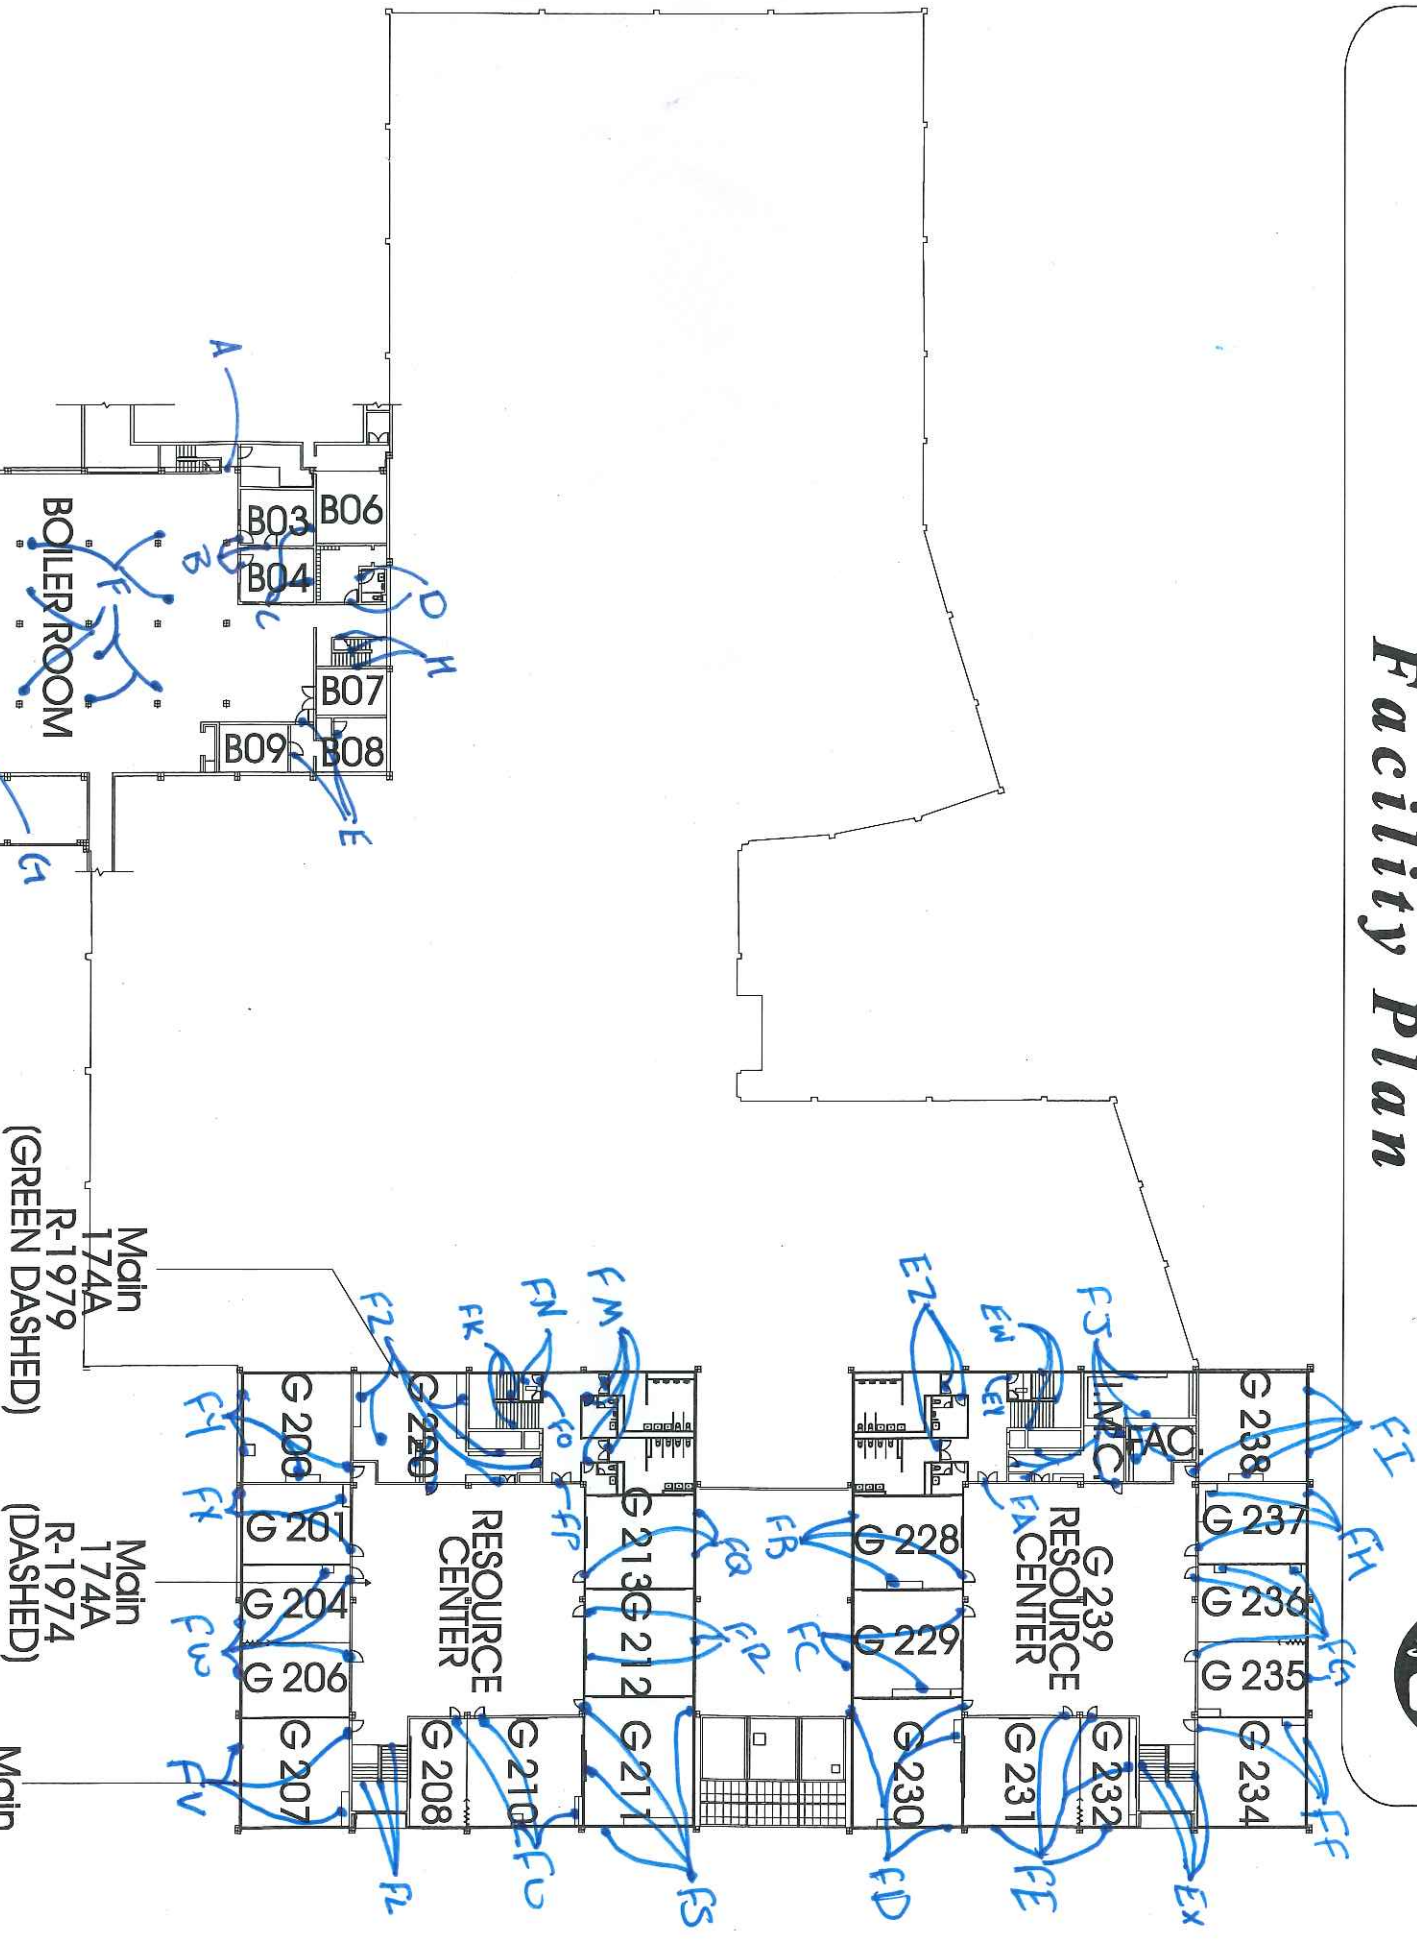
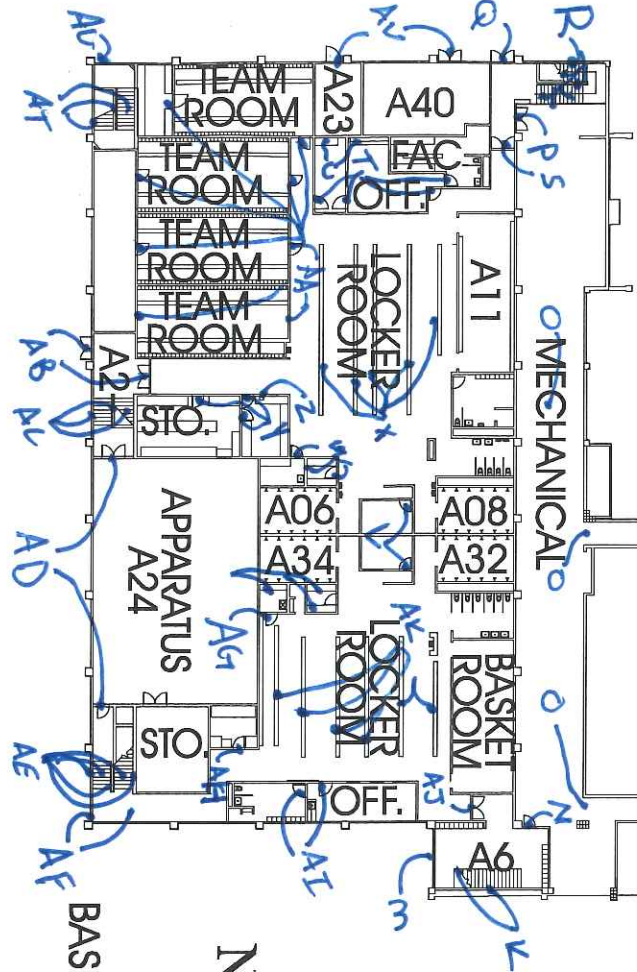
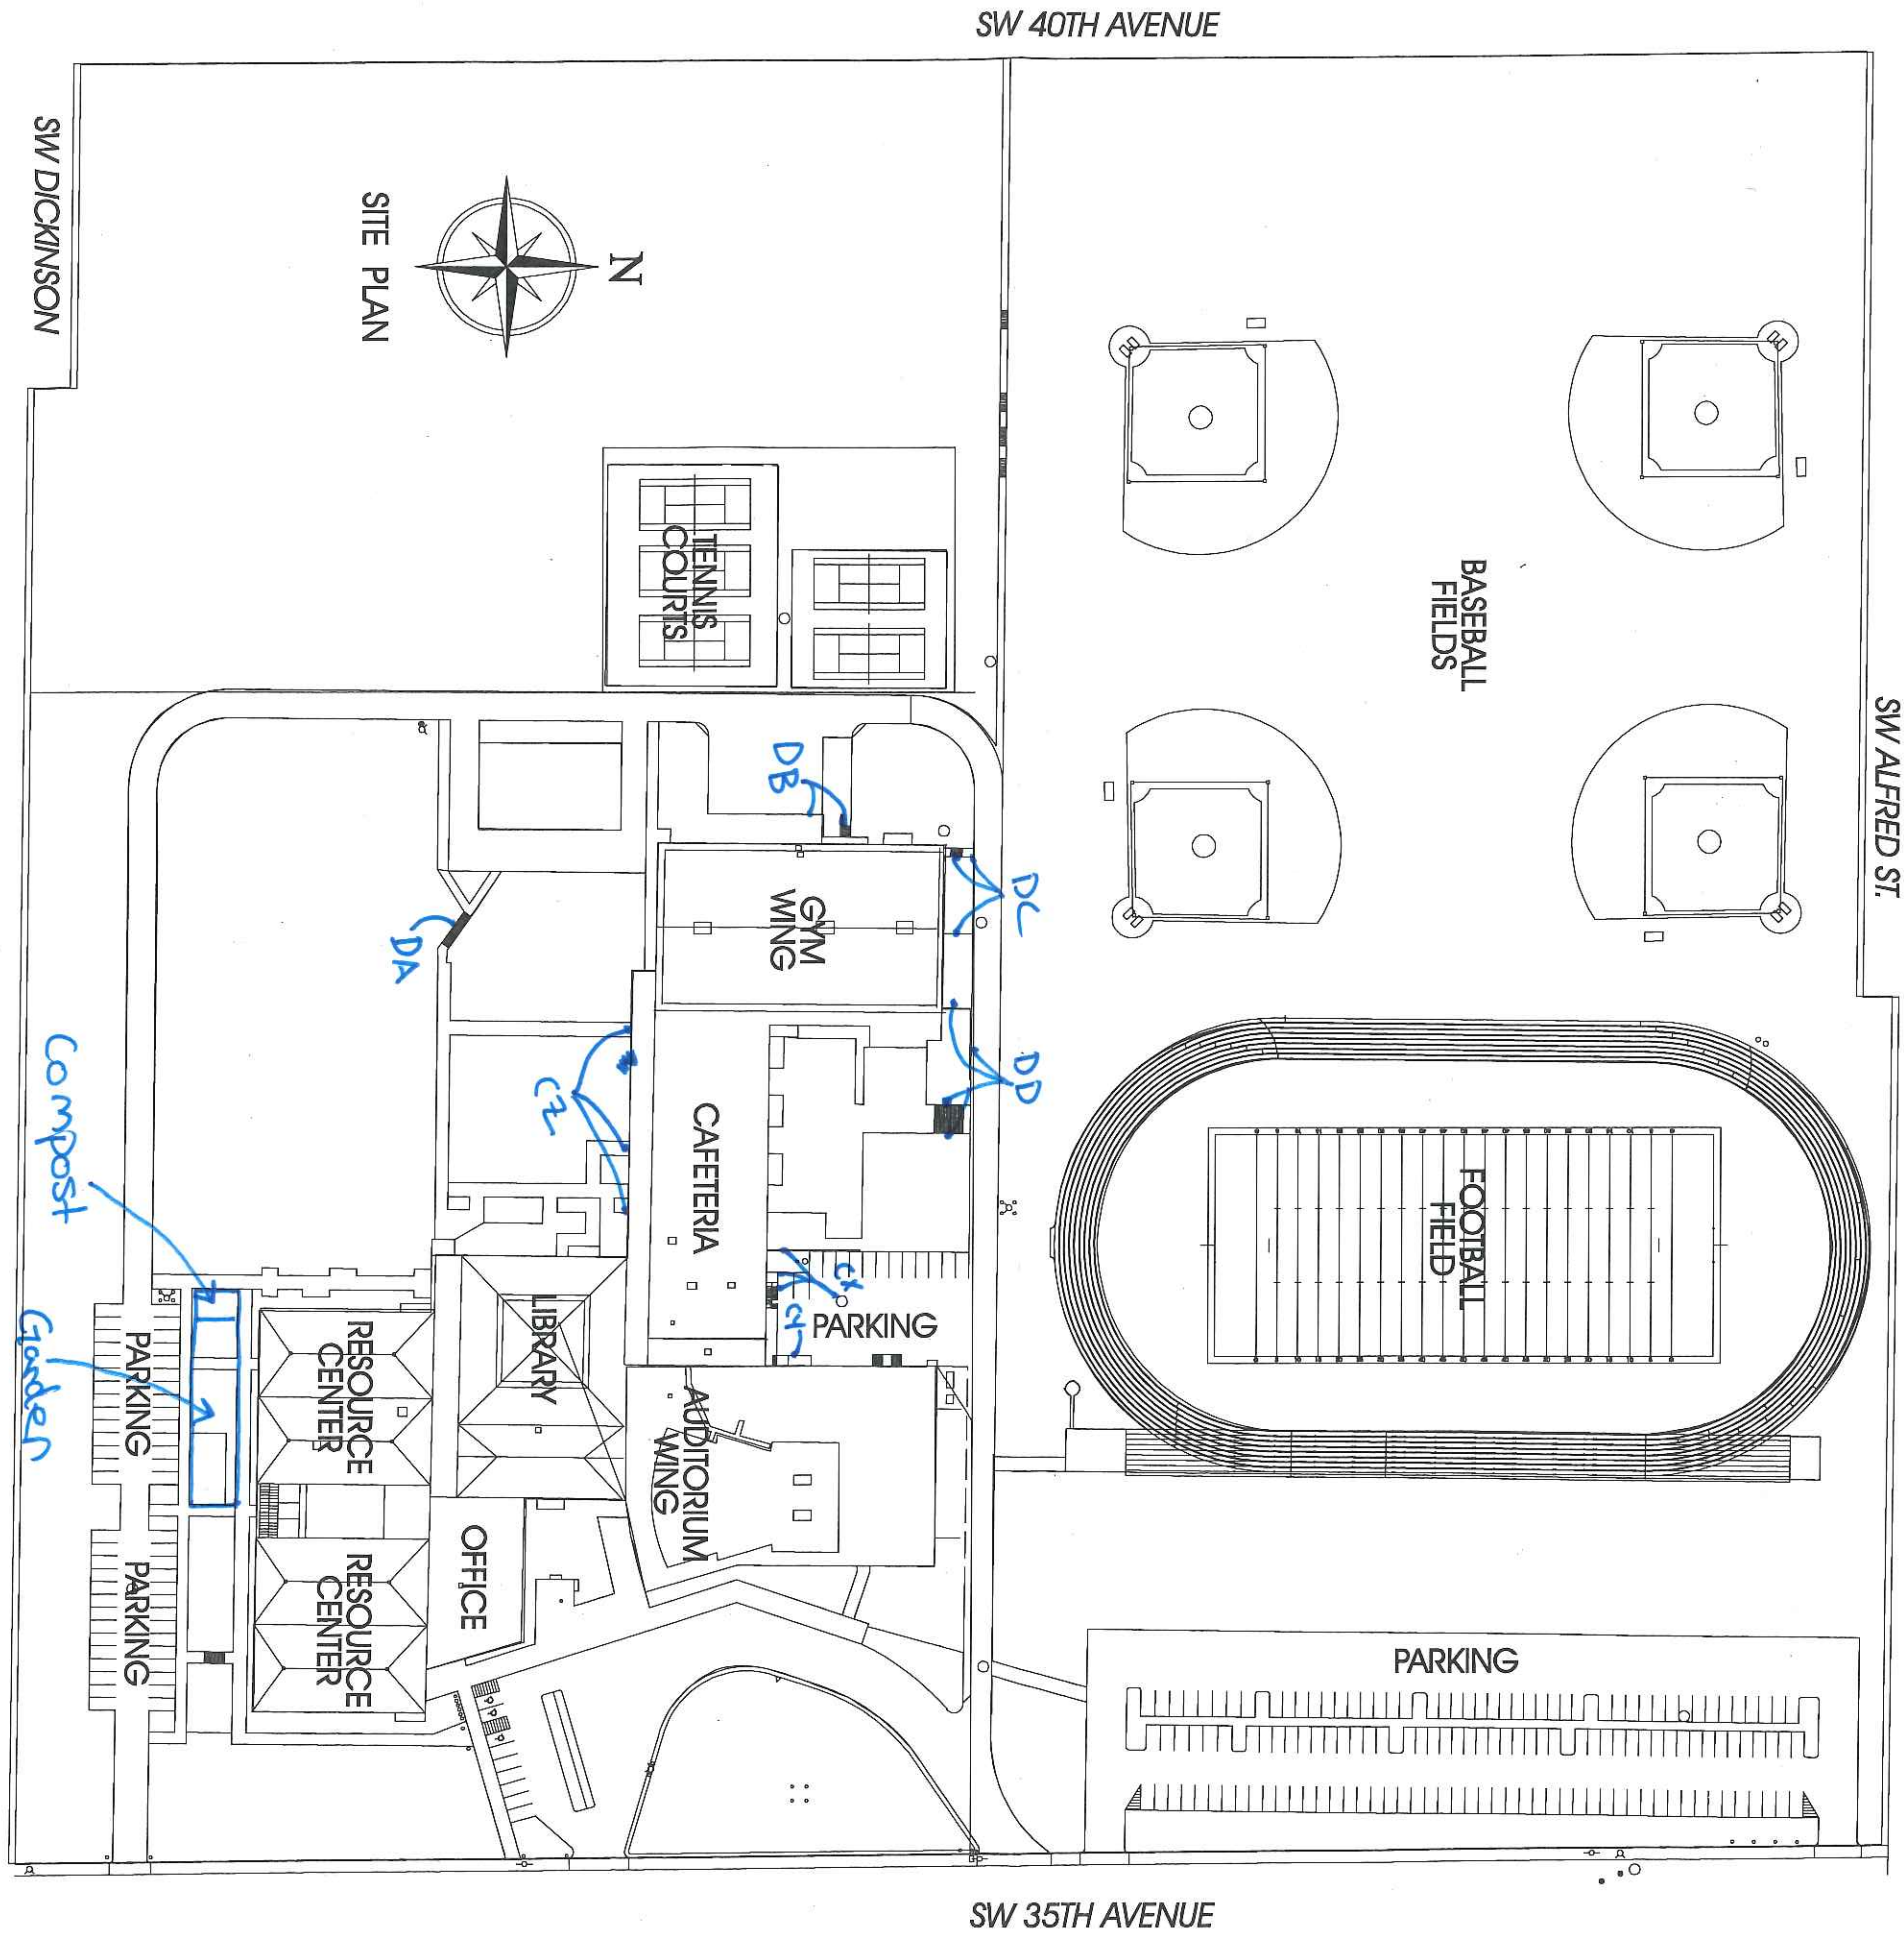
Jackson Middle School 10625 SW 35th 97219 Facility Plan

Overall, the building's painted and varnished surfaces were found to be in intact condition with areas of fair and deteriorated conditions. A table listing the locations and quantity of surfaces in deteriorated condition is attached to this report.

PBS recommends that all painted or varnished surfaces in deteriorated condition noted on the attached table be stabilized.
