Regarding: Lead Paint Condition Assessment
Woodstock Elementary School
5601 SE 50th Avenue
Portland, Oregon 97206
PBS Project: 6500.721 Phase 0058

**Woodstock Elementary School
Assessment of Paint/Varnish in Deteriorated Condition**

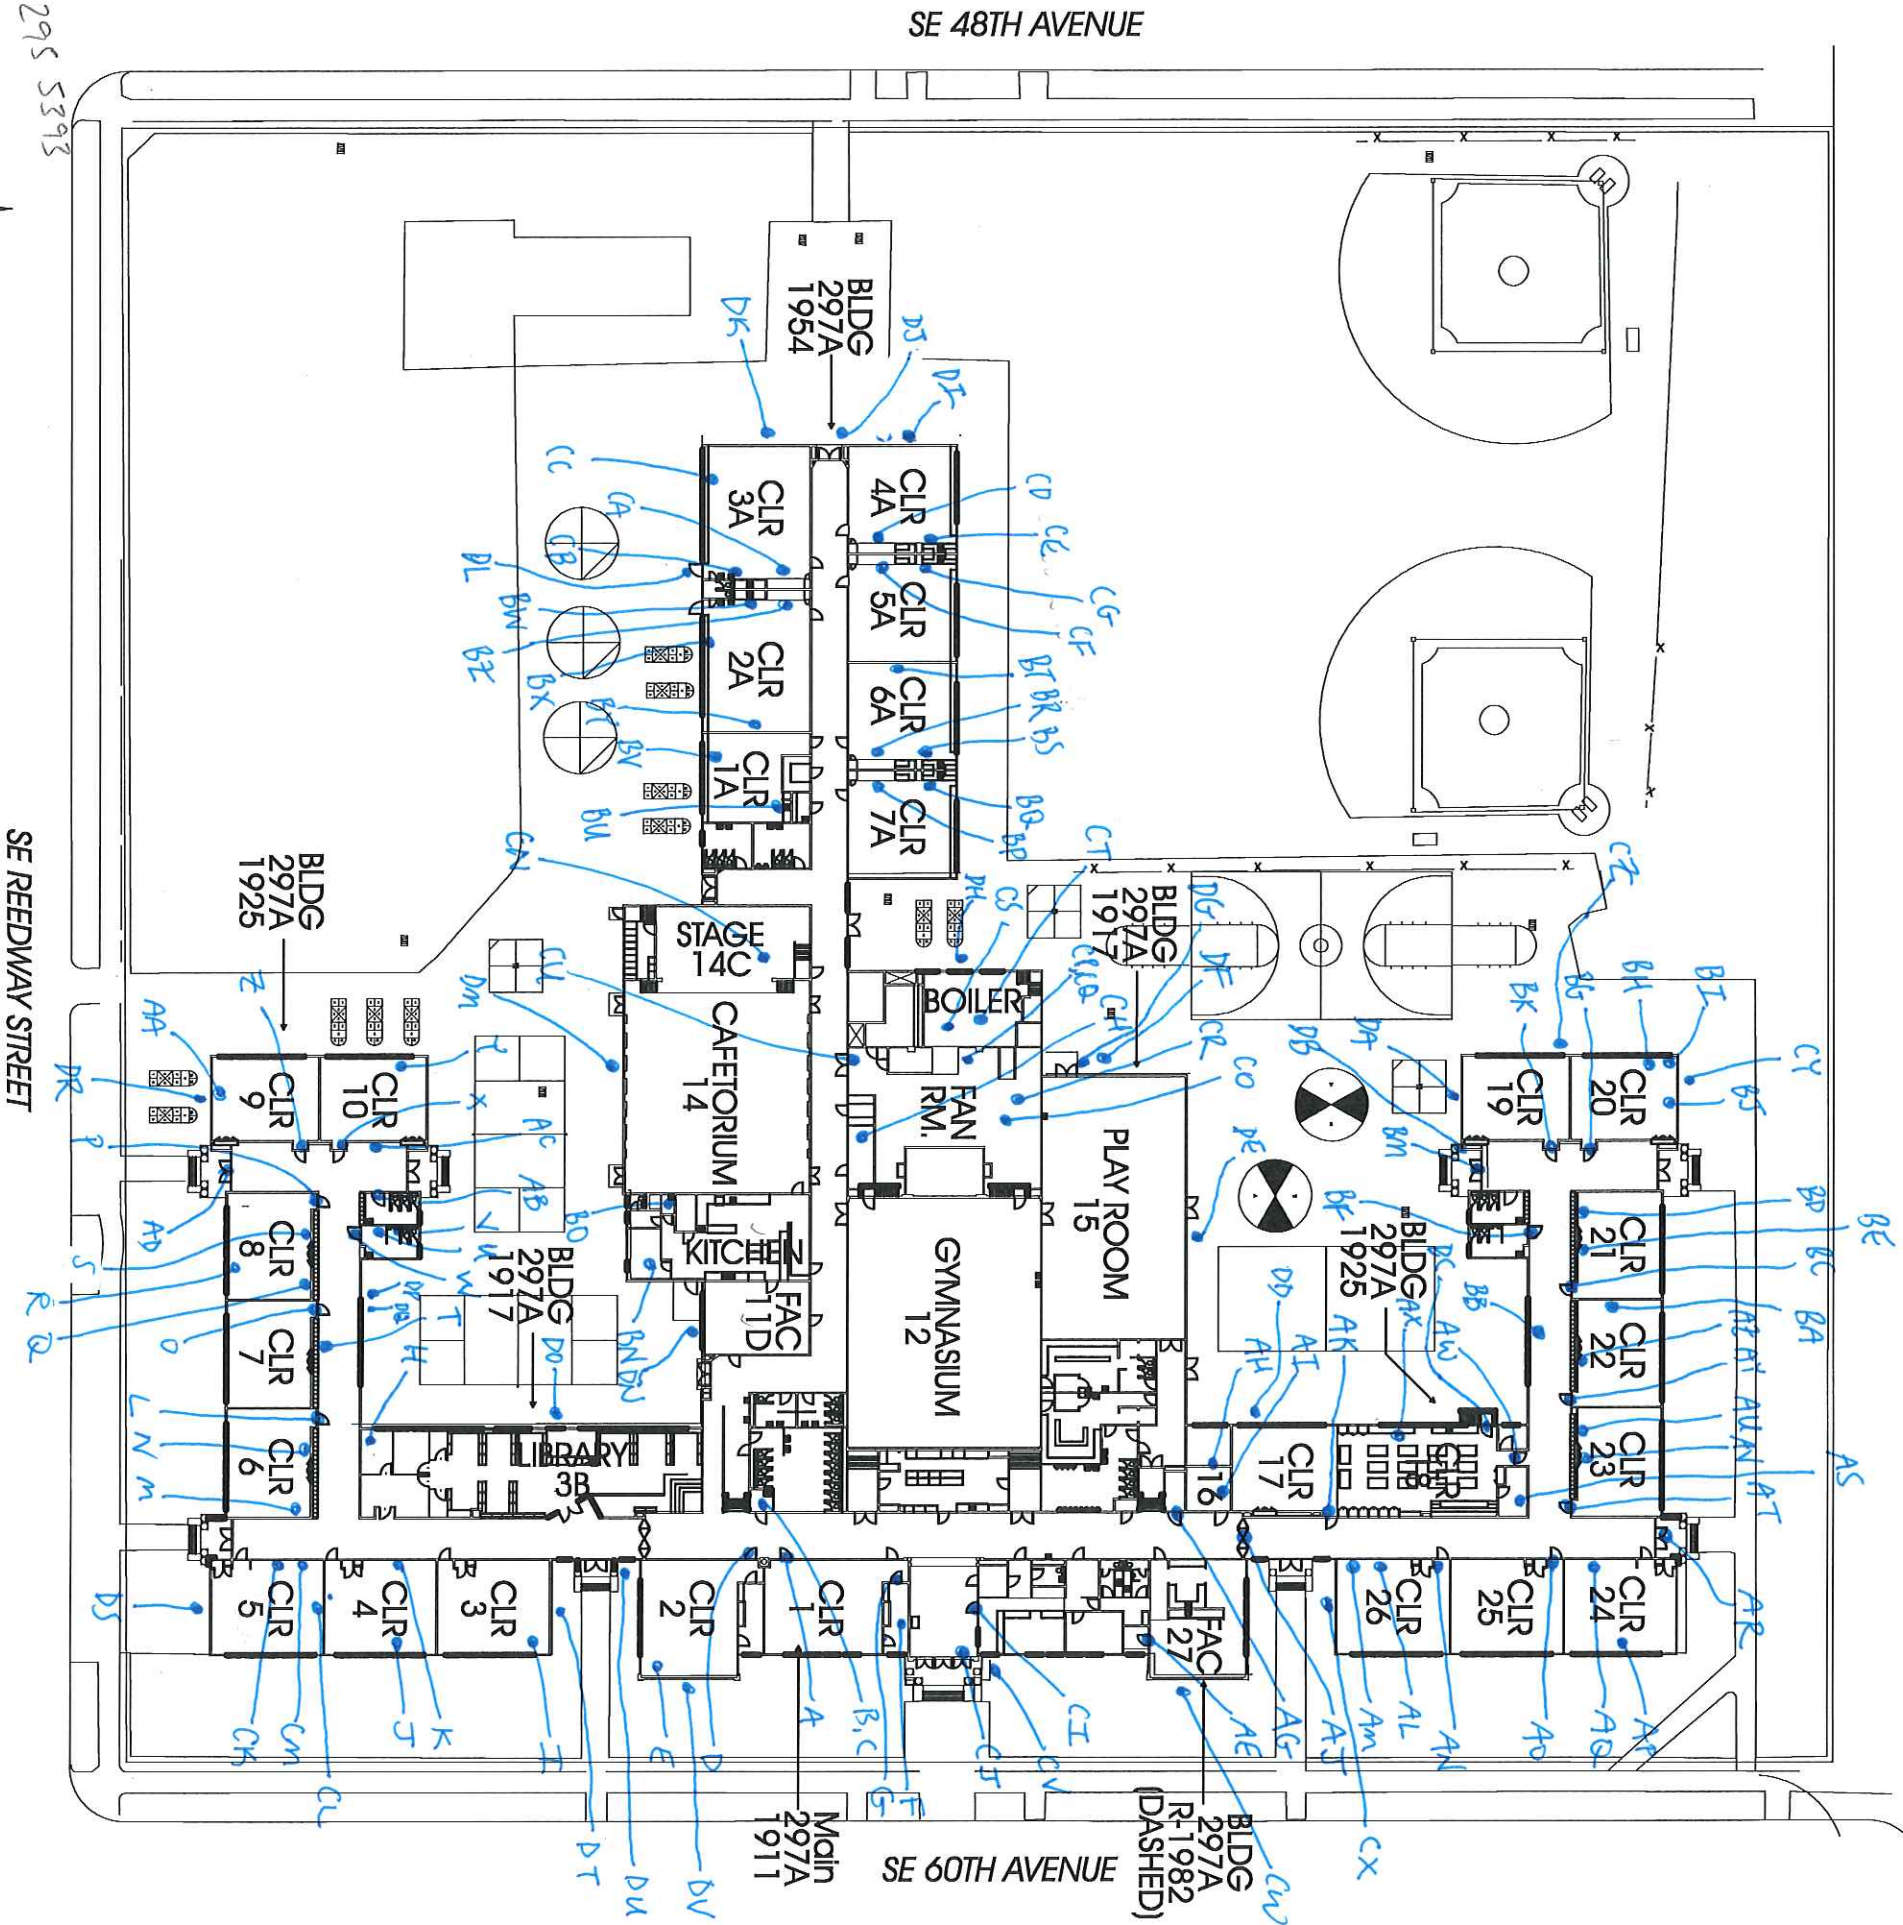
SITE / FIRST FLOOR PLAN

Overall, the building's painted and varnished surfaces were found to be in intact condition with areas of fair and deteriorated conditions. A table listing the locations and quantity of surfaces in deteriorated condition is attached to this report.

No paint chips were observed in garden spaces; however, paint chips were observed on concrete on the exterior of the west hallway near deteriorated paint conditions. Deteriorated paint conditions exist in multiple locations on the building's exterior.

PBS recommends that all painted or varnished surfaces in deteriorated condition noted on the attached table be stabilized, including the school's exterior, which should be stabilized in the near future. All paint chips noted in this report should be removed. Window troughs in classrooms 1A through 7A should be cleaned.
