## SEISMIC STUDY OF EXISTING SCHOOL FACILITIES

**Portland Public Schools**

**December 7, 2009**

### Executive Summary

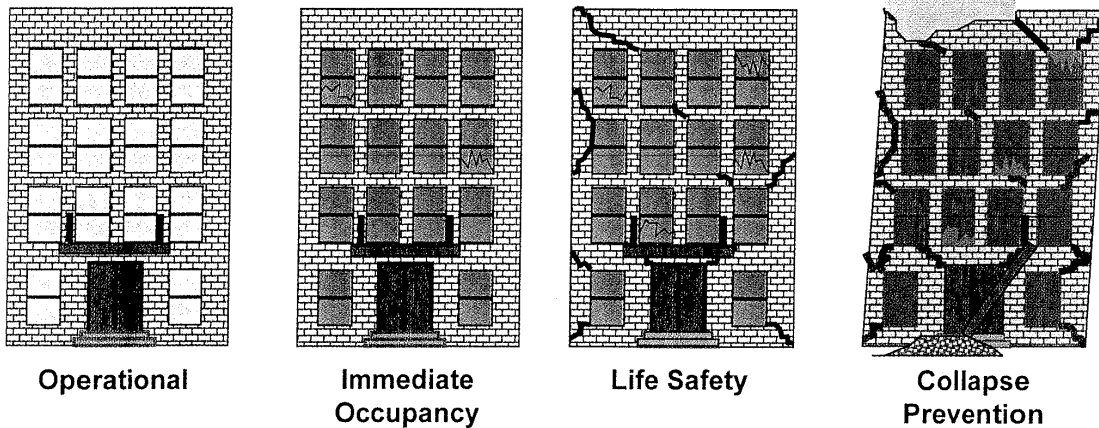
Graphic illustration of Operational, Immediate Occupancy, Life-Safety, and Collapse Prevention Performance Levels. (Courtesy of R. Hamburger)
