Regarding: Lead Paint Condition Assessment Creative Science School 1231 SE 92nd Avenue Portland, Oregon 97216 PBS Project: 6500.721 Phase 0018

On January 9, 2017, PBS Engineering and Environmental Inc. conducted a visual inspection and assessment of painted and varnished surfaces on the interior and exterior of Creative Science School located at 1231 SE 92nd Avenue in Portland, Oregon.

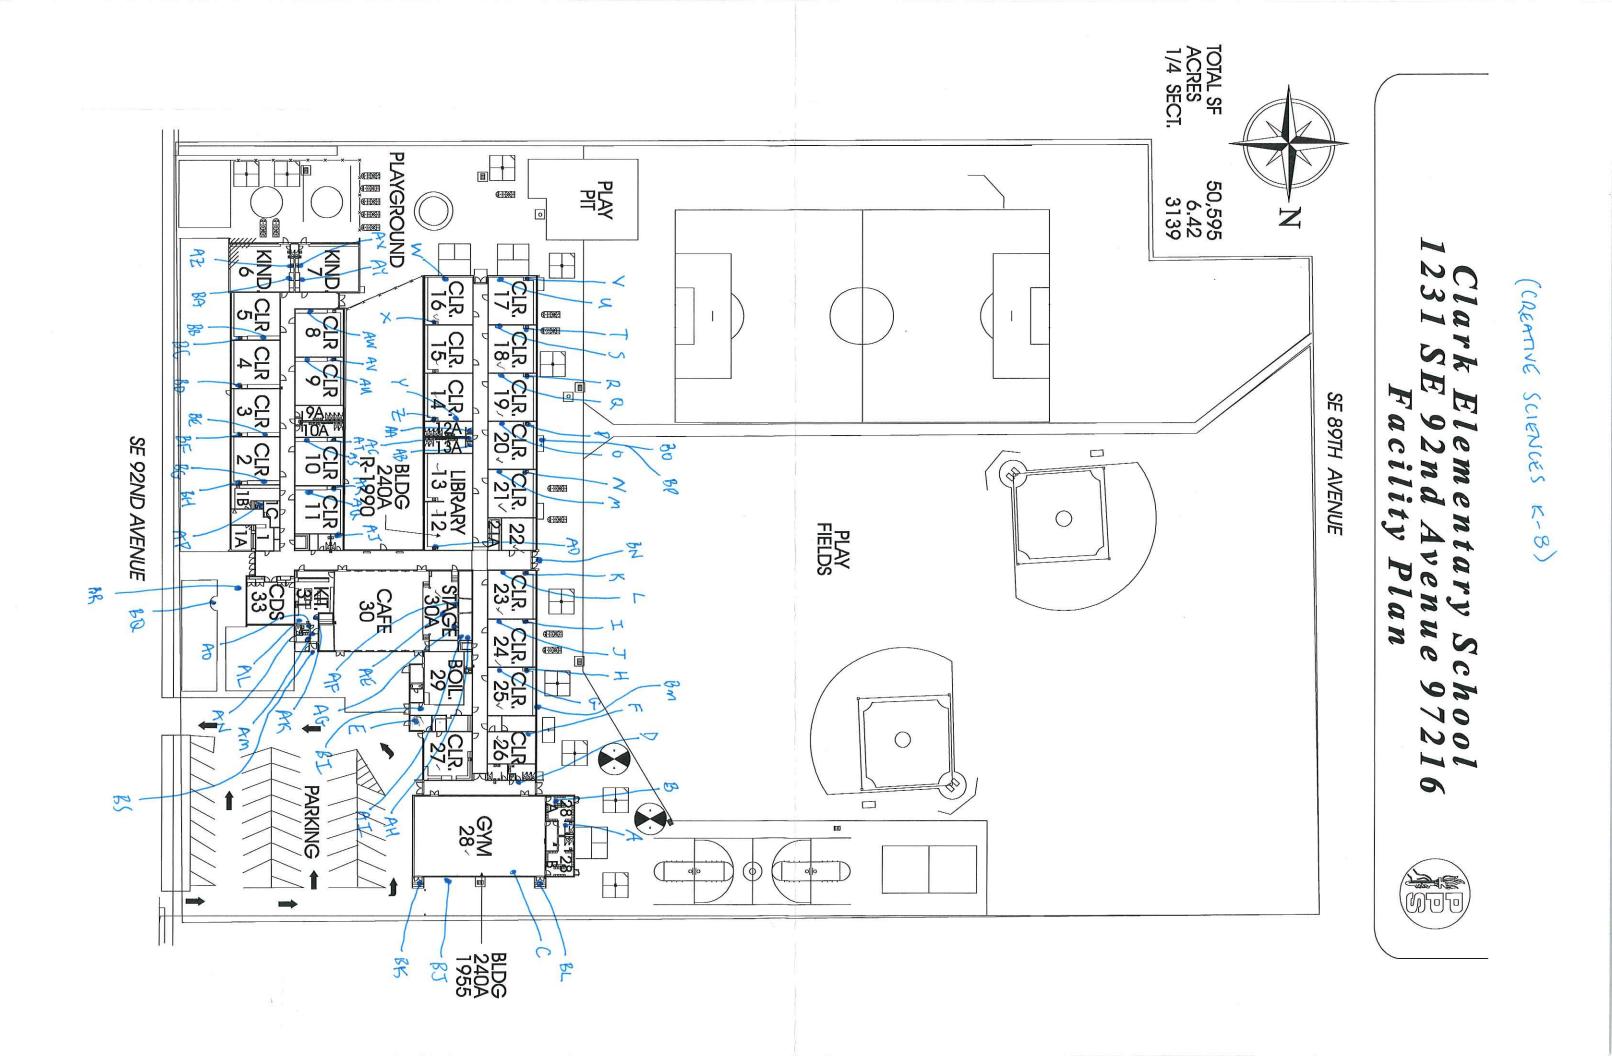
Overall, the building's painted and varnished surfaces were found to be in intact condition with areas of fair and deteriorated conditions. A table listing the locations and quantity of surfaces in deteriorated condition is attached to this report.

ID	Interior / Exterior	Location	Structure	Above / Below five feet	K-2nd Grade	Substrate	Quantity
А	Interior	28A near toilets	Ceiling	Above	No	Plaster	25
В	Interior	28A along south wall	Ceiling	Above	No	Plaster	50
С	Interior	Gym	Trim along floor	Below	No	Wood	400
D	Interior	Boys restroom across from gym	Door	Above and below	No	Wood	45
Е	Interior	Electrical room	Wall	Above and below	No	Plaster	80
F	Interior	Classroom 26	Built-in cabinets and trim under sink	Below	Yes	Wood	40
G	Interior	Classroom 25	Shelves in coat closet	Above	Yes	Wood	24
Н	Interior	Classroom 25	Built-in cabinets and trim under sink	Below	Yes	Wood	40
I	Interior	Classroom 24	Built-in cabinets and trim under sink	Below	Yes	Wood	40
J	Interior	Classroom 24	Shelves in coat closet	Above	Yes	Wood	24
К	Interior	Classroom 23	Built-in cabinets and trim under sink	Below	Yes	Wood	40
L	Interior	Classroom 23	Shelves in coat closet	Above	Yes	Wood	24
М	Interior	Classroom 21	Shelves in coat closet	Above	Yes	Wood	24

PBS recommends that all painted or varnished surfaces in deteriorated condition noted on the attached table be stabilized.
